**MULTI-MODAL INTERSECTIONS:
RESOLVING CONFLICTS
BETWEEN TRAINS, MOTOR
VEHICLES, BICYCLISTS AND
PEDESTRIANS**

Final Report

SPR 794

Oregon Department of Transportation

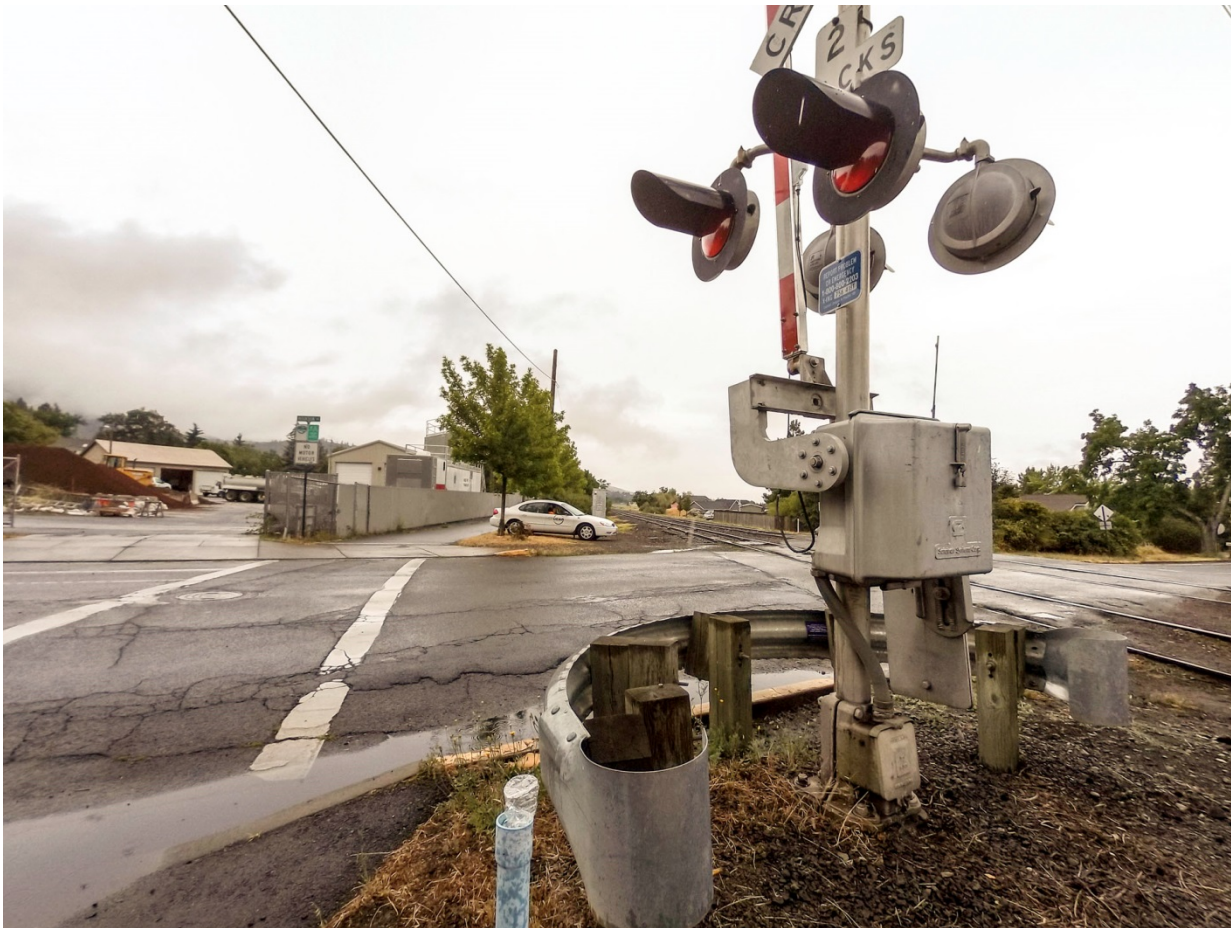
Figure 3.49: The trail, known as The Central Bike Path continues on the other side of the crossing

Adjacent to the railroad tracks are a multiuse trail called the Central Bike Path, that was observed to be primarily used by pedestrians and a very few bikes. The trail is 1.8 miles long and connects residential areas with business areas and with Southern Oregon University. The users of the trail at the time of the observations were recreational in nature. Around half of the pedestrians continued across the crossing and onto the trail, whereas the other half crossed the railroad tracks.

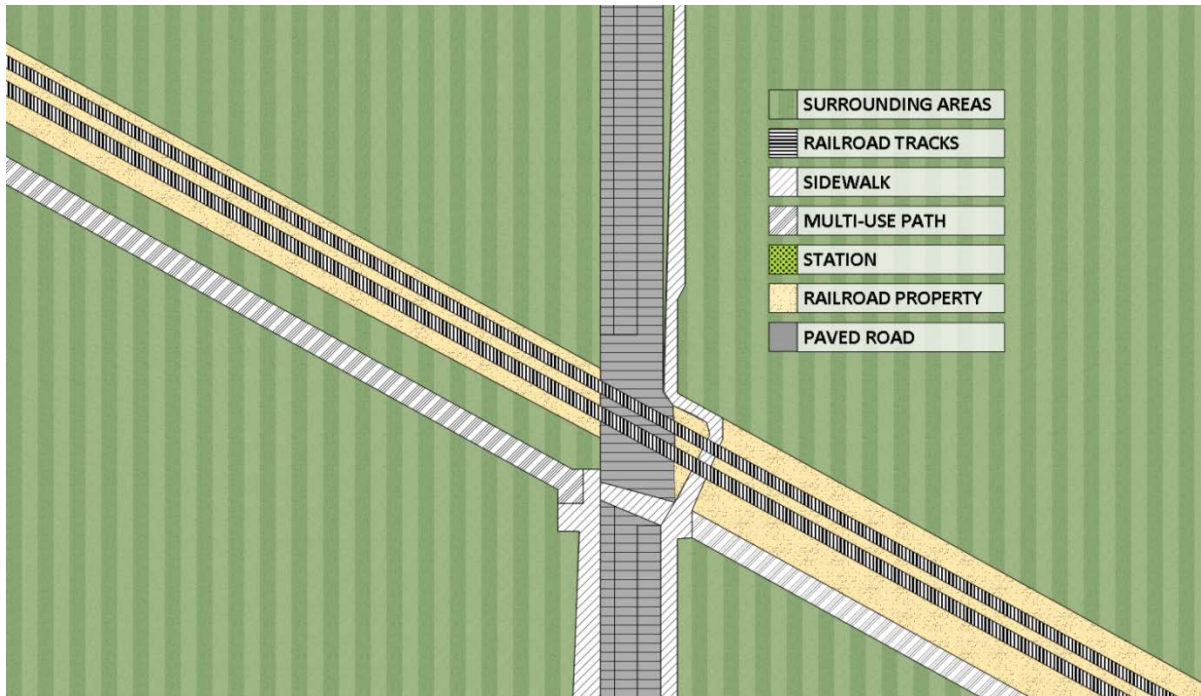
Figure 3.50: N Mountain Ave.

A simplified diagram of N Mountain Ave. is included below to exemplify the dynamic movements of road and path users at this crossing.

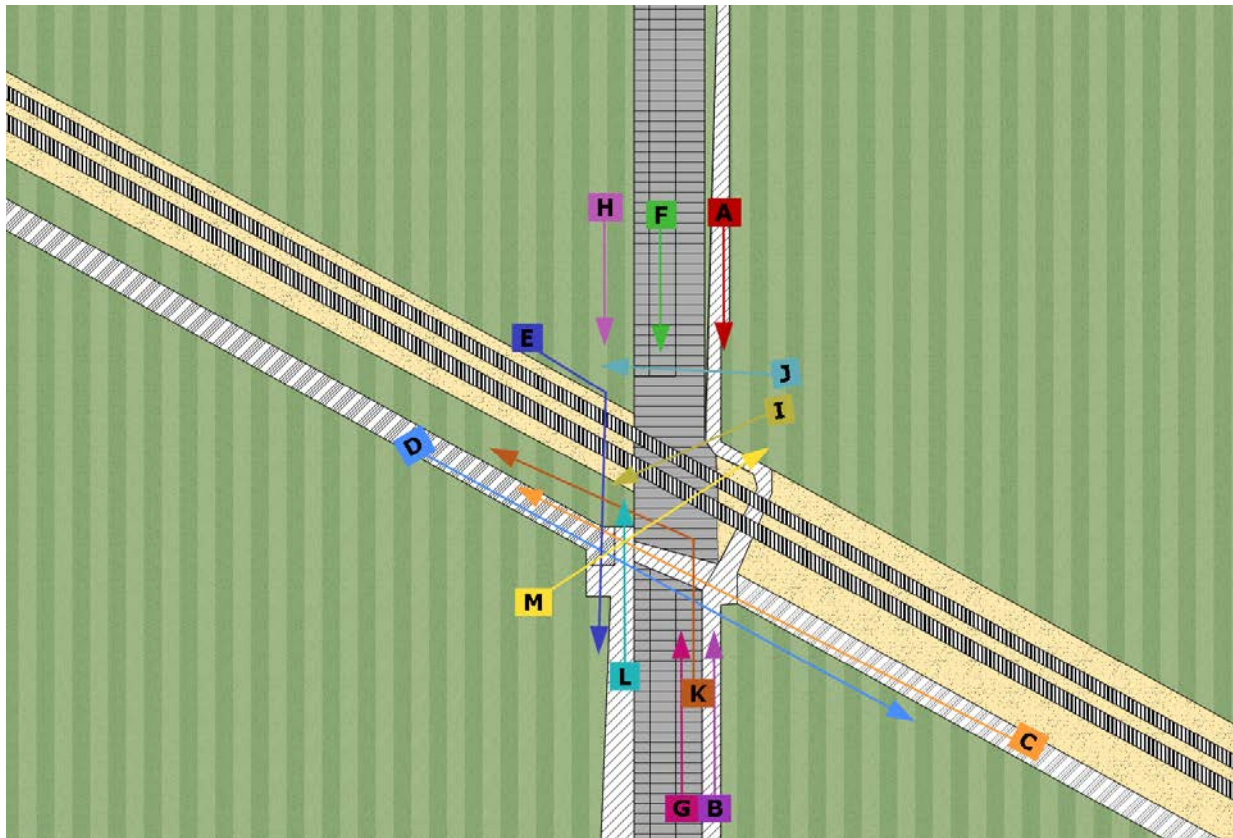
Figure 3.52: Diagram depicting observed pedestrian and bike movements

Two of the most frequently observed pedestrian movements are staying along the path which is exhibited by Movement C & D.

Observed undesired pedestrian movements include: Movement E, I, J, L, & M.

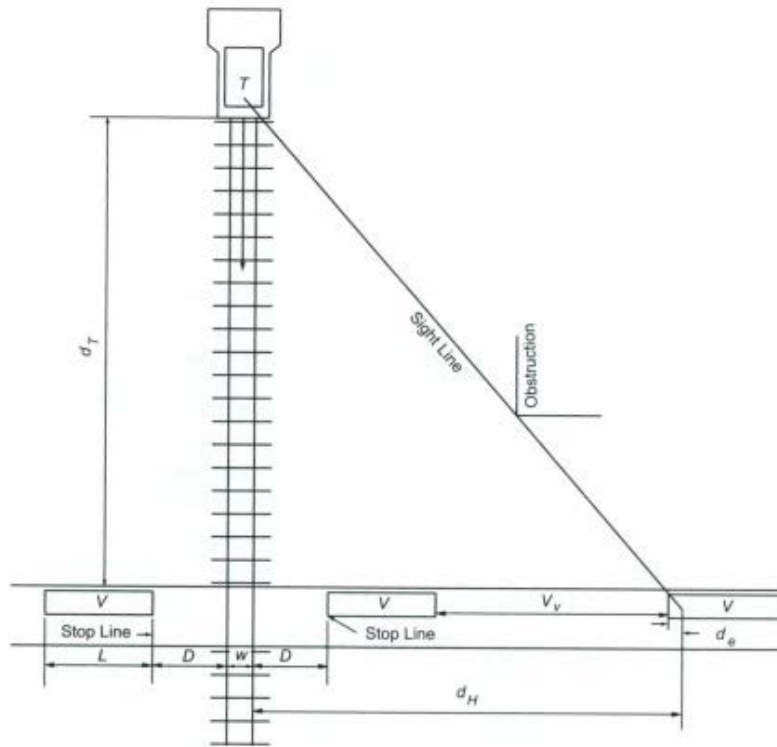
Figure 4.2: Moving vehicle to safely cross or stop at railroad crossing (AASHTO, 2012)

All values are U.S. Customary. Adjustments should be made for skewed crossings and highway grades other than flat (AASHTO, 2012).

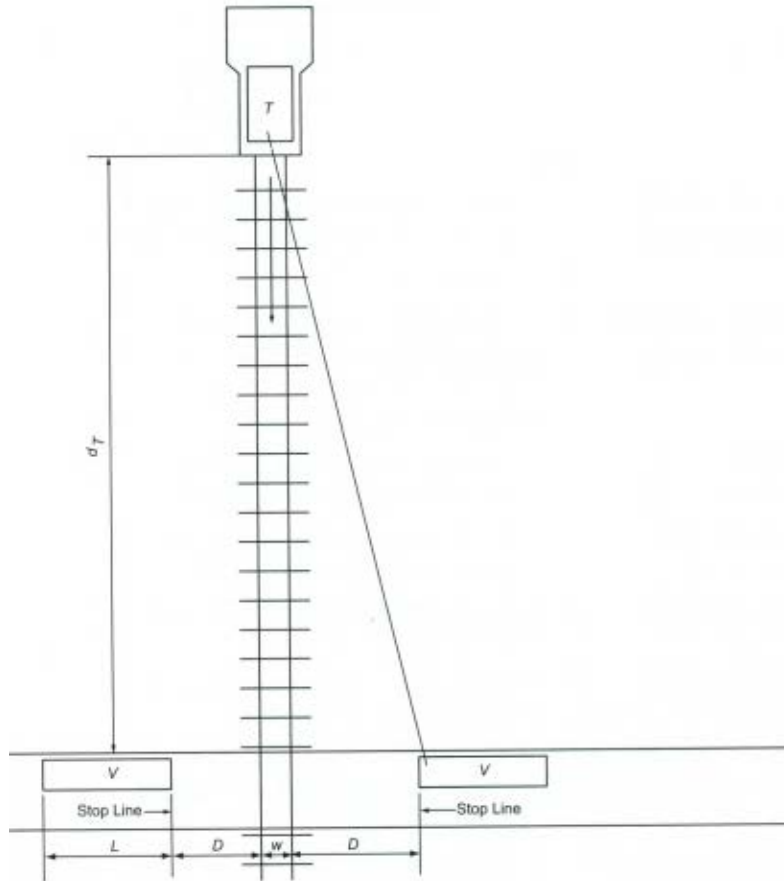
Figure 4.3: Sight line for stopped vehicles (AASHTO, 2012)

$$d_a = \frac{V_G^2}{2a_1} = \frac{(8.8)^2}{(2)(1.47)} = 26.3 \text{ ft} = \text{Distance vehicle travels while accelerating to maximum speed in first gear (ft)}$$

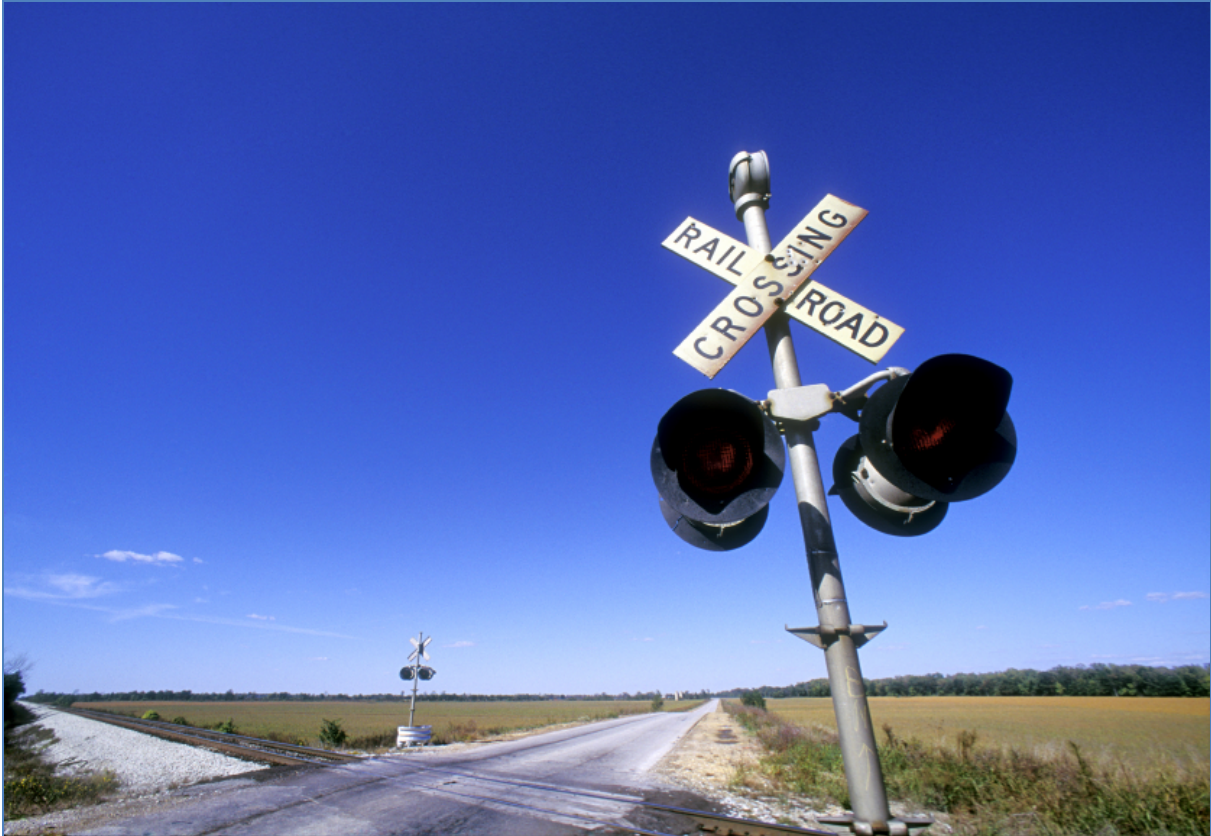
Figure 5.1: Flashing Light Signal (Mixon, 2015)

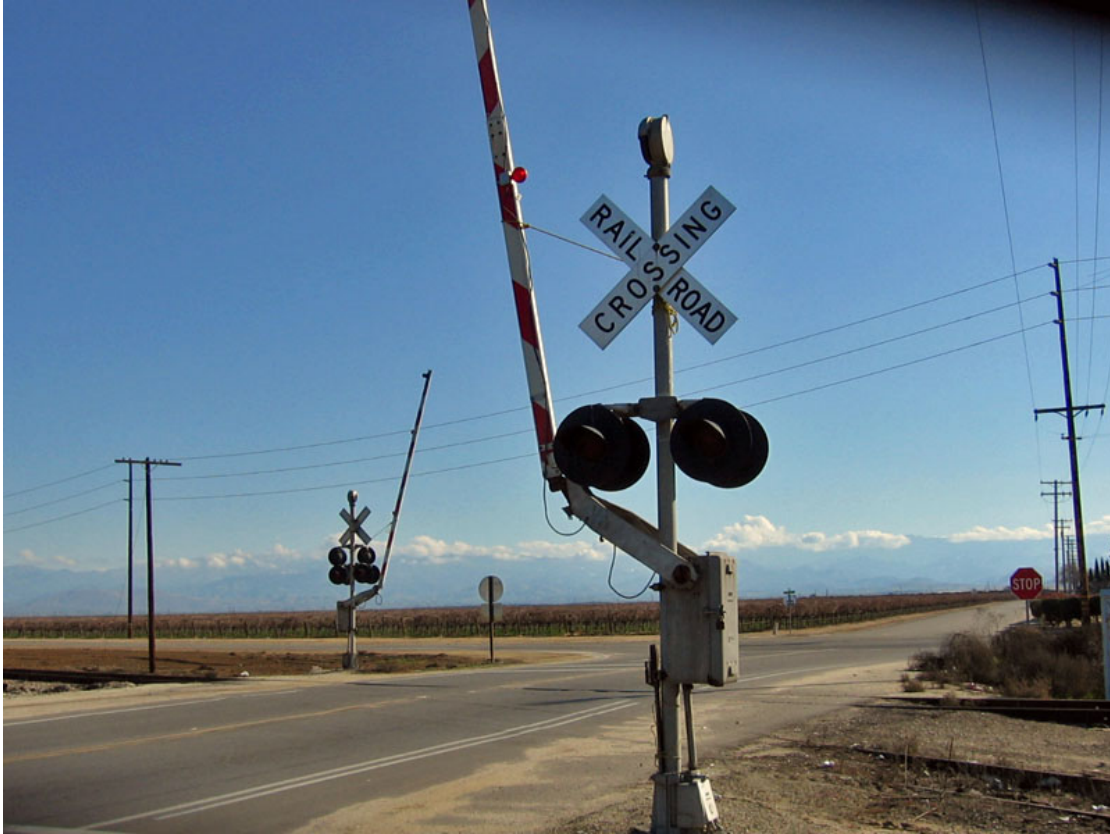
Figure 5.2: Bells (Steck, N/A)

The Oregon Department of Transportation (ODOT) requires bells at all signalized railroad crossings.

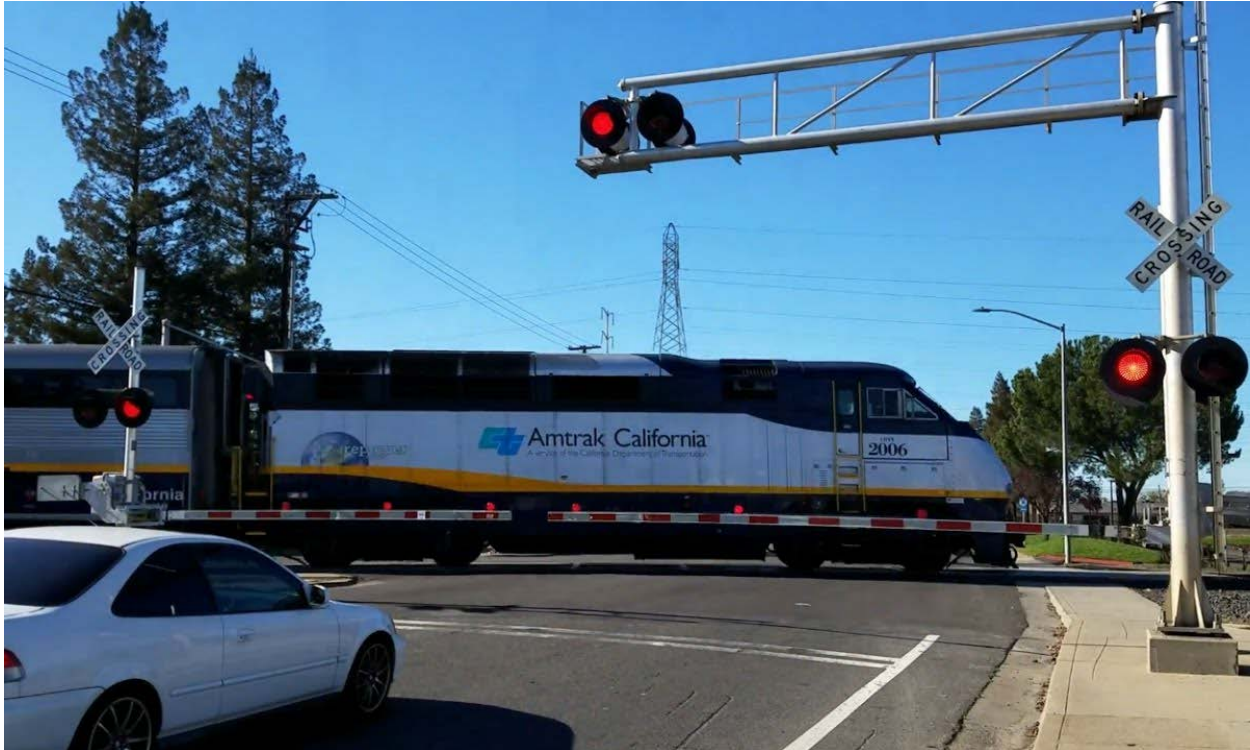
Figure 5.3: Vehicle Automatic Gates (N/A, N/A)

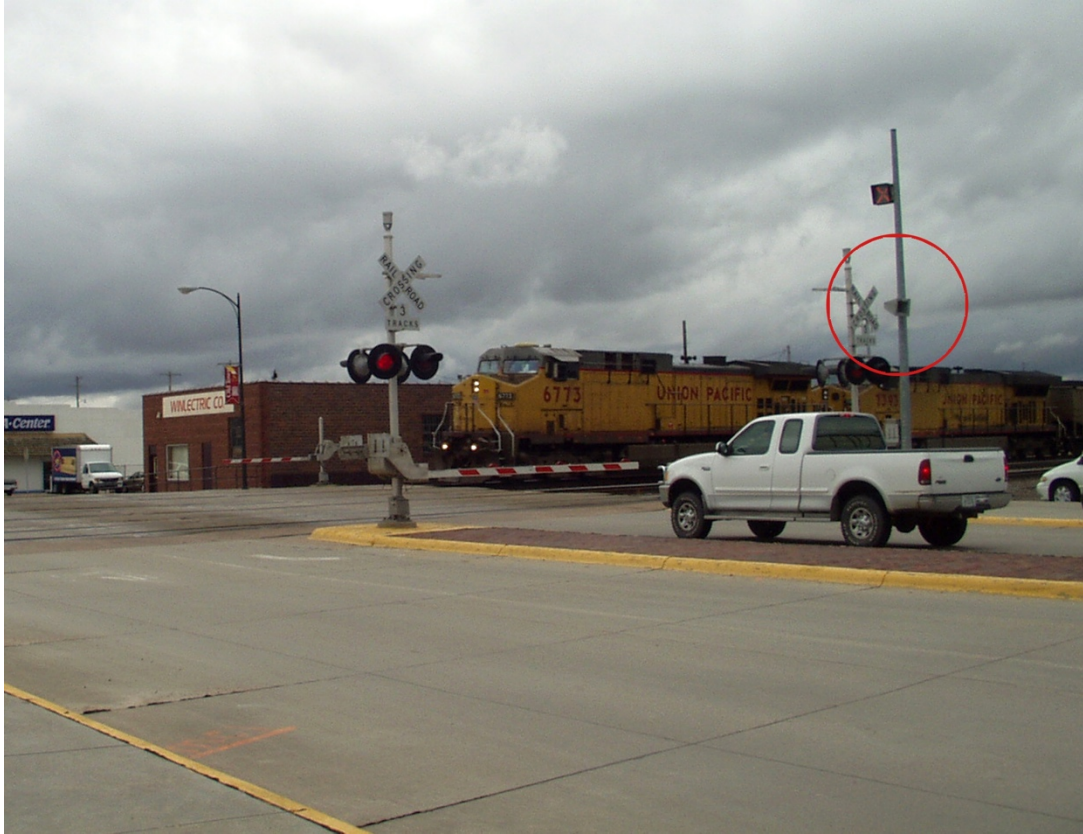
Figure 5.4: Wayside Horn System (APWA Reporter, 2007)

Railroad crossings in quiet zones must find alternative warning methods to the train blowing its horn down the railroad and disturbing communities. The wayside horn system is made up of a combination of speakers and a flashing red 'X' installed at a crossing. The speakers emit a digitized train horn down onto the tracks, which is quieter when compared to a train horn which travels down the railroad tracks. The flashing 'X' functions to inform the train crew that the wayside horn system is indeed working, and they then refrain from blowing the train horn when approaching a crossing (WSDOT, 2009). The sound waves moving downward onto the tracks by the wayside horn system allows for the sound warning system to function while also adhering to noise level restraints.

Wayside horn systems are expensive to implement. It costs approximately \$100,000 to add this system to a crossing (National Highway Traffic Safety Administration (NHTSA), N/A). No additional information or data on its efficacy.

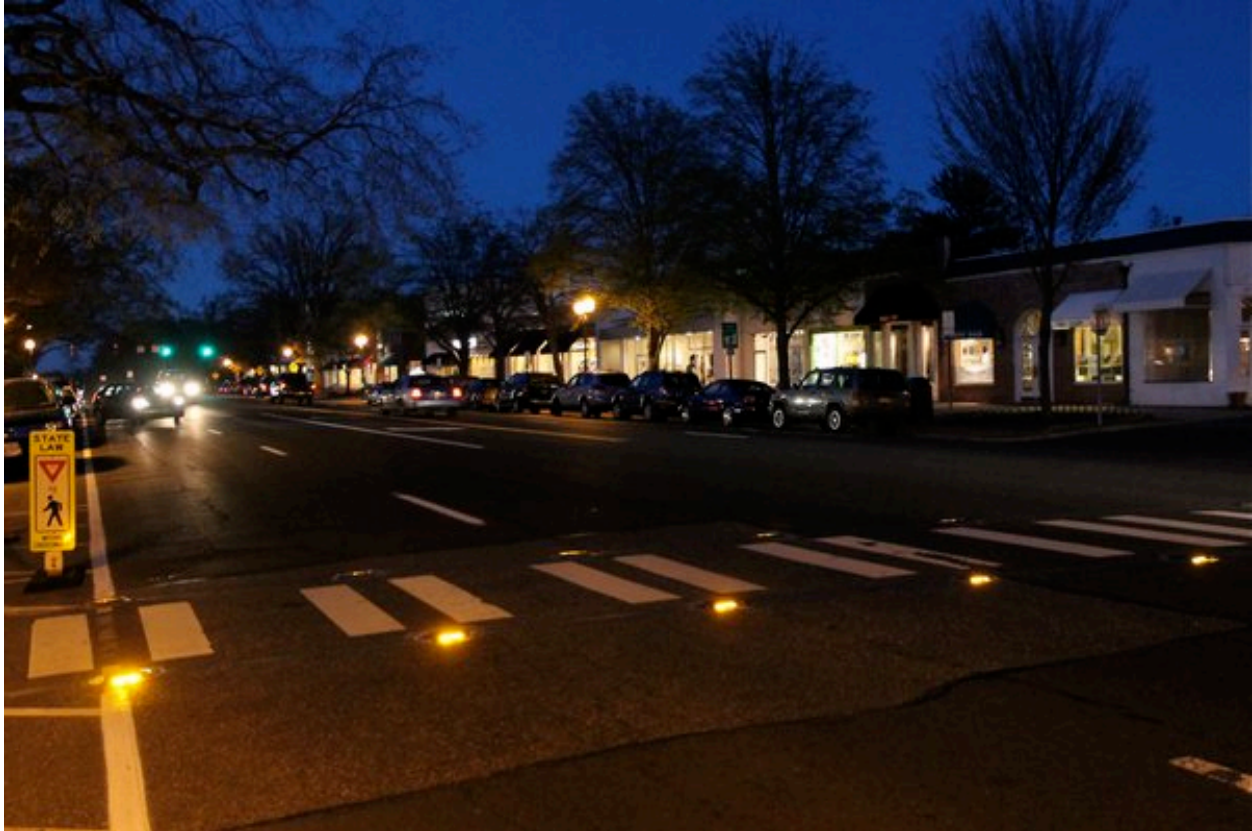
Figure 5.5: In-Pavement Marker System (Bromley, 2013)

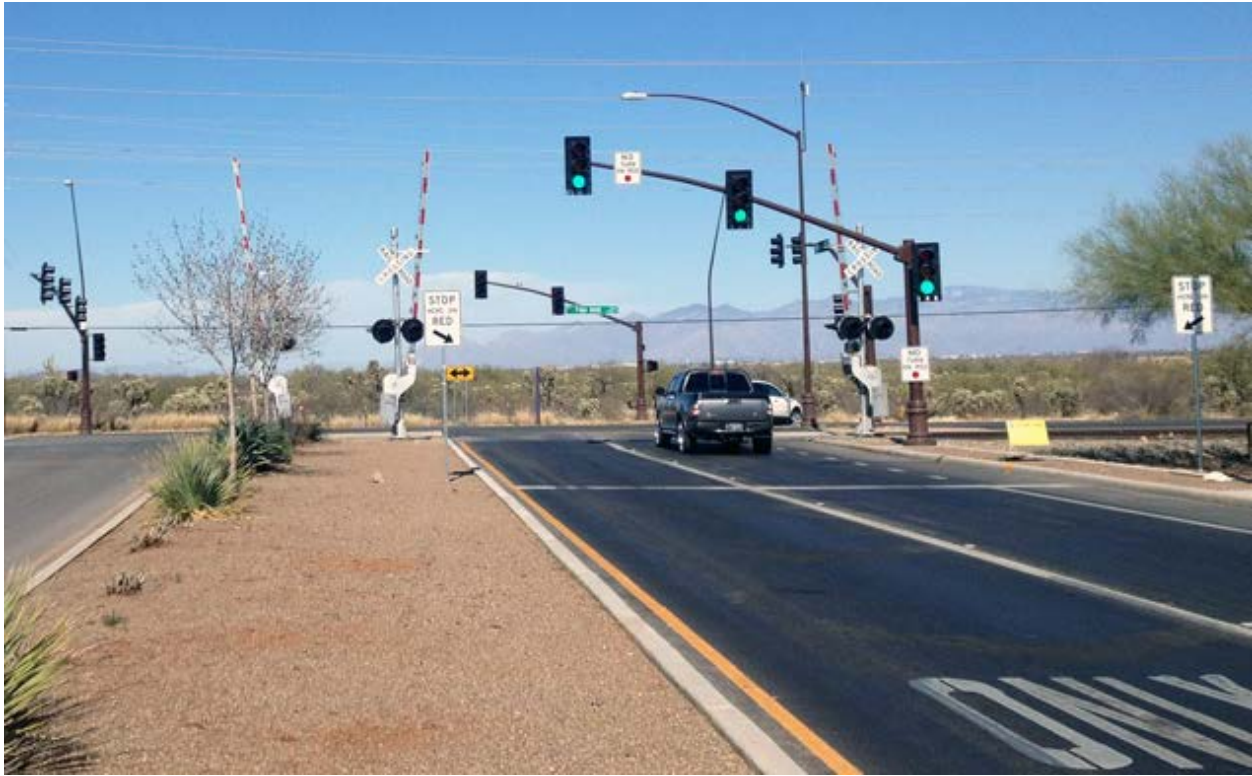
Figure 5.6: Pre-Signals/Traffic Lights (PSOMAS, N/A)

The pre-signal for the traffic signal ahead of it and emits green, yellow, or red depending on crossing conditions. To create a cohesive and desirable pre-signal, “No Turn on Red” and “Stop Here on Red” sign should also be installed. Regarding heavy rail in Oregon:

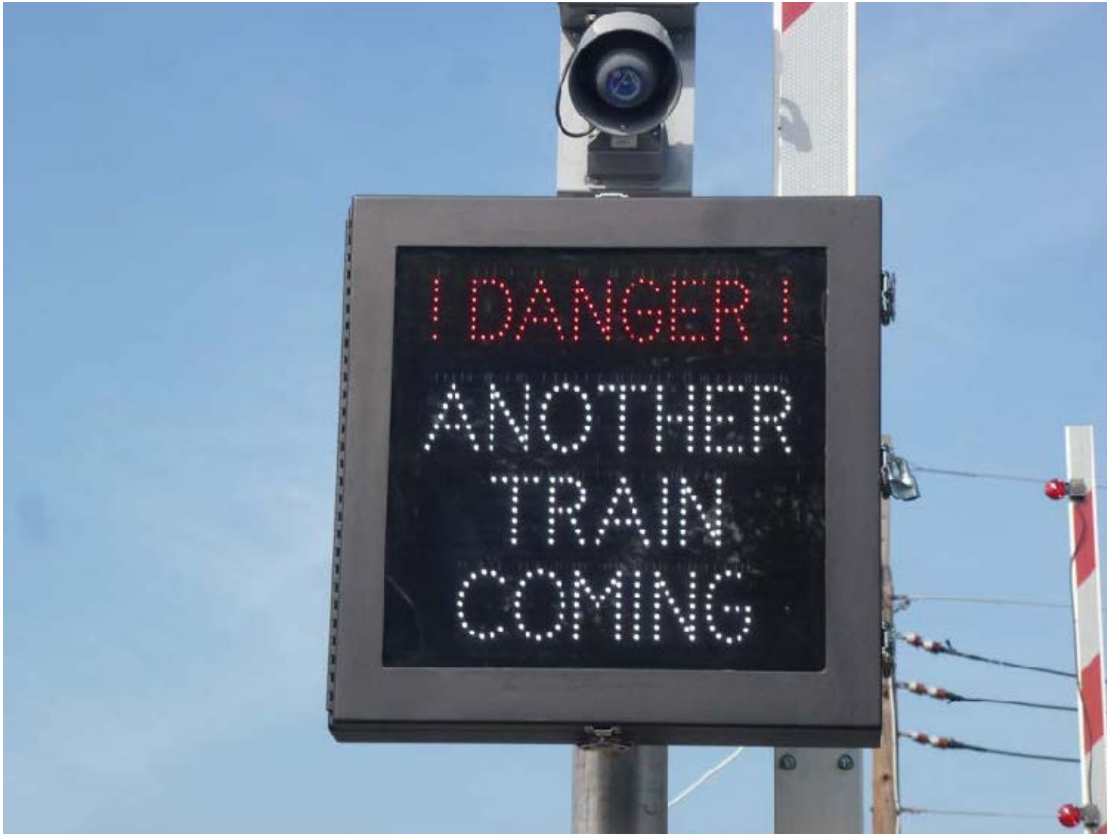
Figure 5.7: Variable Message Signs (Gabree & daSilva, 2014)

A variety of Flashing LED Messages are available such as: “Train Approaching,” “Second Train Approaching,” “Warning! Another Train Coming,” and an arrow indicating no right turn. Depending on roadway operations/configuration this may not just be limited to a right turn.

A study conducted in LA showed that two measures of pedestrian behavior were examined: (a) the number of pedestrians entering the track area at 15 seconds or less before a train entered the crossing and (b) the number of pedestrians entering the track area at 6 seconds or less before a train entered the crossing with the flashers activated, a much riskier behavior. The study compared pedestrian behavior before and after installation and found that the installation of the signal reduced the incidence of risky pedestrian behavior by 14 % on the first benchmark and 32 % on the second one (Metaxatos & Sriraj, Pedestrian/Bicyclist Warning Devices and Signs at Highway-Rail and Pathway-Rail Grade Crossings, 2013).

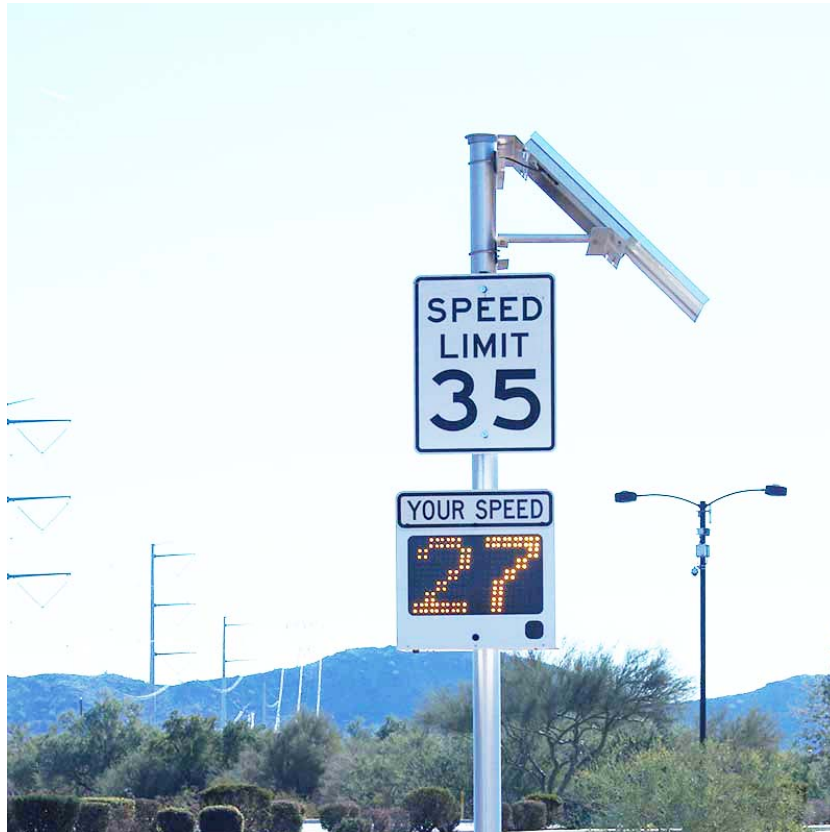
Figure 5.8: Dynamic Speed Monitoring Display (N/A, N/A, n.d.)

Another study entitled, “Efficacy of Radar Speed Monitoring Displays in Reducing Vehicle Speeds” implemented three DSMDs in Nebraska. In aggregating and comparing traffic speeds before and after implementation, it was found that the mean speed reduced by 3-4mph and the 85th percentile speed reduced by 2-7 mph. Within this study, the DSMD was tested at various other locations, all of which had positive results and showed unanimous efficacy in alerting and slowing down drivers.

If battery operated, there are high maintenance costs, however it can also be implemented with a solar panel to avoid frequent maintenance.

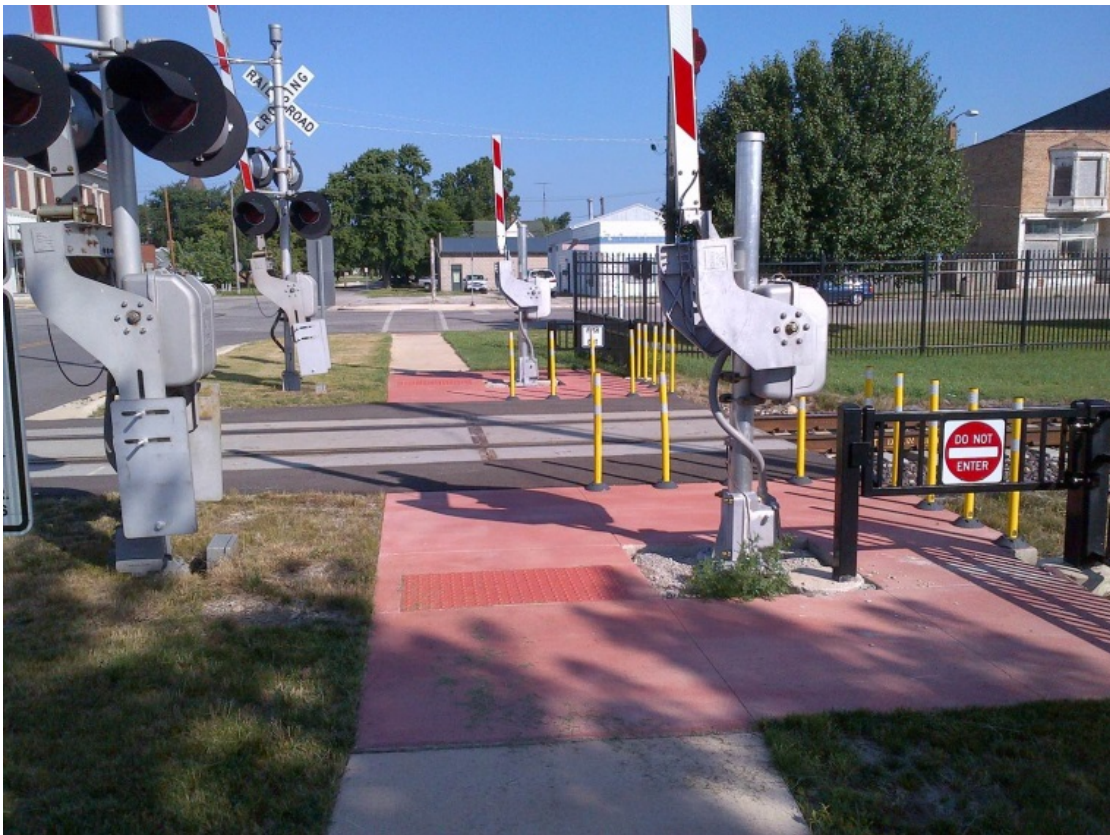
Figure 5.9: Pedestrian Automatic Gates (N/A, N/A, n.d.)

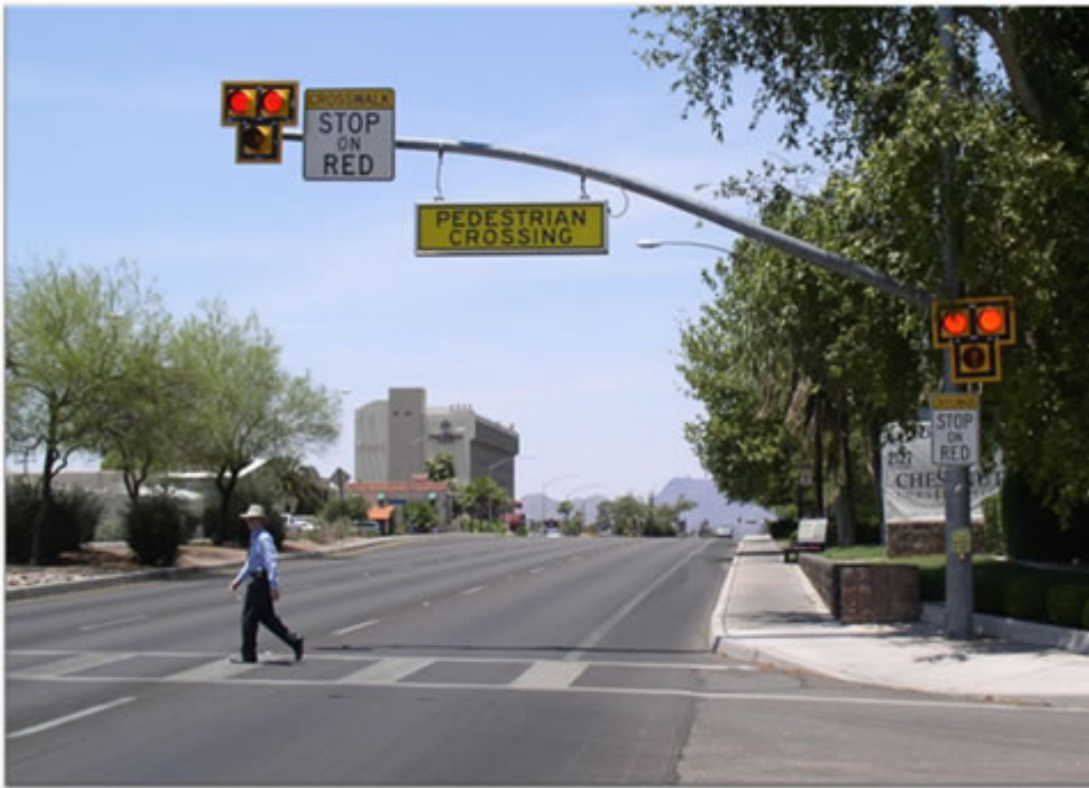
Figure 5.10: High-Intensity Activated Crosswalk (HAWK) (USDOT FHWA, 2016)

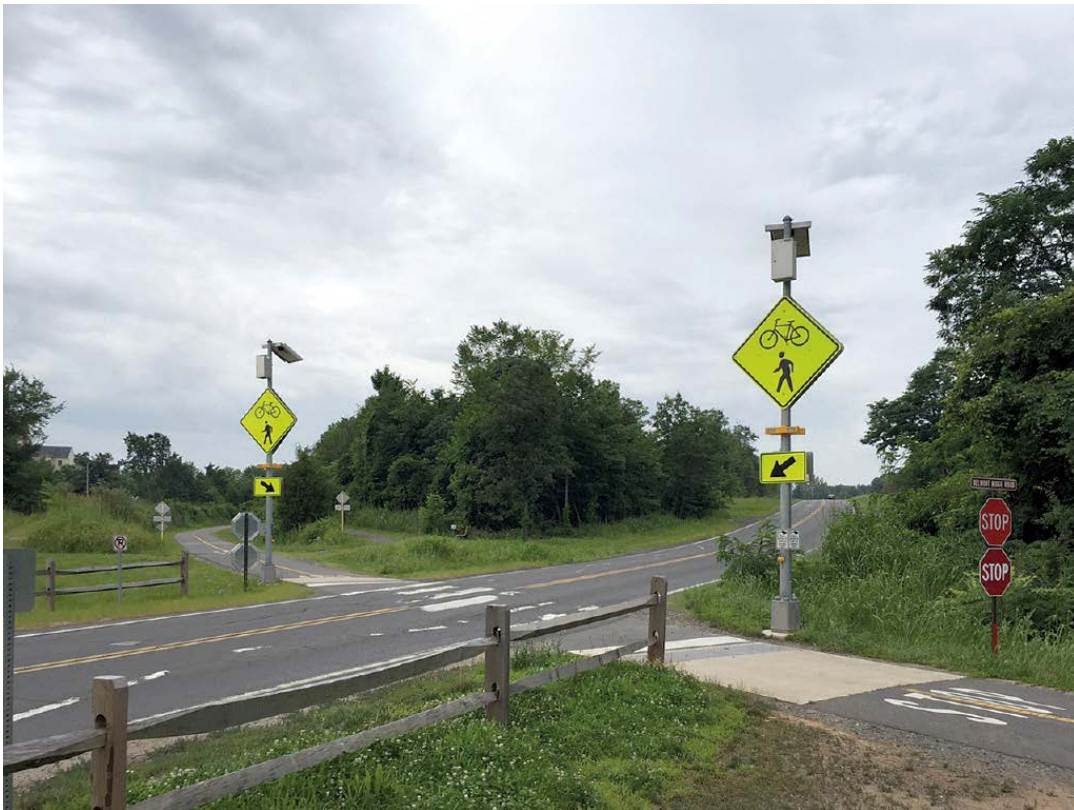
Figure 5.11: Rectangular Rapid Flash Beacon (RRFB) (N/A, N/A, N/A)

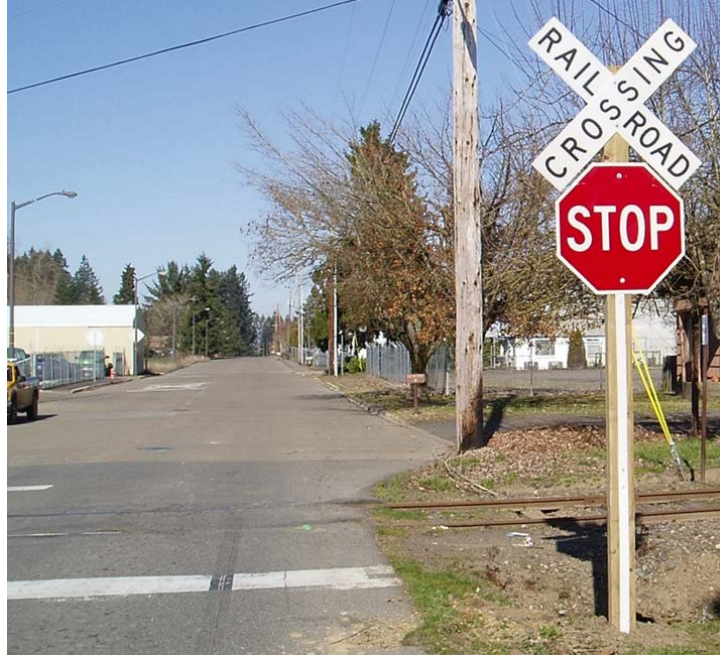
Figure 5.12: Crossbucks + Stop (ODOT, N/A)

A study on stop signs at highway-rail crossings in seven Midwestern states concludes that collision rates increased when 'Stop' signs are added to 'Crossbucks' signs. The author speculates that there is a lower compliance rate of 'Stop' signs at low-volume intersections (Raub, 2006). A recent study on driving performance at 'Crossbucks' or 'Crossbucks + Stop' conflicts this previous study. This research found that almost 100% of their sample population reduced their speed and engaged their brake at a 'Crossbucks + Stop' sign versus just 56% that slowed down at a 'Crossbucks' sign (USDOT - FRA, 2014). This was surprising to find since national statistics on incidents at 'Crossbucks' vs. 'Crossbucks + Stop Sign' between 2008-2012. Suggest that more railroad incidents occurred at 'Crossbucks' only signs than at 'Crossbucks + Stop Signs.'

It costs \$1,200-\$2,000 to install (FHWA, 2007). There is concern of rollover stoppings onto the tracks, which increases exposure time to the train.

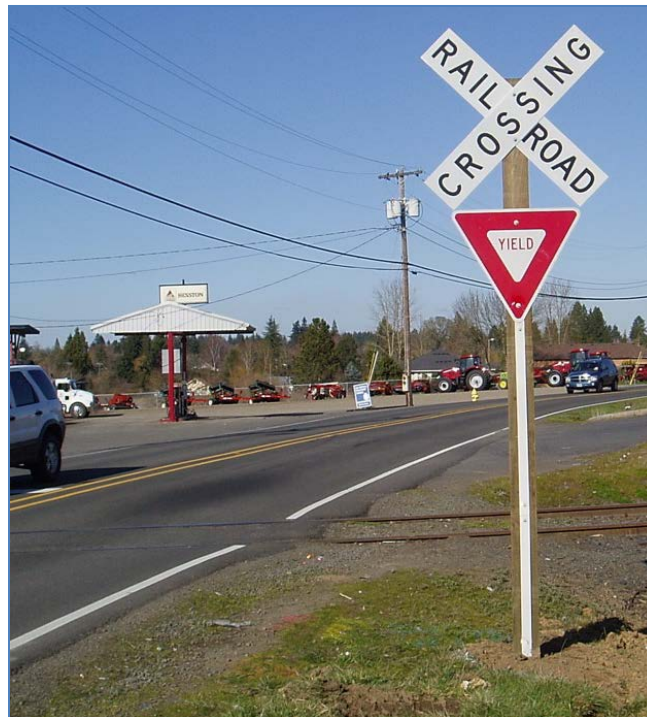
Figure 5.13: Crossbucks + Yield (ODOT, N/A)

The Yield sign emphasizes that road users must slow down and yield to oncoming railroad traffic. Research done by Lumm and Stockton suggest that 'Yield' signs are more effective at having drivers slow to 5 miles per hours or under than 'Stop' signs. It costs \$1,200-\$2,000 to install (FHWA, 2007).

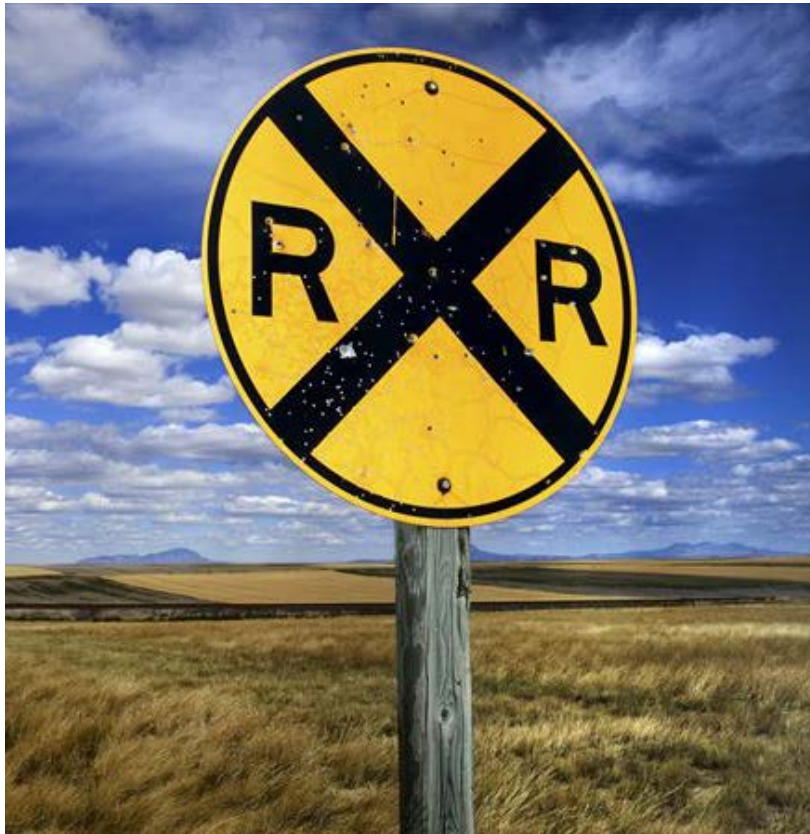
Figure 5.14: Advance RR Crossing Sign (N/A, NA)

A railroad crossing advance sign warns road users that there is a railroad crossing ahead. It is considered a supplemental sign. ” These supplemental signs inform drivers of vehicles carrying passengers for hire, school buses carrying students, or vehicles carrying hazardous materials that a stop is not required at certain designated highway-light rail transit grade crossings, except when a light rail transit vehicle is approaching or occupying the highway-light rail transit grade crossing, or the driver's view is blocked” (FHWA, 2003).

“A round, black-on-yellow warning sign placed ahead of a public railroad-highway crossing. The warning sign tells you to slow down, look and listen for the train, and be prepared to stop at the tracks if a train is coming” (2005 American Association of Motor Vehicle Administrators CDL Manual, 2005).

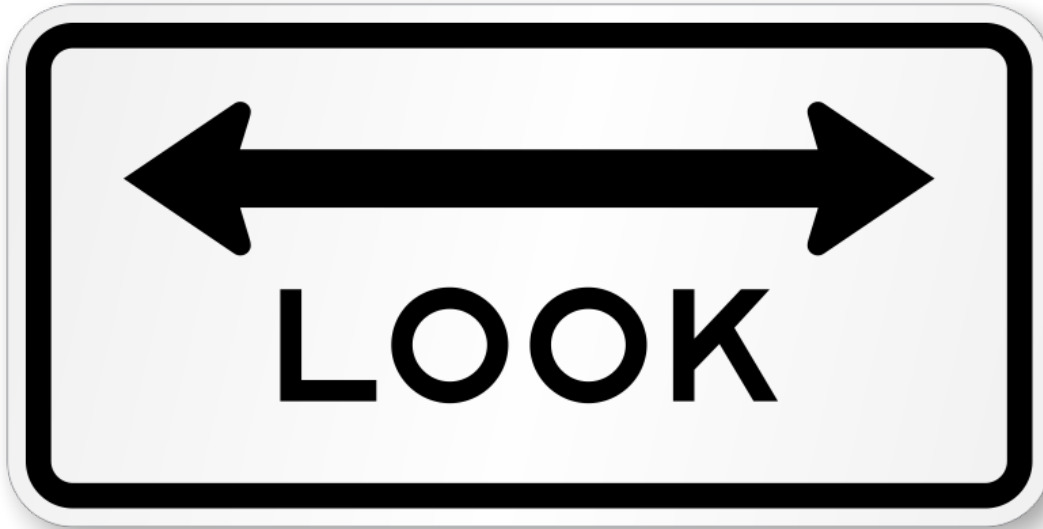
Figure 5.15: Look Both Ways Sign (<http://www.roadtrafficsigns.com/Arrow-Traffic-Sign/Look-Arrow-Sign/SKU-X-R15-8.aspx>)

Therefore, at all light-rail systems in Portland, "Look Both Ways" signs at all "pedestrian crossings adjacent to a gated motorist crossing and at many station platform crossing" have been installed (Korve, et al., 2001). This is a low-cost treatment to remind road users to look both ways and that they are in the presence of train activity. Note that implementation of too many treatments may lead to confusion or ignorance. No additional information or data on its efficacy.

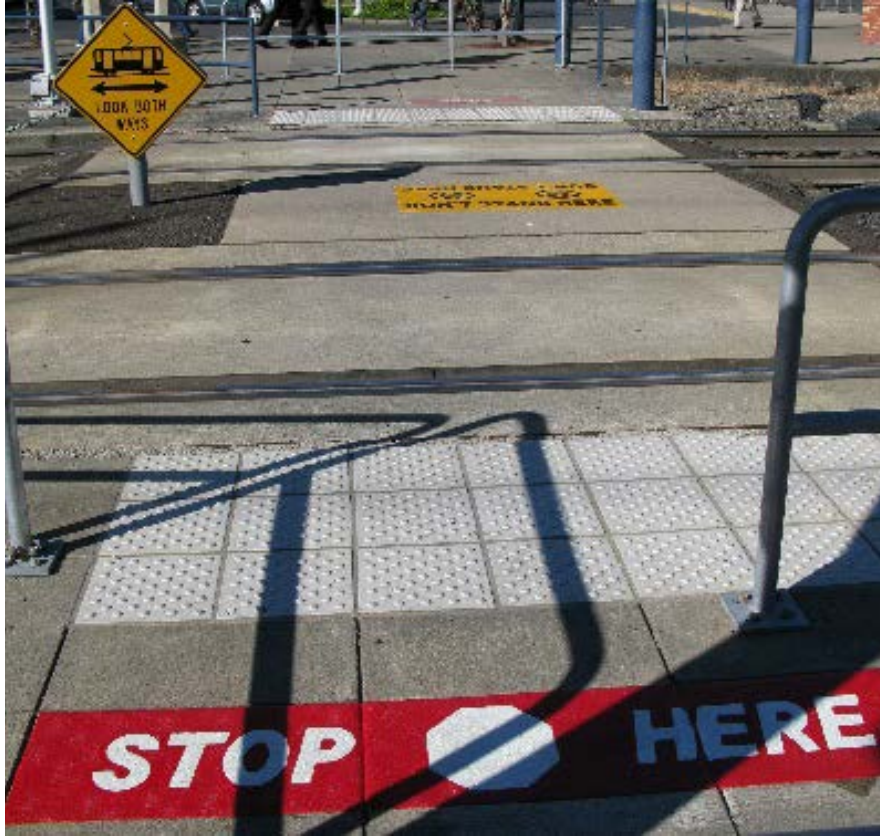
Figure 5.16: Pavement Marking (N/A, N/A)

The highway-rail grade crossing is a white RxR symbol that is marked on the road near the advance warning sign and may also include a stop bar to signal that drivers must come to a full stop before the white line if a train is present. Stop lines, crosswalks, and all other pavement markings are included under "Pavement Marking."

Pavement signs painted on the panels near railways with warnings such as "Stop for Trains, Look for Trains in Both Directions, Stop Here, Do Not Stand Here, Watch for Trains. Salt Lake City, Utah is currently evaluating the effectiveness of this treatment option (Boucher, et al., 2008). Though the efficacy of this treatment has not been recorded since then, the UTA Light Rail Design Criteria approves of pavement markings as long as they adhere to Utah MUTCD requirements (Utah Transit Authority, 2015). All pavement markings are prone to low visibility during extreme weather conditions and may require frequent maintenance to maintain visibility and clarity.

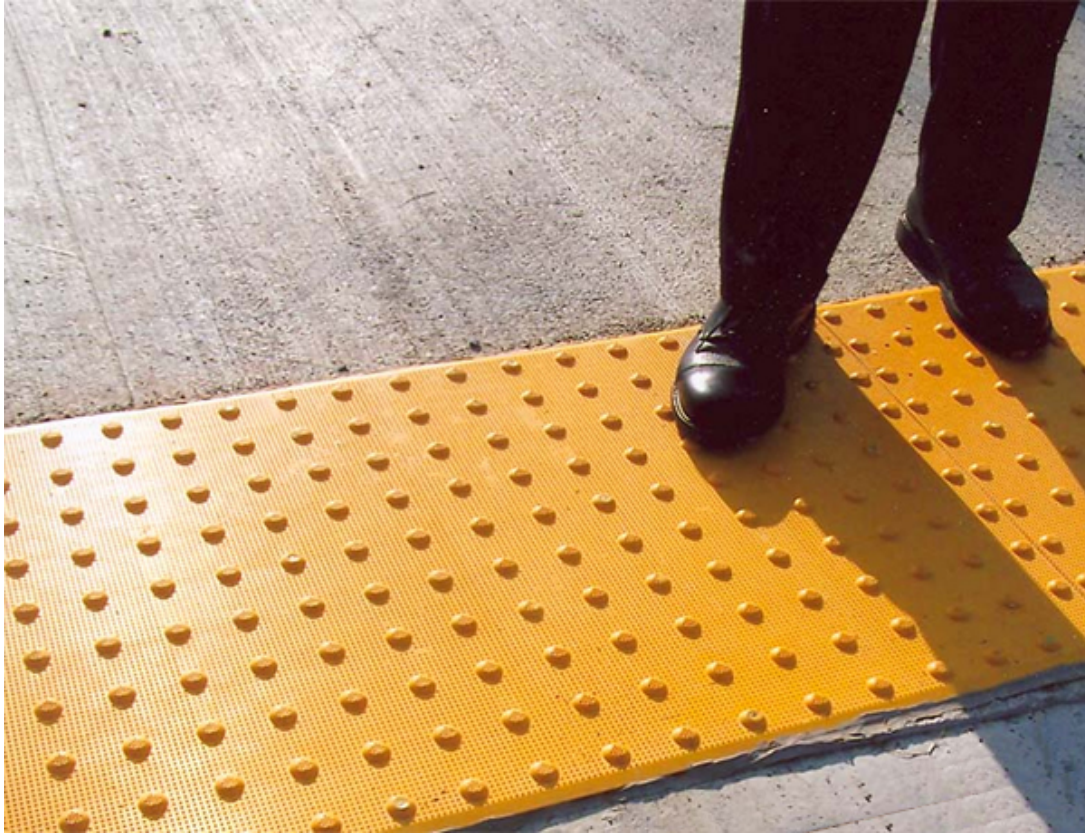
Figure 5.17: Tactile Warning (N/A, N/A, N/A)

Road texture such as bumpers and rumble strips for cyclists assist in heightening awareness train presence and forces cyclists to reduce their speed as they approach an at grade crossing and can also serve as an audible warning method (Yeh & Multer, 2008). It is interesting to note that tactile warning treatments may also cause reckless behavior if users try to avoid the textured surfaces (Yeh & Multer, 2008). This is a rather low-cost treatment that requires frequent maintenance to keep markings clear and visible. Snow can obstruct the visibility and effectiveness of tactile treatment methods. Tactile treatment methods are widely used in the United States and there are many professionals

in the field who firmly believe that this treatment method undoubtedly improves low-risk behavior for pedestrians, visually impaired, and cyclists. However, there is no additional information or data on its efficacy (Cleghorn, Clavelle, Boone, Masliah, & Levinson, 2009).

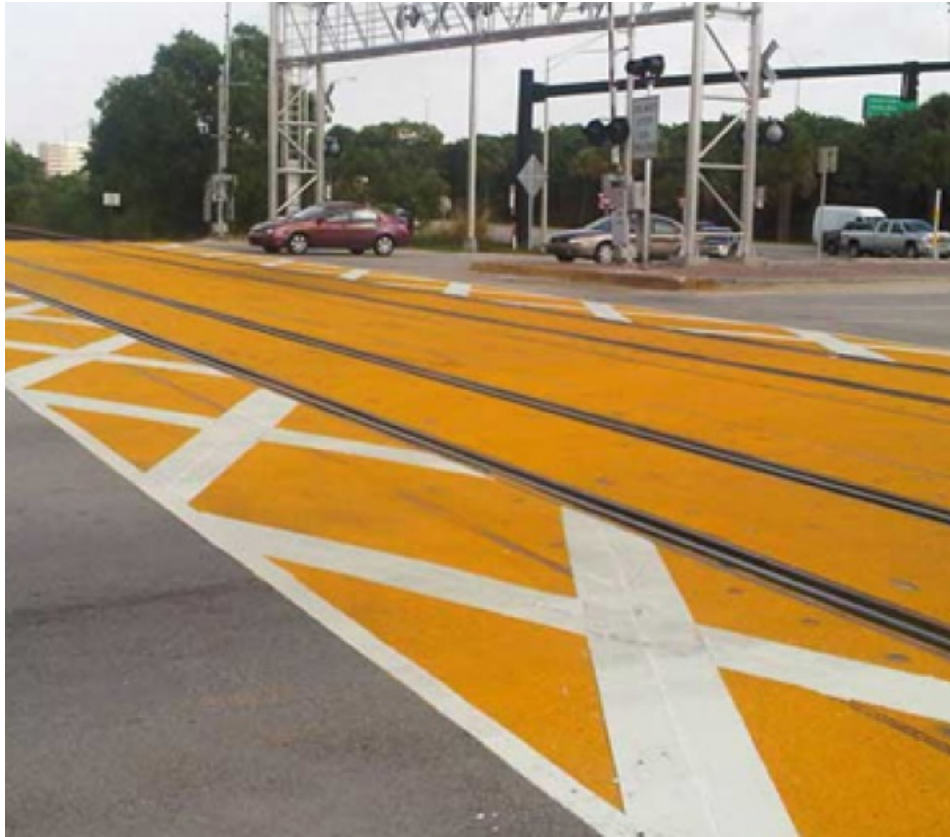
Figure 5.18: Figure Dynamic Envelope (N/A)

Different design measures can be used to deter road users from dwelling in the dynamic envelope such as barrier curbs and tactile treatments within the envelope to make it uncomfortable to ride a bike or walk on uneven pavement, ultimately discouraging people from dwelling on the tracks. Paint covering the dynamic envelope marking is another treatment option to emphasize train-activated space on the road. Depending on the type of treatment and site specifics, the cost and maintenance levels will vary. According to Transpo Industry Inc., a company that specializes on painting dynamic envelope marking this treatment resulted in a 39% reduction in the number of motorists stopping on or near tracks.

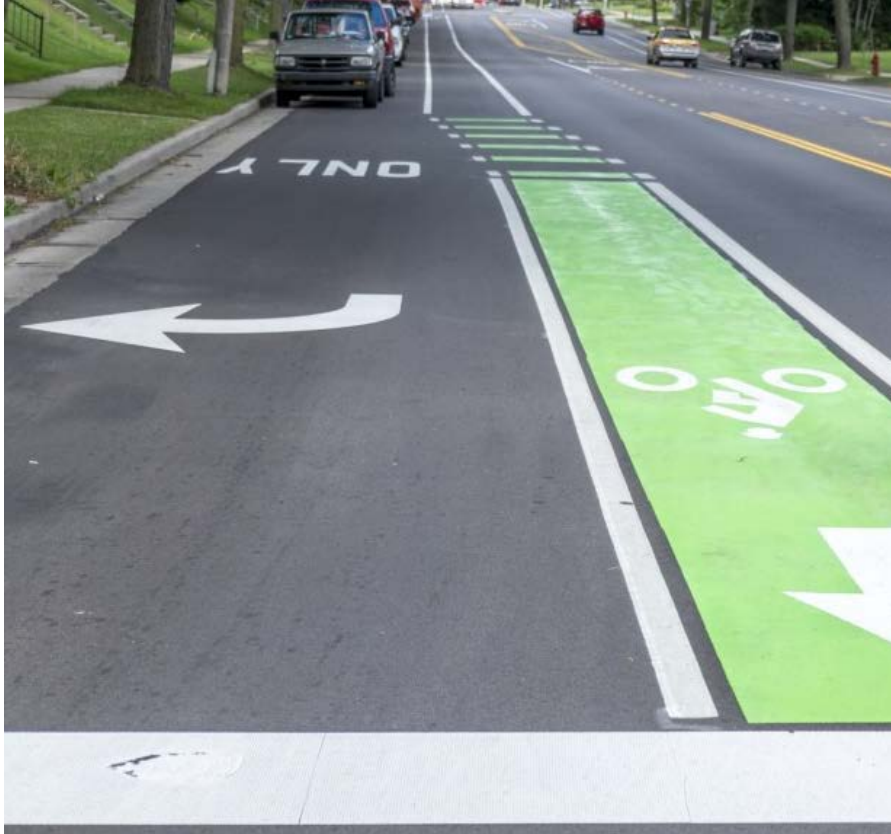
Figure 5.19: Conflict Paint (Cieslewicz, seen 2017)

Another study conducted by the Florida Department of Transportation in 2008 recorded the interactions between bicycles and motor vehicles before and after green paint was applied to a weaving area. A typical bike lane treatment was repainted with green paint at the conflict points. The results from this study indicate that colored pavement and signage are indeed effective and improve behavior for both bicyclists and vehicle drivers. In fact, results show that significantly more motor vehicles yielded to bicyclists and a fewer percent of motor vehicles used less of the bicycle lane during weaving maneuvers when the bike lane was painted green. This study also indicates that “motor vehicles slowed down 2.0% of the time in the after period compared to 5.8% in the before period. On the other hand, motor vehicles braked more often in the after period (34.6% in the before period versus 36.7% in the after period). Overall, the green paint and signage had positive results and the percentage of conflicts decreased after the lane was painted green (William, Srinivasan, & Martell, 2008).
