**MULTI-MODAL INTERSECTIONS:
RESOLVING CONFLICTS
BETWEEN TRAINS, MOTOR
VEHICLES, BICYCLISTS AND
PEDESTRIANS**

Final Report

SPR 794

Oregon Department of Transportation

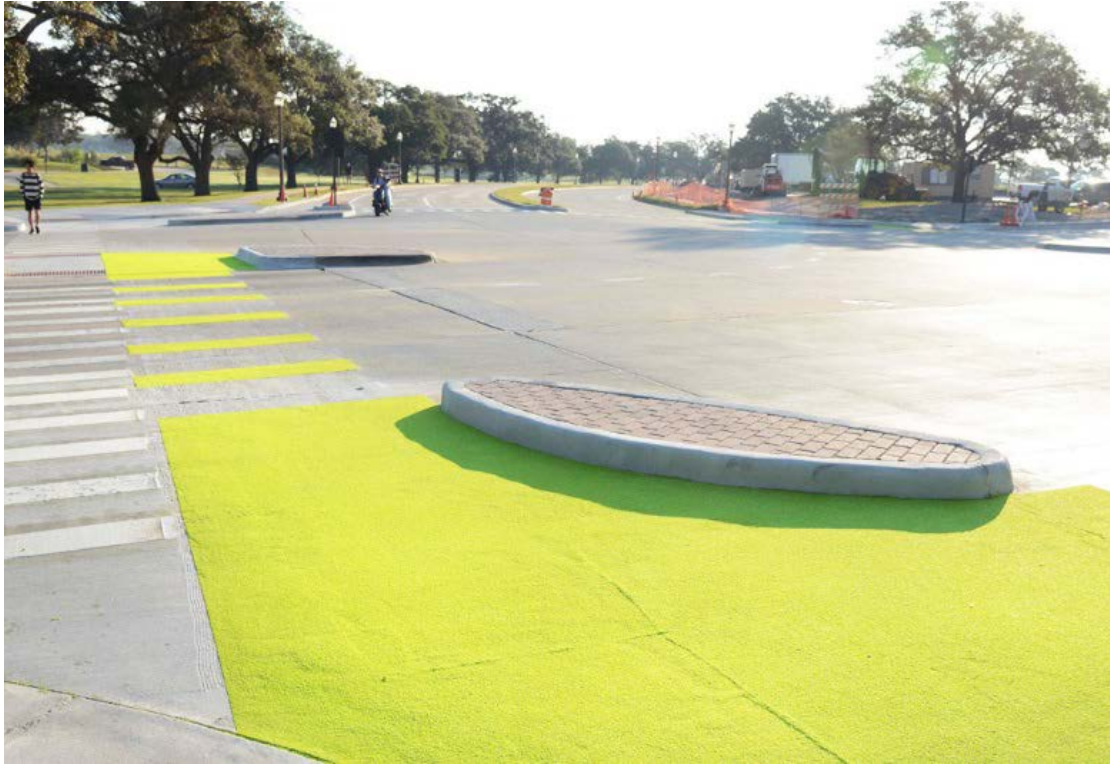
Figure 5.20: Glow in the Dark Paint - Day Visibility (Texas A&M, 2017)

Texas A&M University received approval from the Federal Highway Administration to test this specially formulated paint on their campus and record the efficacy of this treatment option. During the day, photo luminescent particles soak up energy from the sun and this energy then emits a luminous soft glow at night. This treatment is currently being tested at Texas A&M. No additional information on its efficacy (Chow, 2017).

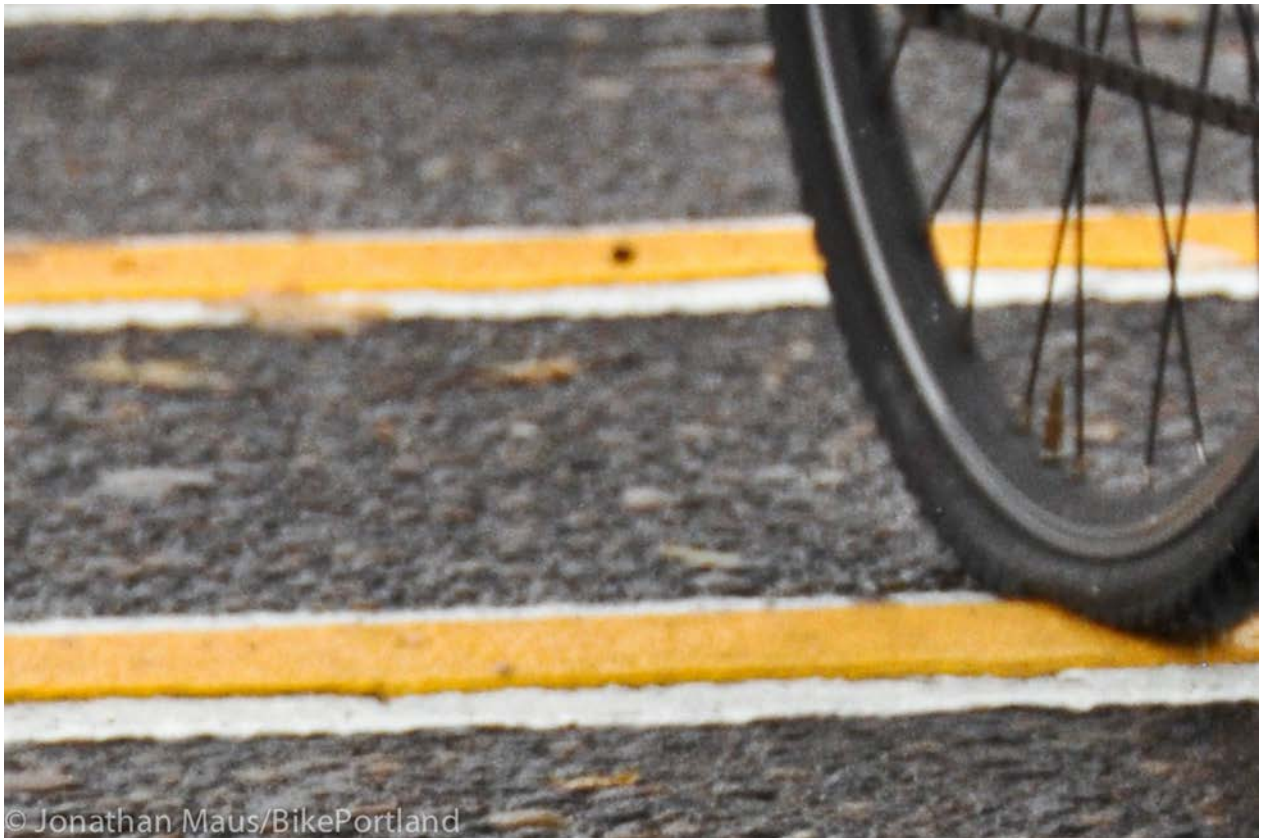
Figure 5.22: Rumble Strips (Maus, 2013)

Rumble strips are horizontal markings that can be applied to shared pedestrian and bicycle paths to decrease the speed of cyclists. Rumble strips have been applied to the Los Angeles River path.

Though this treatment is intended to slow cyclists and increase awareness of their surroundings, cyclists must focus on the ground in order to anticipate rumble strips instead of being alert and ready to react to their dynamic environment. No additional information on efficacy.

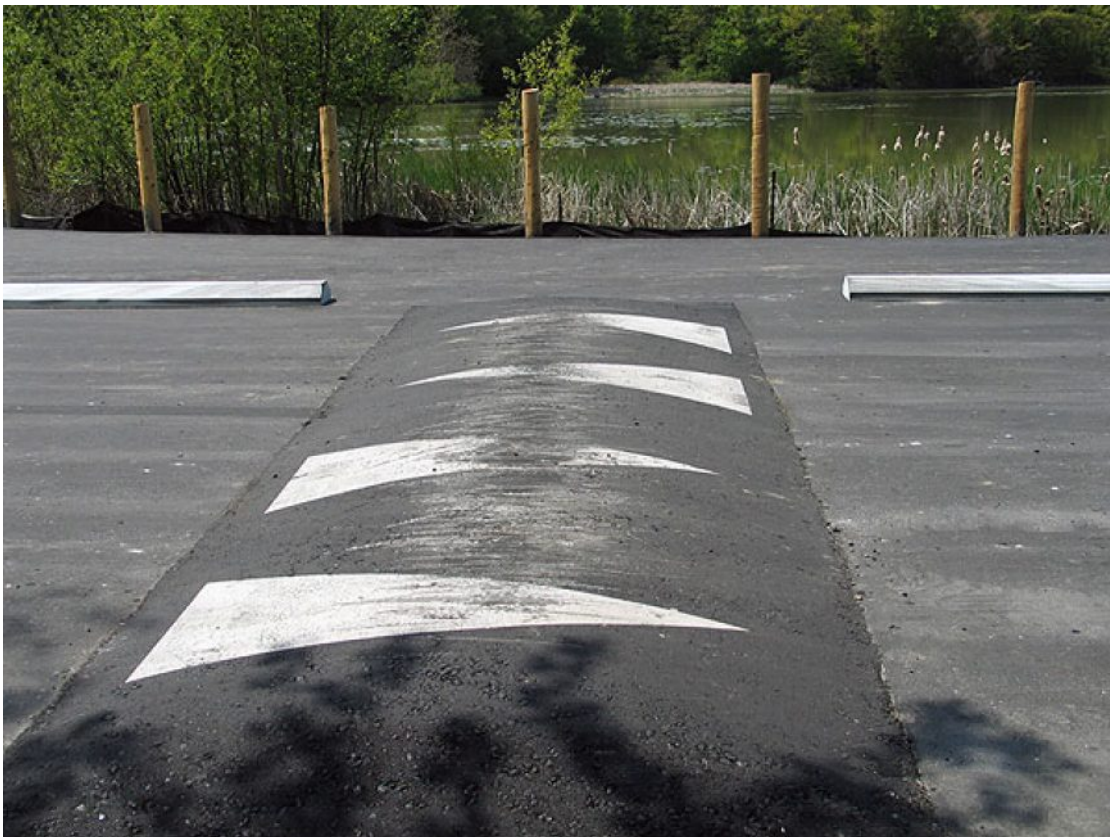
Figure 5.23: Speed Bump (Lakey, NA)

Speed bumps are another variation of a traffic calming method typically used for vehicles. A speed bump's design differs from that of a speed hump in that it is more severe and aggressive in slowing down vehicles. "A speed bump is also a raised pavement area across a roadway. Speed bumps are typically found on private roadways and parking lots and do not tend to exhibit consistent design parameters from one installation to another. Speed bumps generally have a height of 3 to 6 inches (76 to 152 mm) with a travel length of 1 to 3 feet (0.3 to 1 m)" (Parkhill, Sooklall, & Bahar, N/A). The presence of speed bumps negatively affects emergency vehicles and their time

sensitive demands. Speed bumps are not conducive to snowplows or other maintenance vehicles as well and can have weather constraints. Like speed humps, speed bumps in the vehicular context also increase fuel usage and consequently emit more CO₂ and pollutants due to the acceleration and braking nature of vehicles around them. This however, may be irrelevant if speed bumps are to be repurposed for pedestrian/bike paths. Note that speed bumps could be considered a nuisance and may impair the quality of experience that path users have, possibly leading to treatment avoidance, and it may also pose a challenge for ADA accessibility. Speeds bumps that are implemented for vehicles must be paired with a “Speed Bump” sign, which is included in the MUTCD as Fig. W17-1, but would be written as “Speed Bump” and not “Speed Hump (Moeur, n.d.). Speeds bumps can be implemented in a series to increase speed control. Speed bumps can cost between \$540 - \$2,300 (Bushell, Poole, Zeeger, & Rodriguez, 2013).

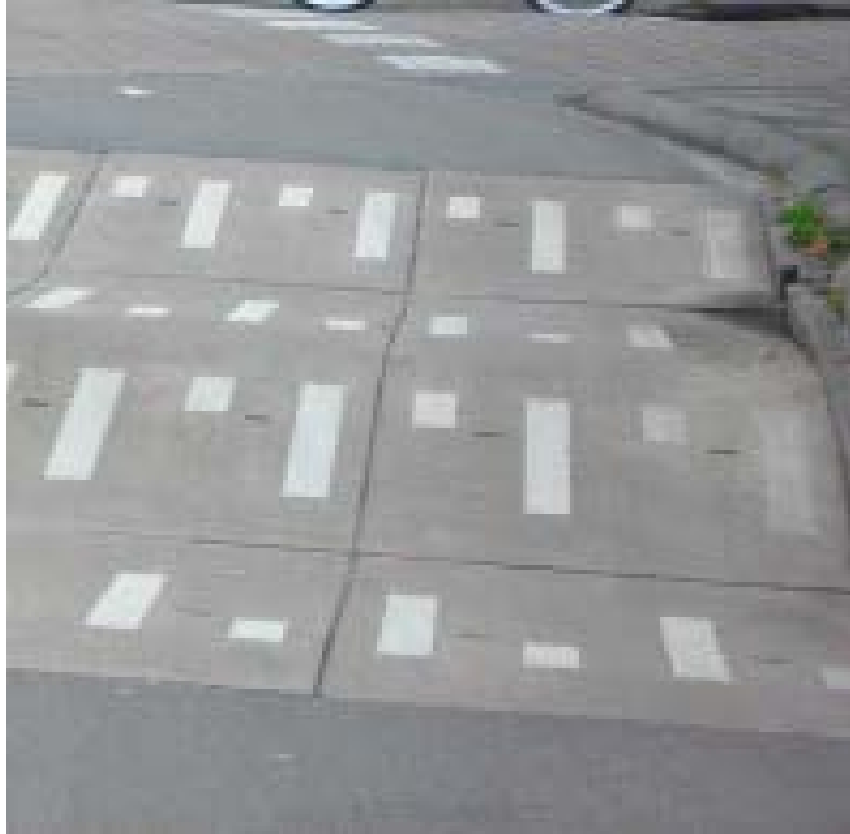
Figure 5.24: Bicycle Speed Hump (Zach, 2011)

This is a traffic calming measure associated with cars, however, this concept can be applied to a path in order to decrease the speed of cyclists as they approach an intersection. The speed humps must consider the speed of the cyclist and topography unique to the site before implementation.

The speed hump can reduce the cyclist's speed near the intersection, and therefore may improve behavior for all road users. According to the Minnesota Department of Transit's Bikeway Facility Design Manual, the general bicycle design speed of 20 mph is desirable on a shared-use path. Bicycle speed humps are not a common treatment option used in the United States; however, European cities such as Groningen have implemented these methods to slow down cyclists and mopeds. According to ITE's recommended practice for vehicles, "A speed hump is a raised area in the roadway pavement surface extending transversely across the travel way. Speed humps are sometimes referred to as "pavement undulations" or "sleeping policemen". Most agencies implement speed humps with a height of 3 to 3.5 inches (76 to 90 mm) and a travel length of 12 to 14 feet (3.7 to 4.3 m). Speed humps are generally used on residential local streets" (Parkhill, Sooklall, & Bahar, N/A). The presence of speed humps negatively affects emergency vehicles and their time sensitive demands. Speed humps are not conducive to snowplows as well and can have weather constraints. Speed humps in the vehicular context also increase fuel usage and consequently emits more CO₂ and pollutants due to the acceleration and braking nature around them. This however, may be irrelevant if speed humps are to be repurposed for pedestrian/bike paths. Note that speed humps could be considered a nuisance and may impair the quality of experience that path users have and it may also pose a challenge for ADA accessibility. Speed humps that are implemented for vehicles must be paired with a "Speed Hump" sign, which is included in the MUTCD as Fig. W17-1 (Moeur, n.d.). Speed humps can be implemented in a series to increase speed control. According to research conducted in Seattle of vehicle speeds before and after the implementation of speed humps, researchers found that speeds reduced by between 79%-88% (Fucoloro, 2014). The National Association of City Transportation Officials note that that speed humps reduce vehicle speeds to 15-20 mph. Speed humps for vehicles cost an average of \$7,500, but can range between \$540 - \$7,500 (Bushell, Poole, Zeeger, & Rodriguez, 2013) & (Markon, 2008).

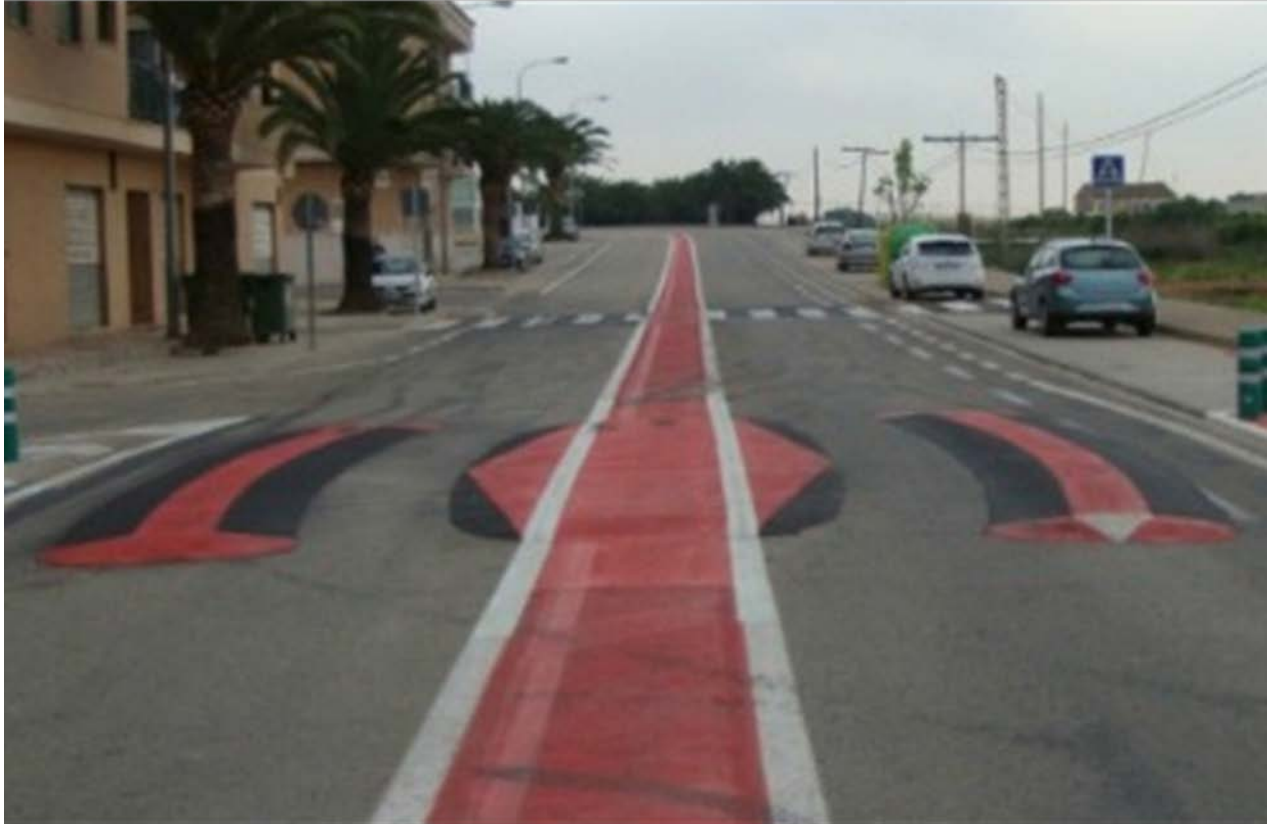
Figure 5.25: Speed Kidney (Garcia, Alfredo, N/A)

This is a traffic calming measure to reduce vehicle speed and road volume and to ultimately improve road use and behavior. A speed kidney consists of two main speed humps that straddle a center complementary speed hump. The speed kidney is typically used for vehicles; however, it is possible to adapt this for cyclists on a path. The design has been carefully constructed to encourage vehicle drivers to slow down and curve along the road to avoid discomfort by having any wheels interact with the humps. The design of the speed kidney does a good job serving various path users and does not obstruct the path for any particular path user. This treatment option can be customized to be ADA accessible.

In a long-term study of the efficacy of speed kidneys implemented in Spain, researchers found that 70% of vehicles followed the curve path encouraged by the speed kidney design and therefore reduced their speeds (Garcia, Moreno, & Romero, 2012). Cost of a speed kidney is ranges between \$3,000 - \$7,000 (Bushell, Poole, Zeeger, & Rodriguez, 2013). This estimate is based off of the cost of speed bumps, humps, and tables.

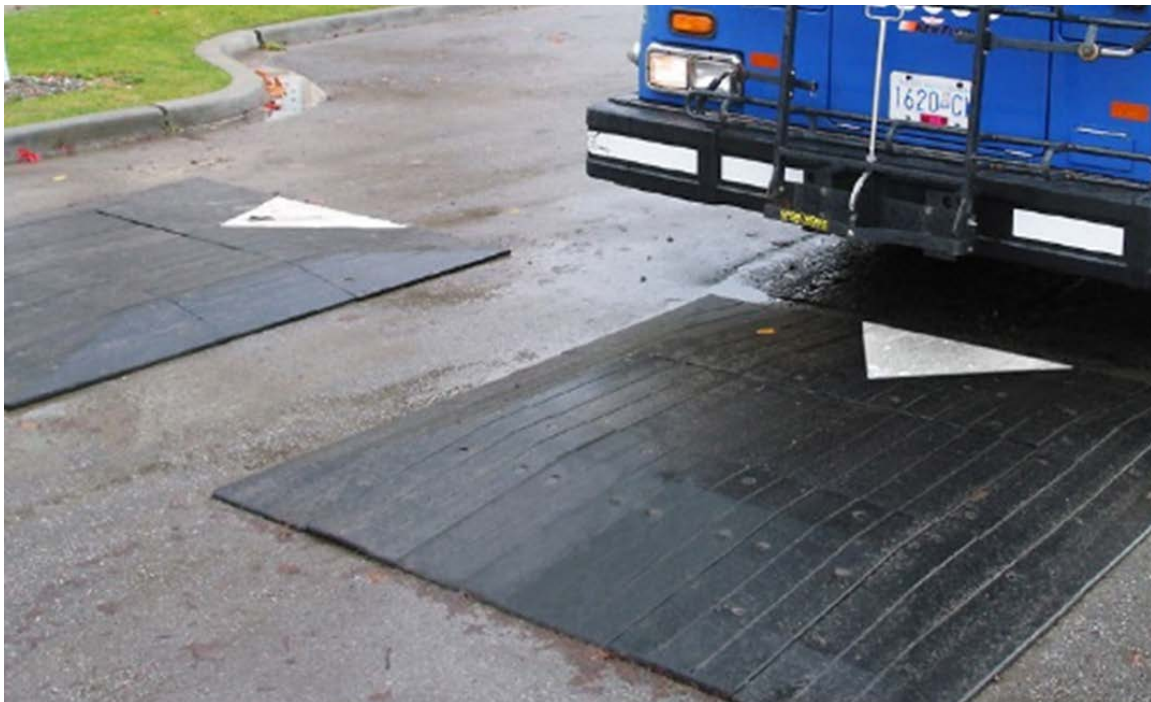
Figure 5.27: Speed Cushion (Drdul, 2006)

Many of the studies observed that speed cushions caused treatment avoidance and therefore, undesired road conditions. In an attempt to avoid the speed cushion and get their wheels in the pockets between speed cushions, drivers would drift between lanes. They may also cause noise pollution and obstruct the road for snowplows or other maintenance vehicles. Note that speed tables must be paired with a “Speed Cushion” sign to alert path users or road users of its presence, which is included in the MUTCD as Fig. W17-1. Speed Cushions cost an average of \$2,800 to install (City of Phoenix, N/A).

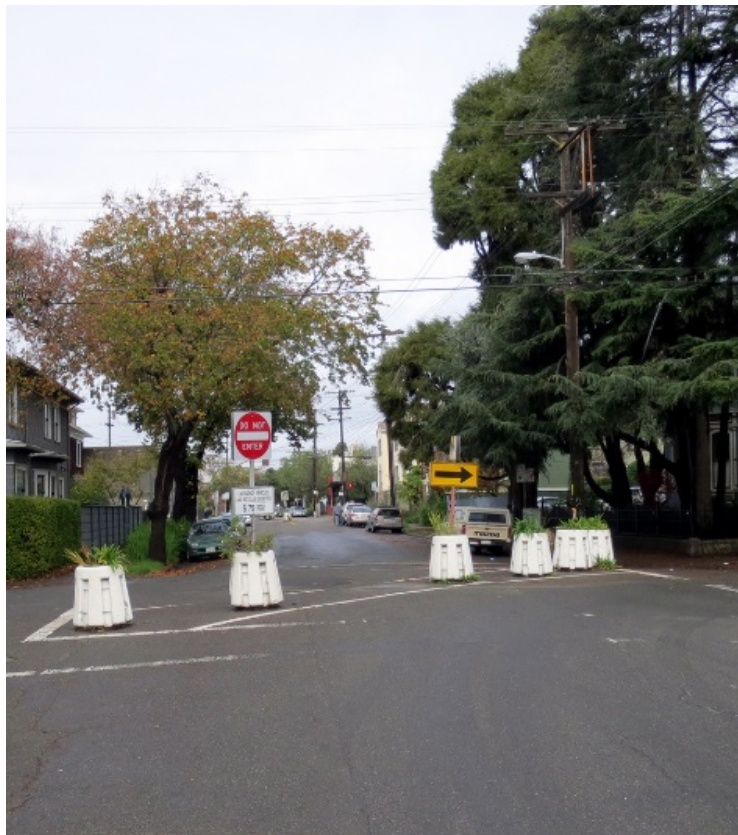
A bollard is a simple, yet effective engineering tool that can be placed on a path near a road intersection to keep vehicles separate from cyclists and pedestrians.

Bollards are used to discourage vehicle drivers from misusing space allocated to cyclists and pedestrians. Bollards can have a range of physical forms (permanent, rising, removable, planters, security, etc.), but they all serve the same function of separating cyclists and pedestrians from vehicles. The cost to implement and maintain the bollards depends on the type of bollard design chosen. However, according to *Costs for Pedestrian and Bicyclist Infrastructure Improvements* (2013), bollards cost an average of \$730.00. No additional information or data on its efficacy.

Figure 5.29: Bollards used to keep vehicles from entering, (N/A, N/A)

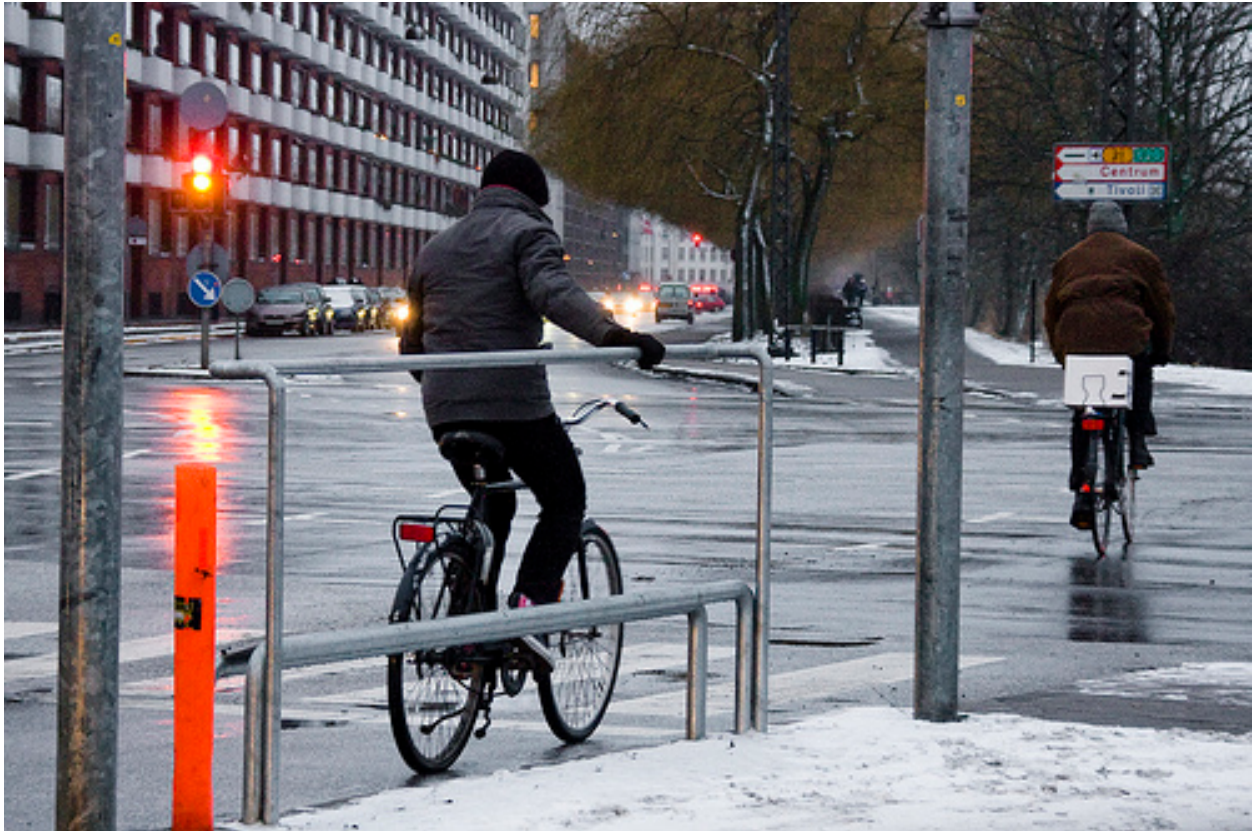
Figure 5.30: Bicycle Lean Rail, (Colville-Andersen, Mikael, 2010)

This is a simple design concept that encourages cyclists to adhere to traffic laws by creating comfortable rest space. Rails have been designed and implemented in major biking cities such as Copenhagen and Seattle. It is a low-cost amenity that facilitates low-risk road or path behavior. Construction, labor, and materials for one rail cost about \$2,000 (Cohen, 2015). No additional information on its efficacy.

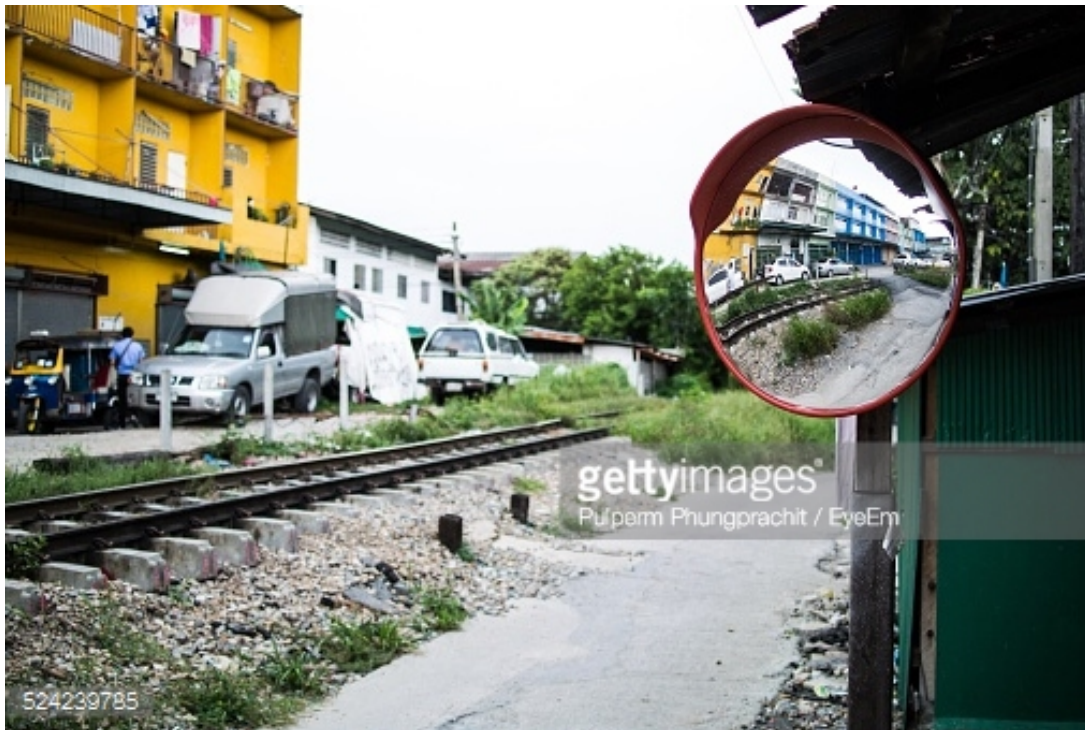
Figure 5.32: Mirror (Phungprachit, N/A)

Though this treatment is not common in the United States, it can be repurposed and be applied to paths to increase awareness and visibility of oncoming vehicles or trains for path users.

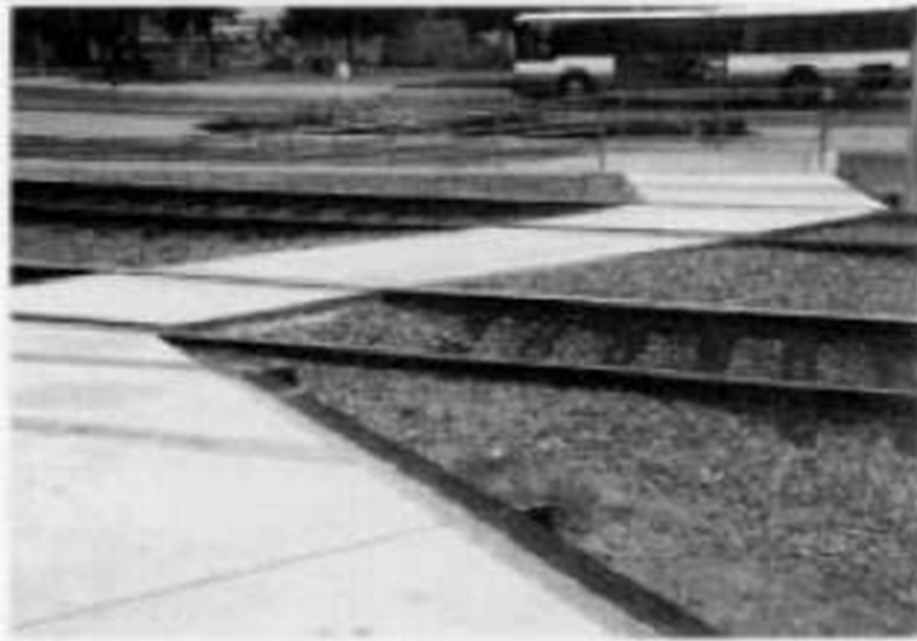
Figure 5.33: Channelization, (Korve, Hans W. , Jose I. Farran, Douglas M. Mansel, et al., 1996)

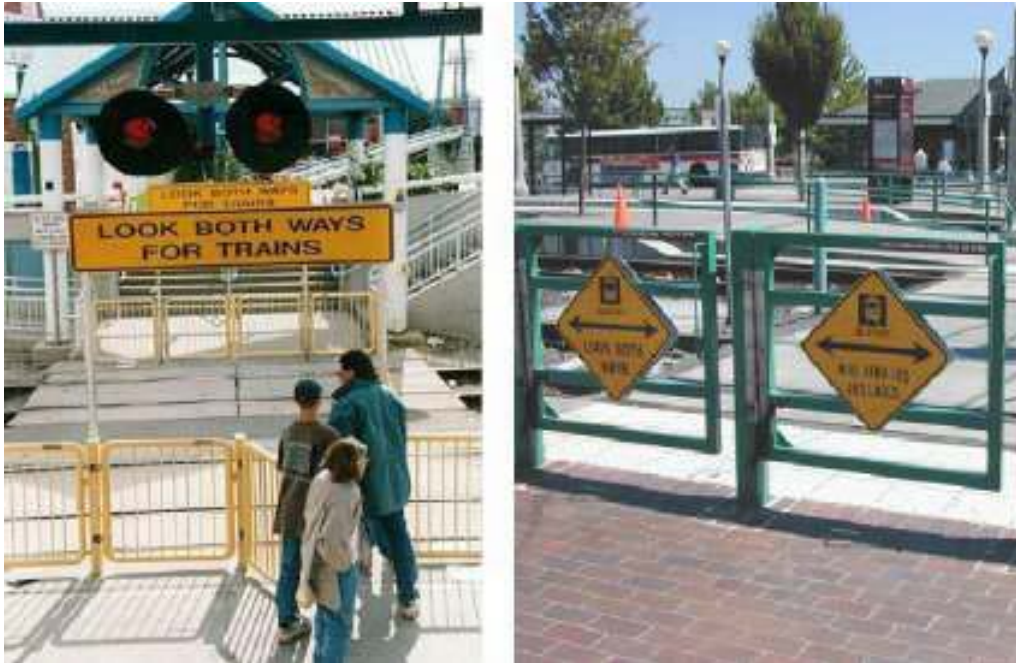
Figure 5.34: Pedestrian Manual Gates, (Korve, Hans W. , Jose I. Farran, Douglas M. Mansel, et al., 1996)

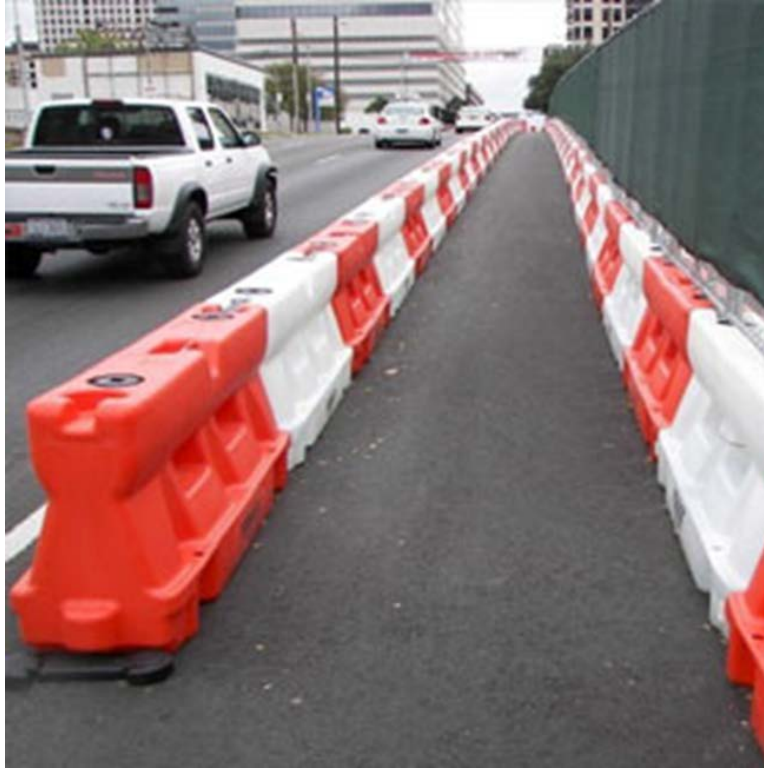
Figure 5.35: Temporary Curb, (N/A, N/A)

This is a quick and temporary treatment option to channel pedestrians and bicyclists through a designated low-risk path. This can be especially useful at LRT pedestrian crossings during large city events such as a game day. This is a popular low cost way for cities to temporarily control and restrict vehicle, pedestrian, or bicycle movements. No additional information or data on its efficacy.
