Detecting Objects at Railroad Crossings

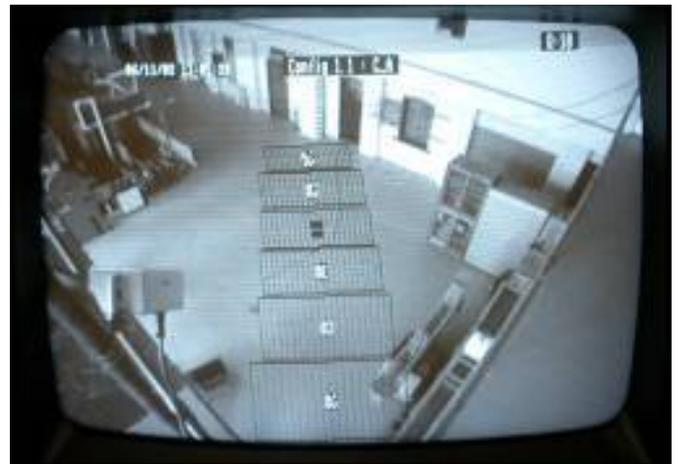
Laboratory video detection zone setup

There are numerous variables that may affect the sensitivity of the detection equipment, such as weather, lighting, object material, object shape and orientation, object color, entry direction, background color, shadows, distance and angle from detection equipment. The first phase of the research was a laboratory evaluation of each detection device, which focused on a qualitative assessment of several of these factors and quantitative tests of the sensitivity to object size.

The results of the laboratory tests suggested that both of the systems had sufficient sensitivity for the detection of potentially hazardous objects on railway tracks. Both the video detection unit and the microwave detection unit could consistently detect objects as small as four inches in diameter. Qualitative testing showed that both systems successfully detected variously shaped objects made of wood, metal, and plastic.

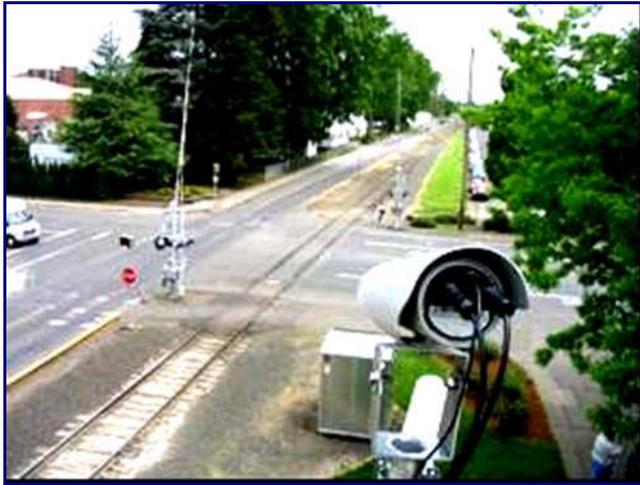
View of the field test site from the video camera location

The second phase of the study was field testing. The video system and the microwave system were installed at a railroad crossing on the campus of Oregon State University. The monitoring stations were remotely located, with communication from the detection devices via wireless modem.

The video-based system showed major limitations in its sensitivity to low contrast between the object and the background and also in conditions of bright light and shadows. It also suffered from false positive detections at night due to reflected headlights off the rails as vehicles approached. The microwave detection performance was impaired by the electromagnetically complex environment, registering false positive signals from a swaying crossing gate arm.
