Pavement
Evaluation/
Maintenance
Management Program
2012

Toledo State
Airport

**2012 Pavement Evaluation / Maintenance
Management Program**

**Final Report – Individual Airports
Functional Category 5, Central Climatic Zone**

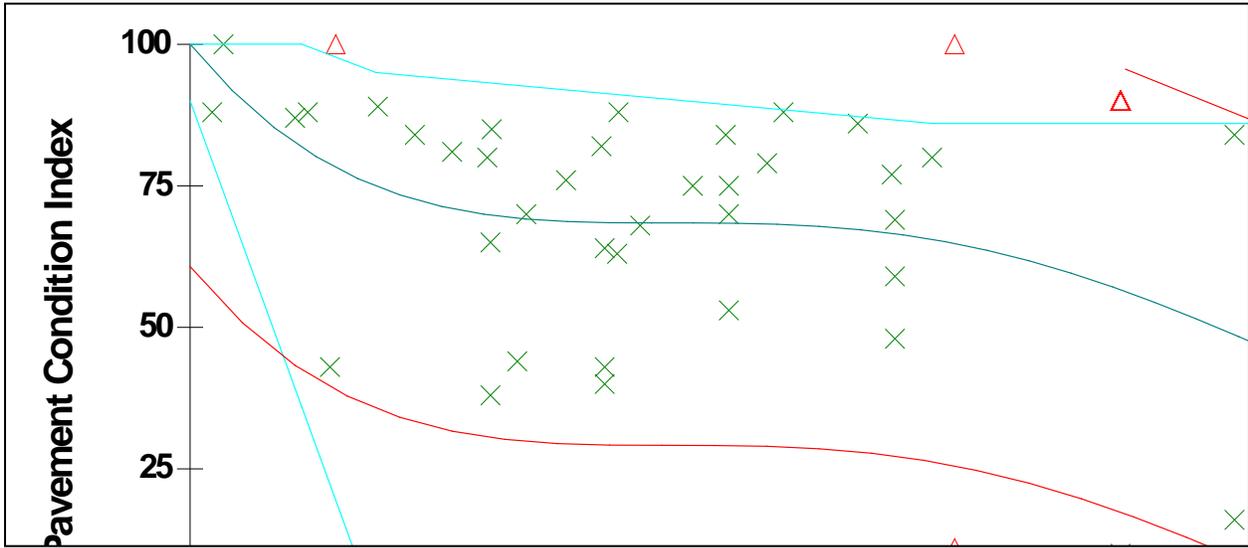
Figure 2. Performance Curve for Category 5 AC Runways – Central Oregon.

To allow future pavement condition to be predicted, data collected throughout the State were used to generate "performance curves". The curves were developed based on surface type, use, airport functional category and climatic region. These curves (models) are used to predict future pavement condition by assuming the behavior of an individual pavement section is similar to the behavior of the pavement sections used to generate the "performance curve". Figures 2 through 9 show the "performance curves" used to model pavements in your airport's functional category and climatic region.

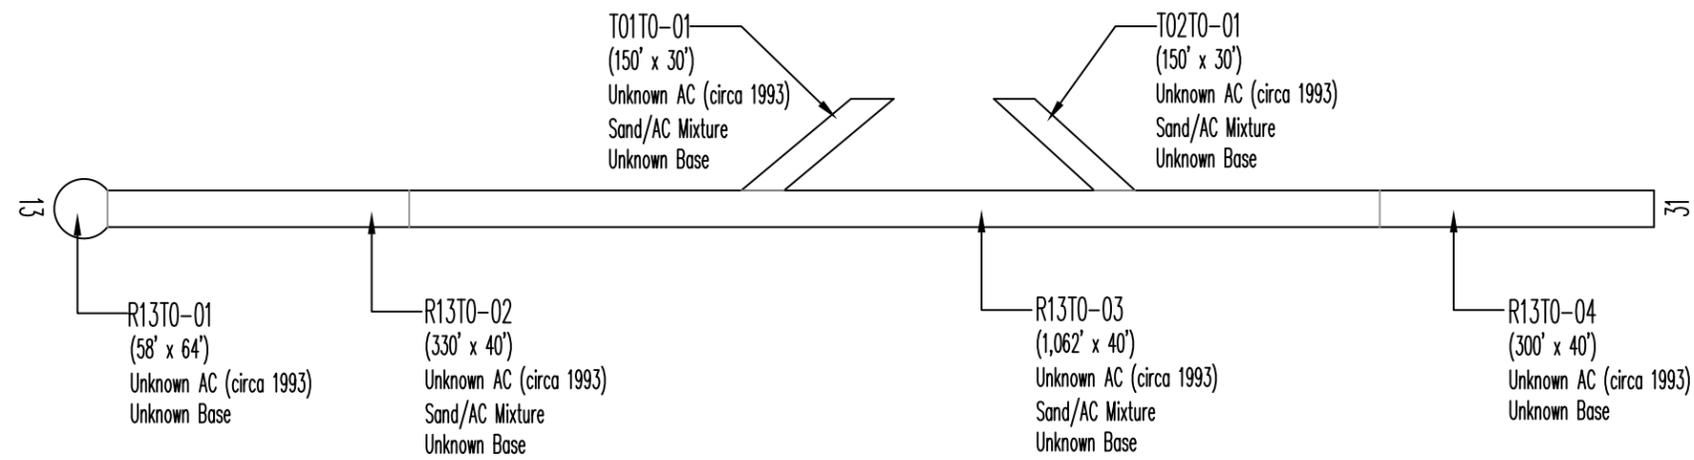
Figure T0-1. Airport Layout, Dimensions and Pavement Cross-Sections.
Toledo State Airport

To determine how your pavements were constructed and their age, a records review was conducted. Figure TO-1 shows the records review results. This figure identifies pavement boundaries, dimensions, pavement layer types, thicknesses and dates of construction. The most recent construction date for each pavement can also be found in the Section Condition Report in Appendix 2. Figure TO-1 and the information contained in Appendices 1, 2 and 4 ensure that your airport complies with the “pavement inventory” requirement of FAA’s PMMP guidelines.

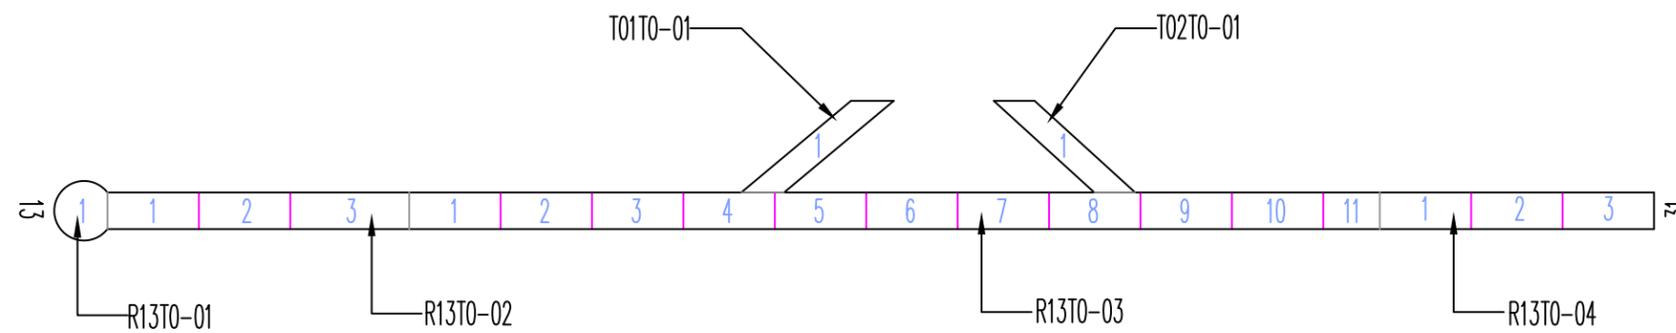
Figure T0-2. Pavement Branch, Section and Sample Unit Layout.
Toledo State Airport

The pavements at your airport were divided into branches, sections and sample units in accordance with the methodology outlined in the current edition of ASTM D5430, *Standard Test Method for Airport Condition Index Surveys*. The branches, sections and sample units established at your airport are shown in Figure TO-2. A Branch Condition Report showing all branches, their associated areas, and their area-weighted average condition is provided in Appendix 1. Additionally, the Appendix 2 Section Condition Report provides information used to define each branch and section in the Micro PAVER database.

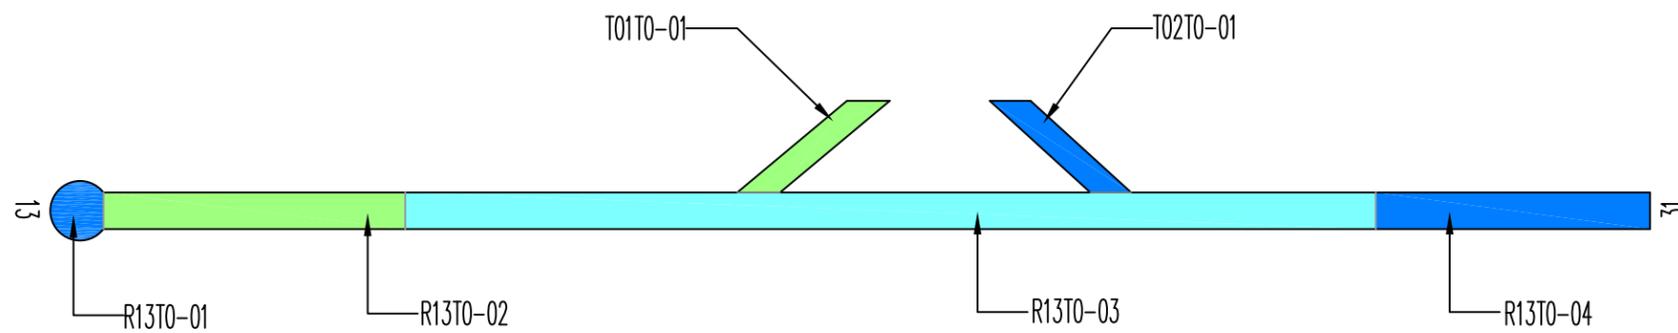
Figure T0-3. Pavement Condition in July 2012.
Toledo State Airport

The Branch Condition Report in Appendix 1 summarizes current pavement condition by branch while the Section Condition Report in Appendix 2 lists pavement condition by section. The current PCR is shown graphically in Figure TO-3.

Section PCIs at Toledo State Airport range from a low of 47 (a PCR of "Poor") to a high of 77 (a PCR of "Satisfactory"). The area-weighted average PCI for all airport pavements is 66, corresponding to an overall PCR of "Fair". Figure TO-4 shows how much pavement area is associated with each Pavement Condition Rating category and also shows pavement condition distribution from the inspections conducted in 2004 and 2008.

The primary distresses observed during the inspection were: longitudinal and transverse cracking, raveling, block cracking, and depressions.

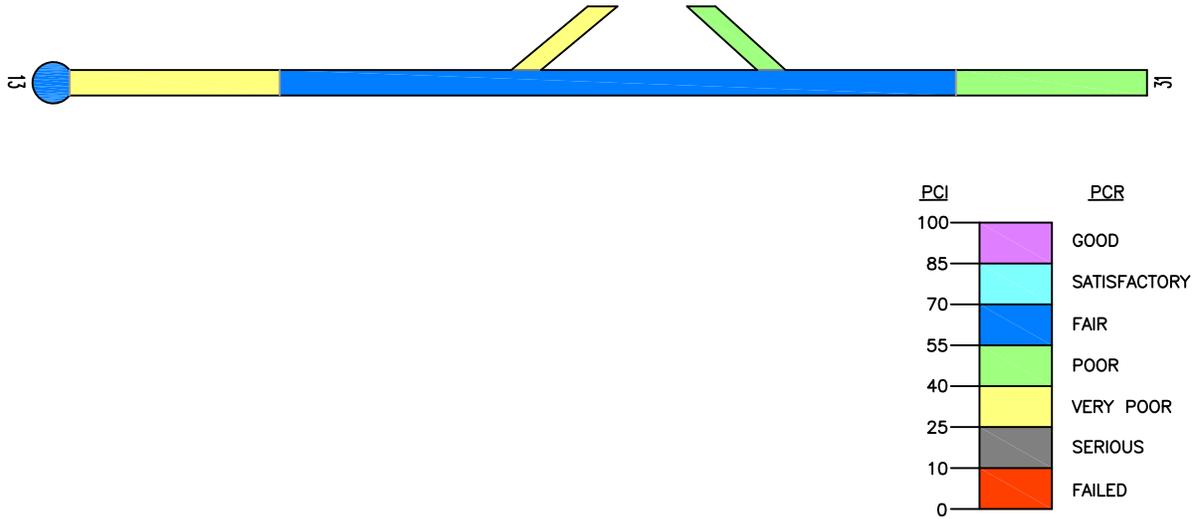
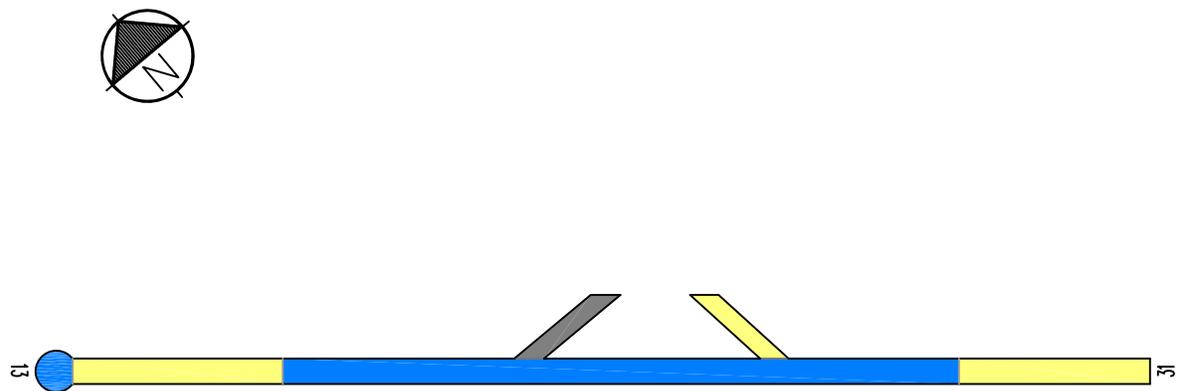
Figure TO-5. Future Pavement Condition.

A graphical representation of the projected PCIs listed in Table 1 is shown in Figure TO-5.

Predicted Condition in 2017.

Predicted Condition in 2022.

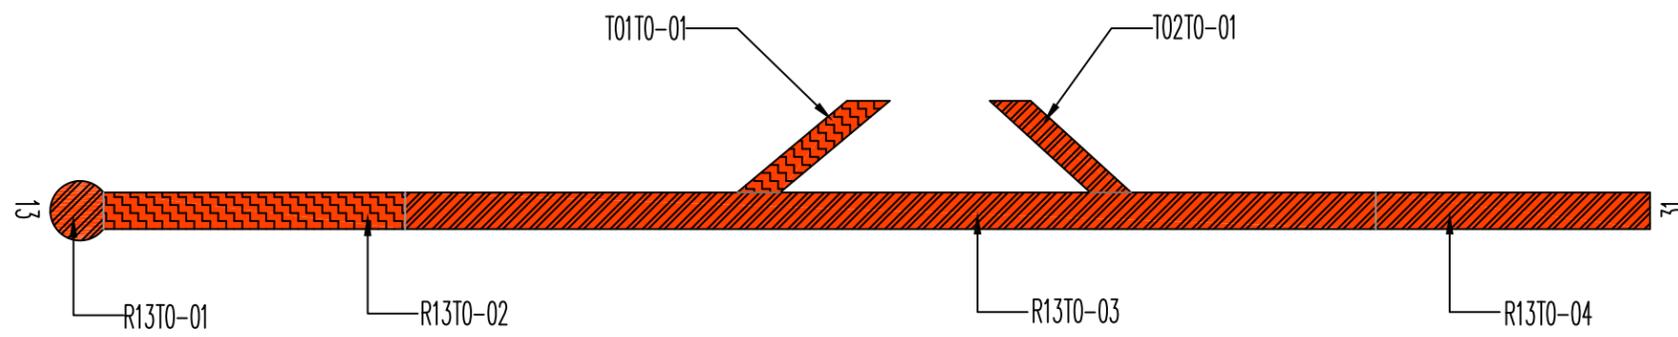
Figure T0-6. Five-Year Pavement Management Plan.
Toledo State Airport

During this project a 5-year program outlining recommended global maintenance and rehabilitation was developed. The program begins in the year 2013 to allow time for project development. These recommendations are presented in Table 2, which identifies the pavement section requiring rehabilitation, the year the action should be completed, the type of action, and an associated cost. This information is also presented graphically in Figure TO-6.

Data collected during the visual condition survey were used by the Micro PAVER software to generate the Network Maintenance Report contained in Appendix 3. This report identifies, for each pavement section, the recommended localized maintenance activities (i.e.-crack sealing, patching) that should be completed to repair the defects observed during the visual inspection. The repair quantities identified in the report were extrapolated to cover the entire pavement section, based on the distresses measured in the inspected sample units. If the repair activities identified are completed, the pavement deterioration rate will be slowed.

- 2,132 linear feet of asphalt concrete crack sealing
