# Pavement Evaluation/ Maintenance Management Program 2019

## Oakridge State Airport

**2019 Pavement Evaluation / Maintenance  
Management Program**

**Final Report – Individual Airports  
Functional Category 5, Eastern Climatic Zone**

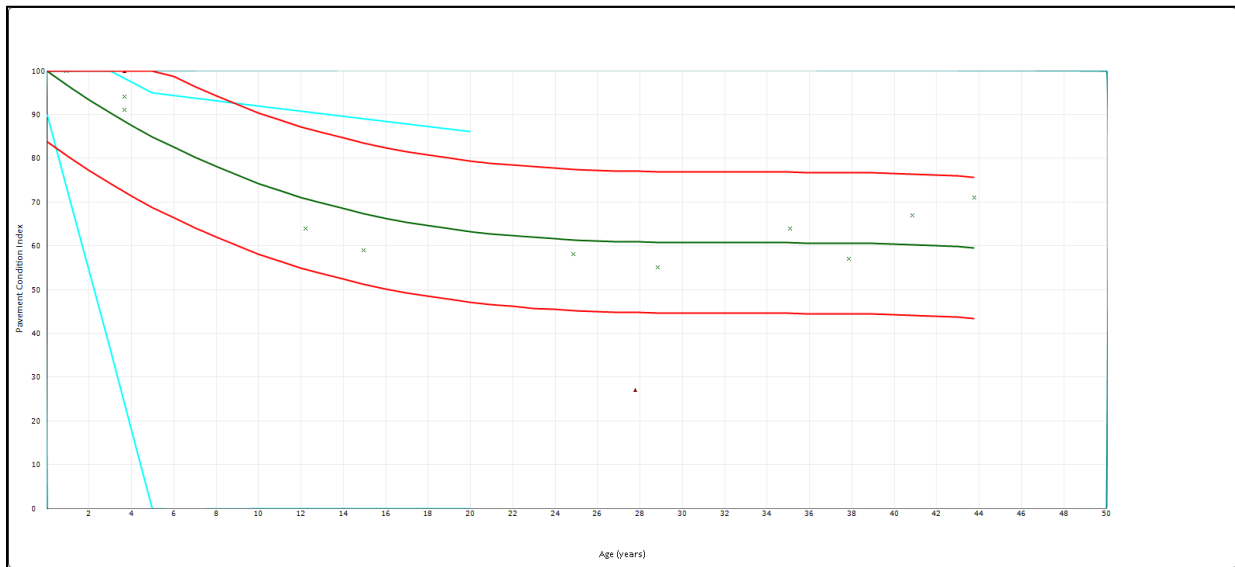
**Figure 2. Performance Curve for Category 5 AAC Aprons – Eastern Oregon.**

To allow future pavement condition to be predicted, data collected throughout the State were used to generate "performance curves". The curves were developed based on surface type, use, airport functional category and climatic region. These curves (models) are used to predict future pavement condition by assuming the behavior of an individual pavement section is similar to the behavior of the pavement sections used to generate the "performance curve". Figures 2 through 10 show the "performance curves" used to model pavements in your airport's functional category and climatic region.

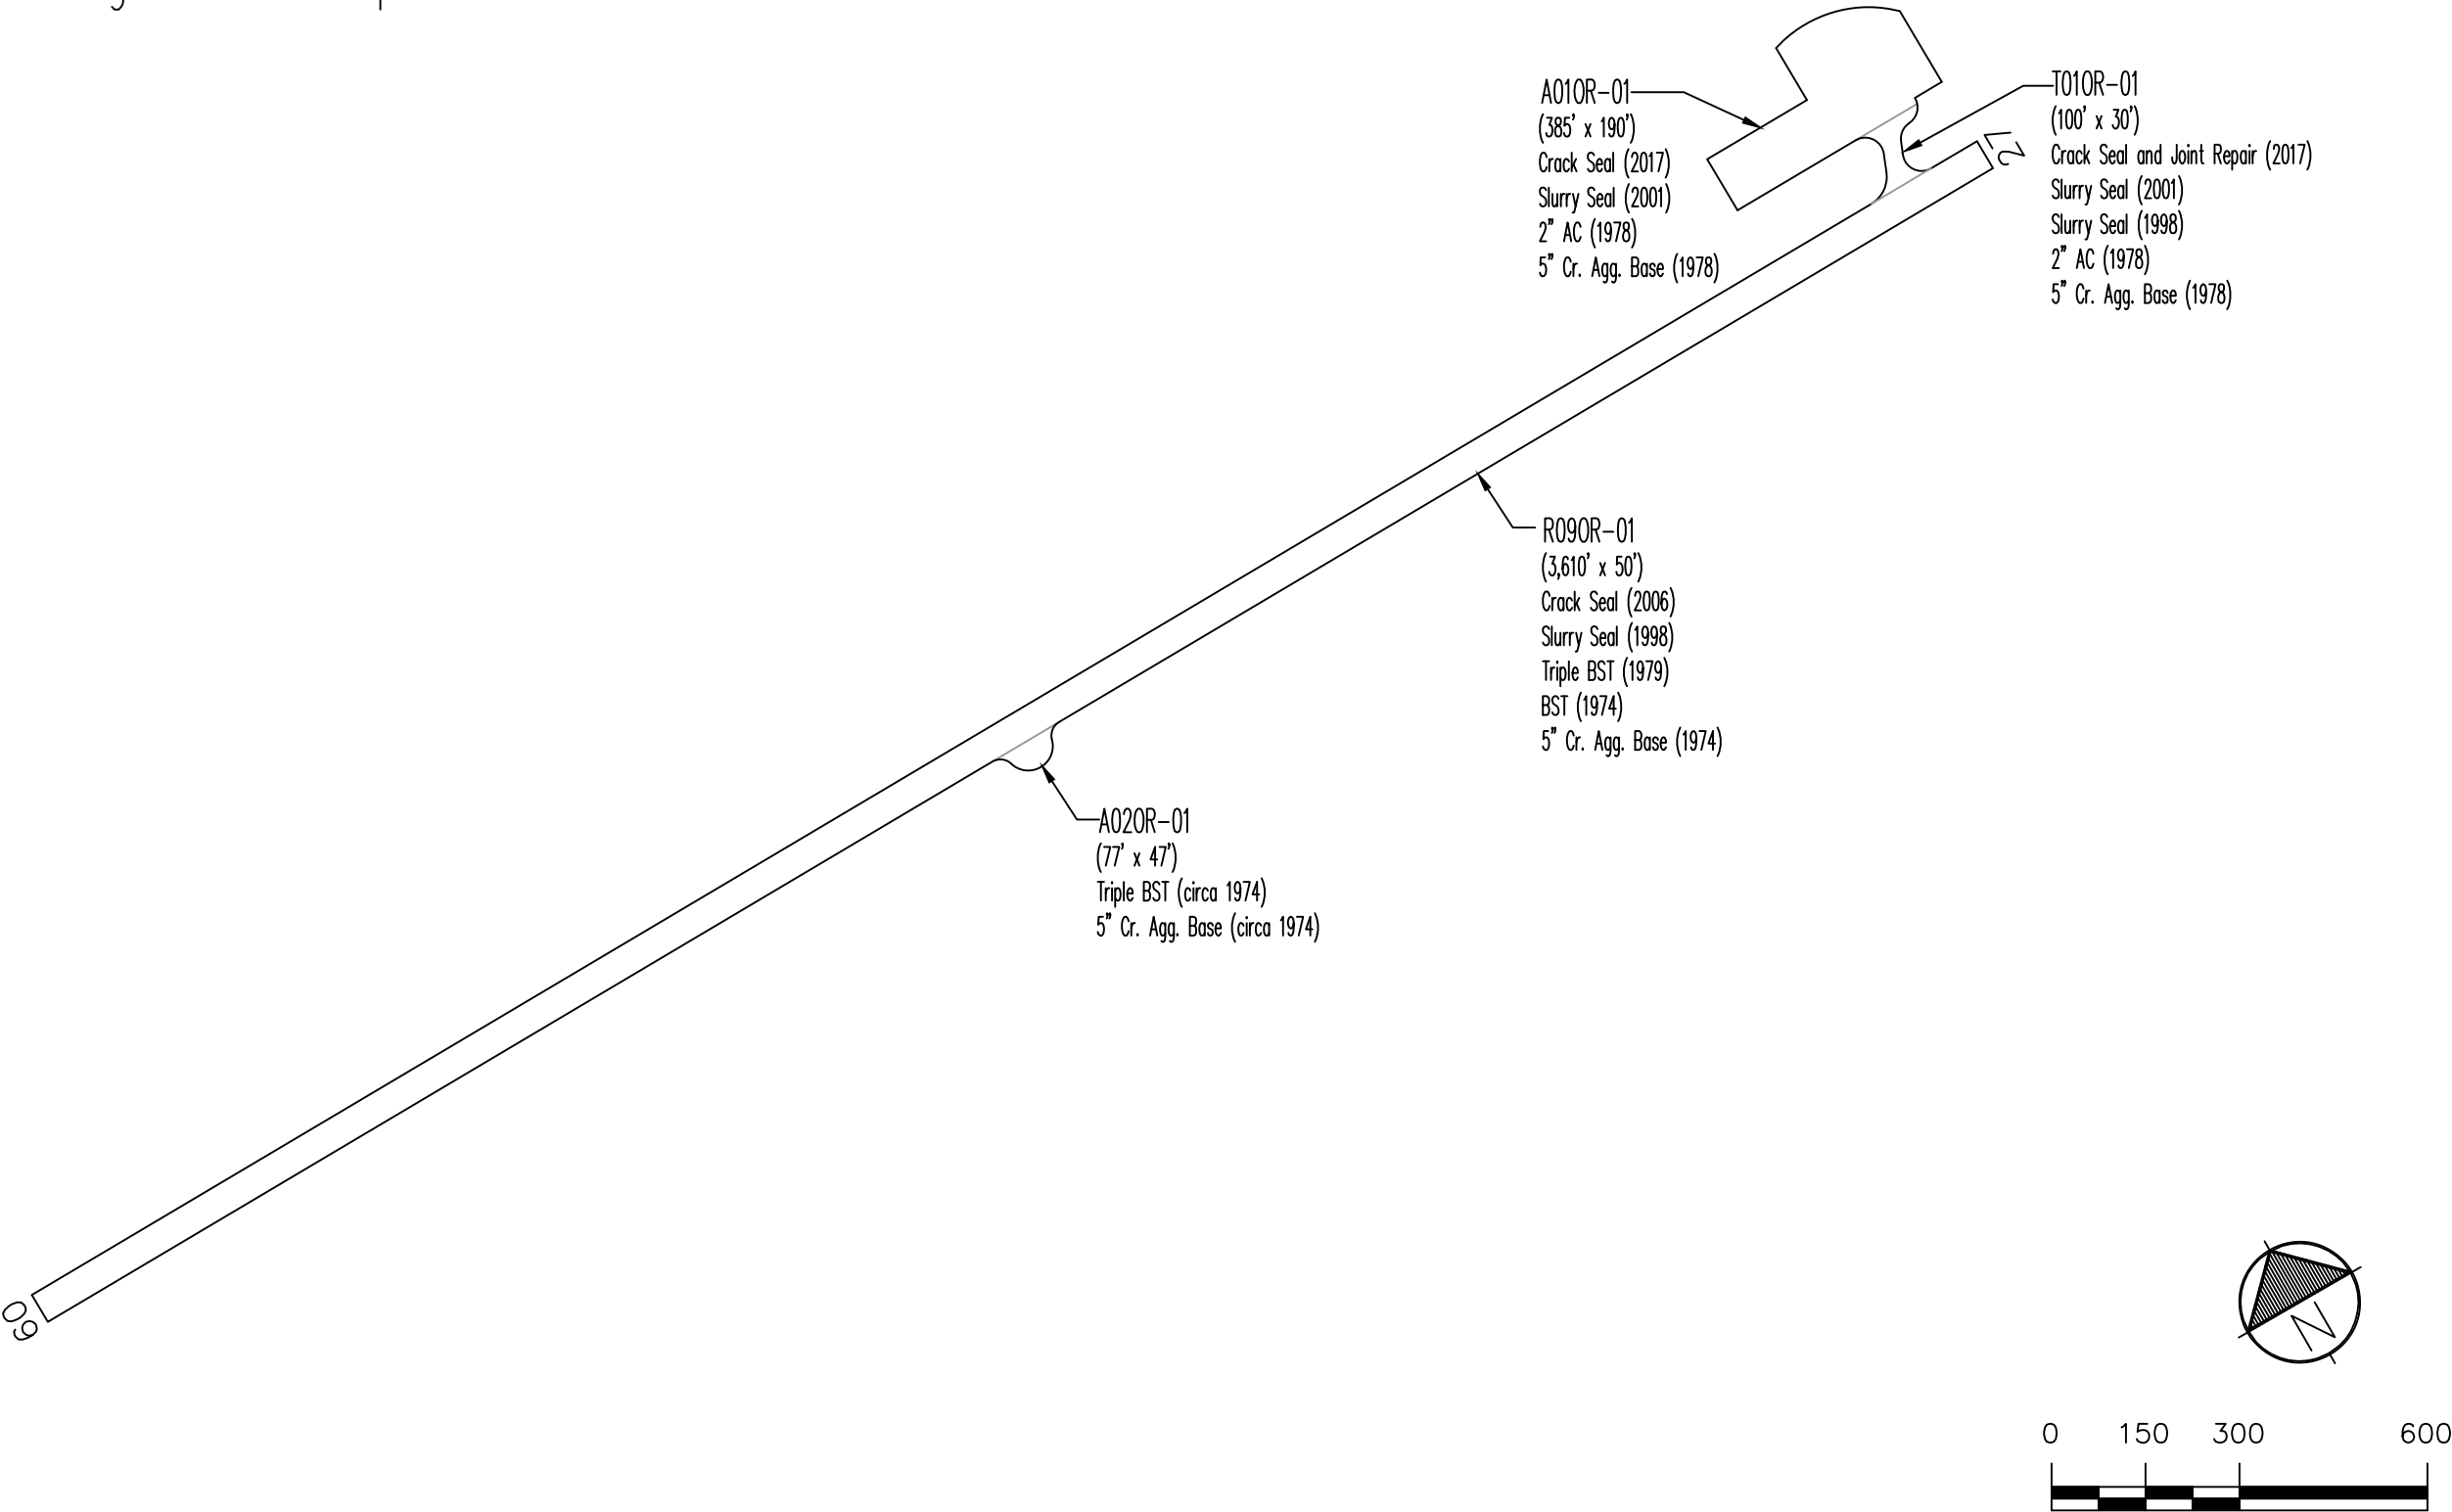
Figure OR-1. Airport Layout, Dimensions and Pavement Cross-Sections.  
Oakridge State Airport

To determine how your pavements were constructed and their age, a records review was conducted. Figure OR-1 shows the records review results. This figure identifies pavement boundaries, dimensions, pavement layer types, thicknesses and dates of construction. The most recent construction date for each pavement can also be found in the Section Condition Report in Appendix 2. Figure OR-1 and the information contained in Appendices 1, 2 and 4 ensure that your airport complies with the “pavement inventory” requirement of FAA’s PMMP guidelines.

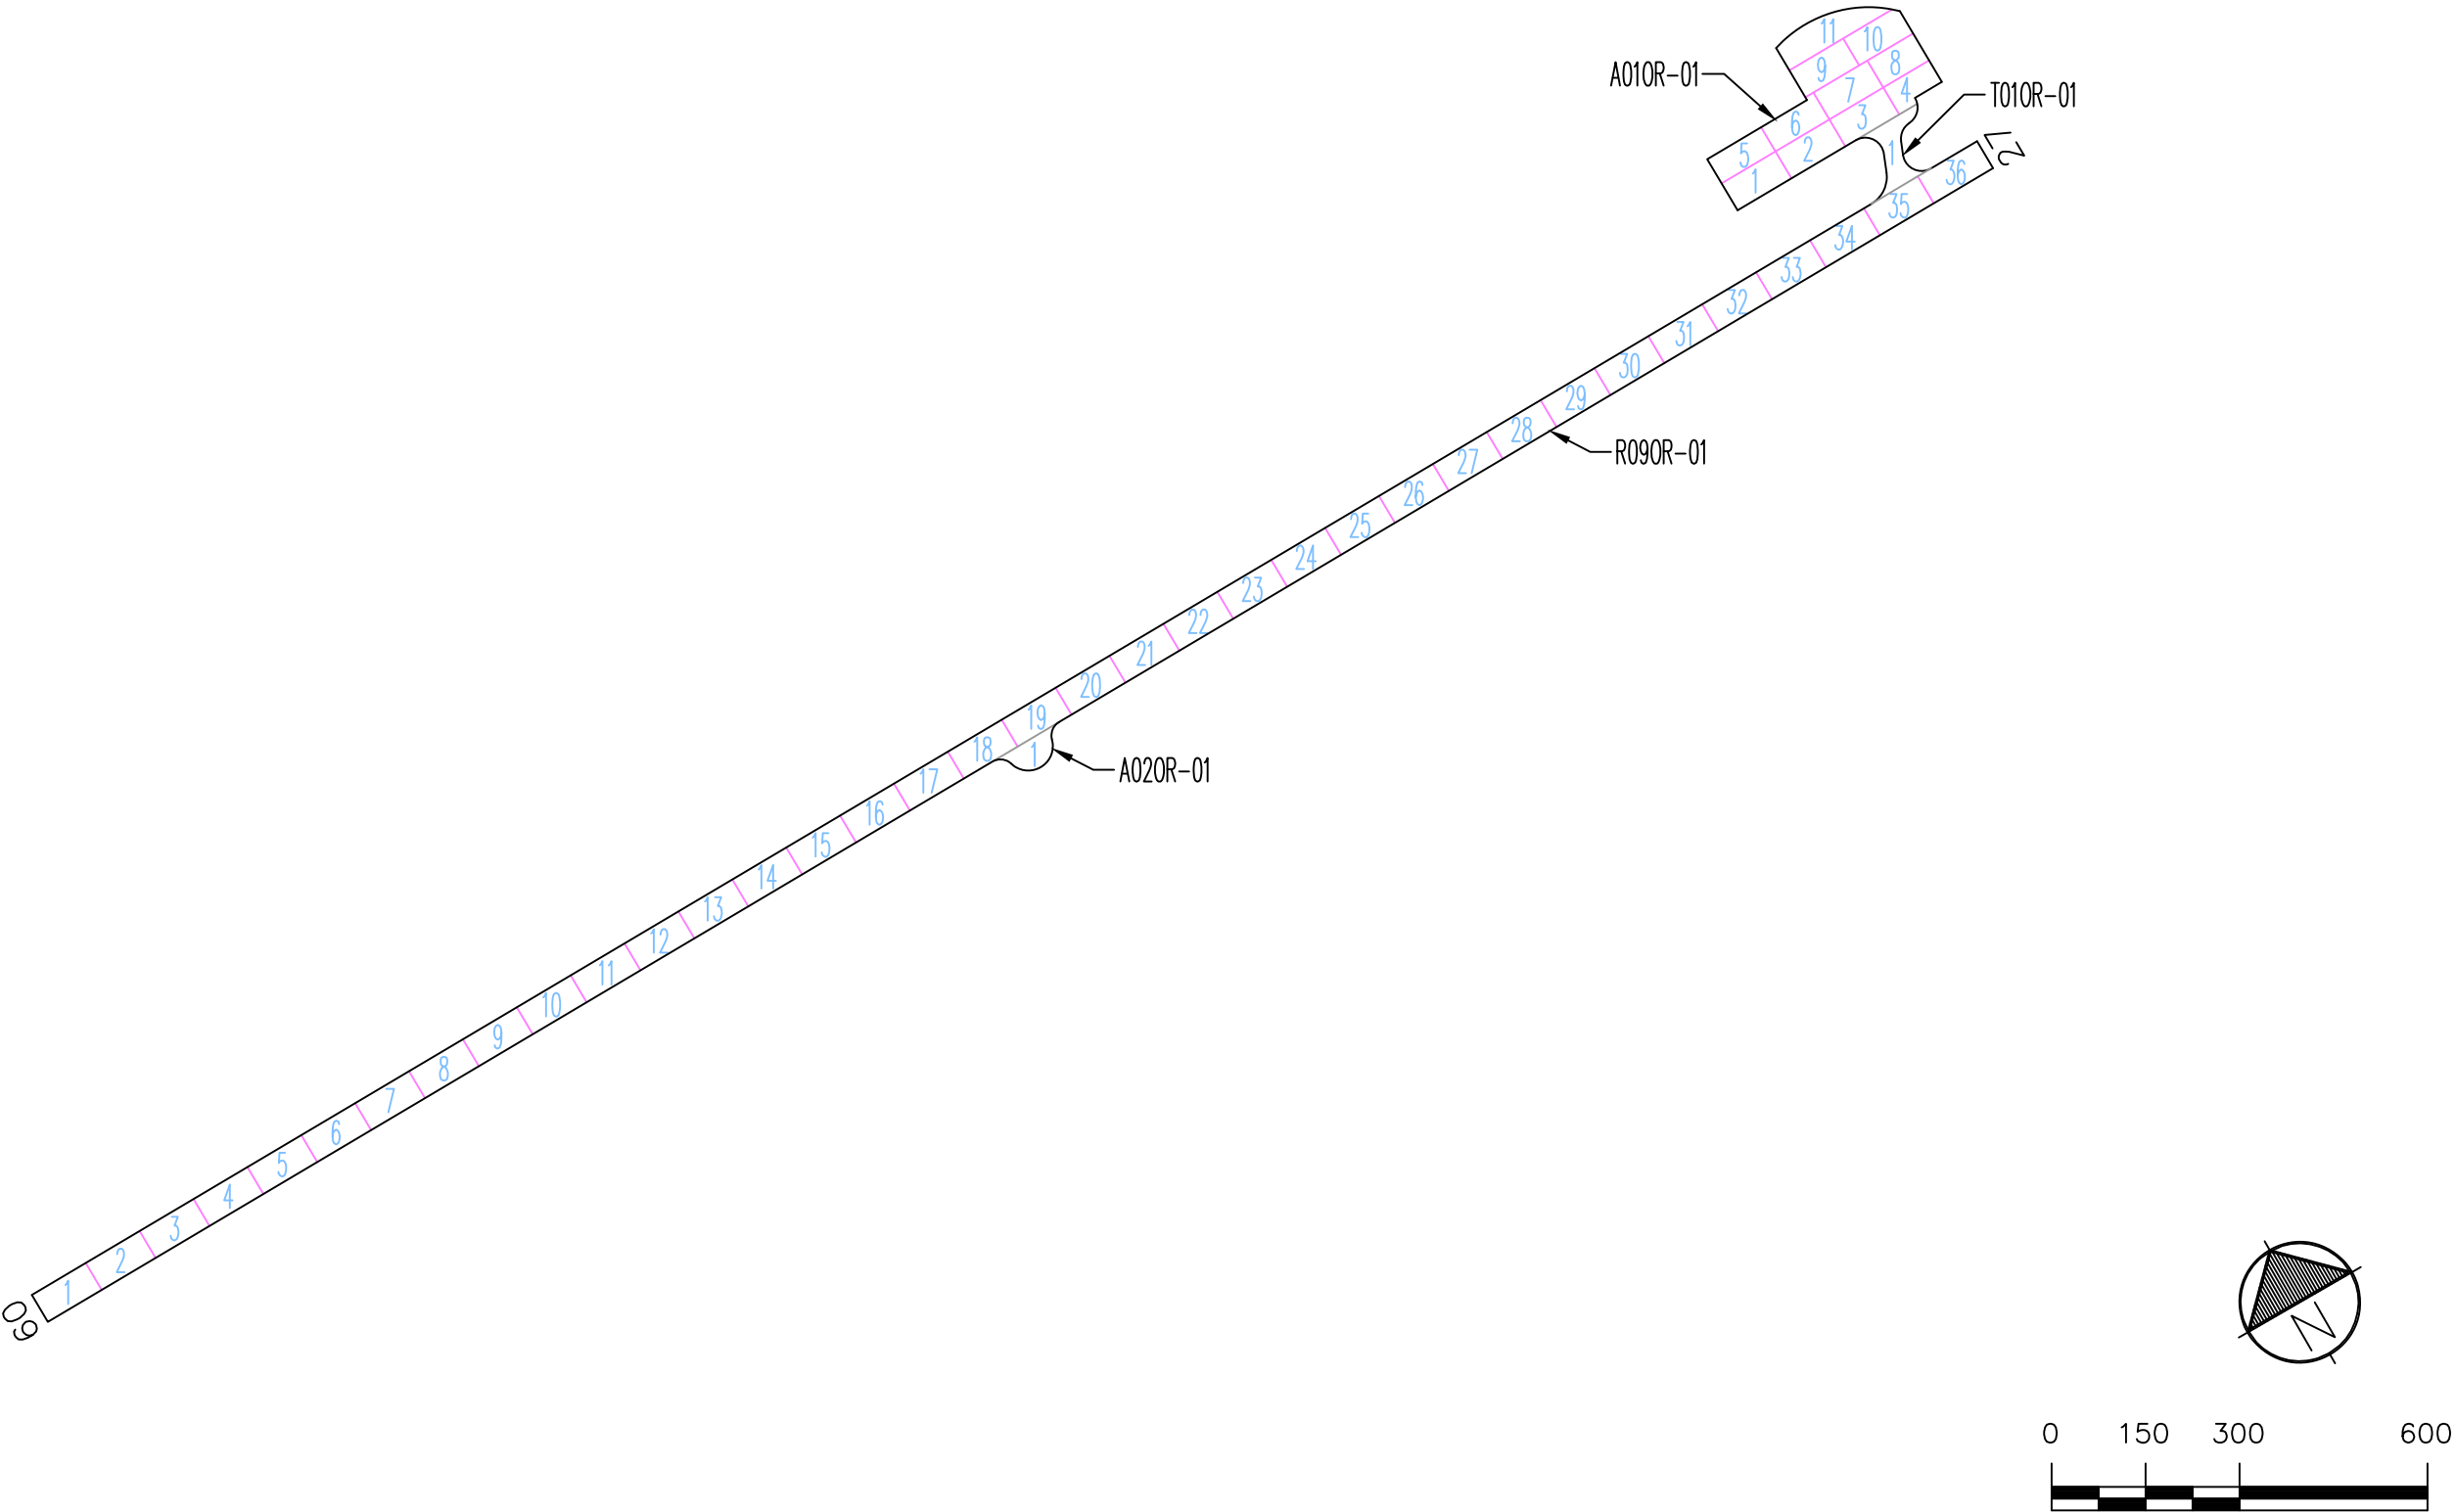
Figure OR-2. Pavement Branch, Section and Sample Unit Layout.  
Oakridge State Airport

The pavements at your airport were divided into branches, sections and sample units in accordance with the methodology outlined in the current edition of ASTM D5430, *Standard Test Method for Airport Condition Index Surveys*. The branches, sections and sample units established at your airport are shown in Figure OR-2. A Branch Condition Report showing all branches, their associated areas, and their area-weighted average condition is provided in Appendix 1. Additionally, the Appendix 2 Section Condition Report provides information used to define each branch and section in the PAVER database.

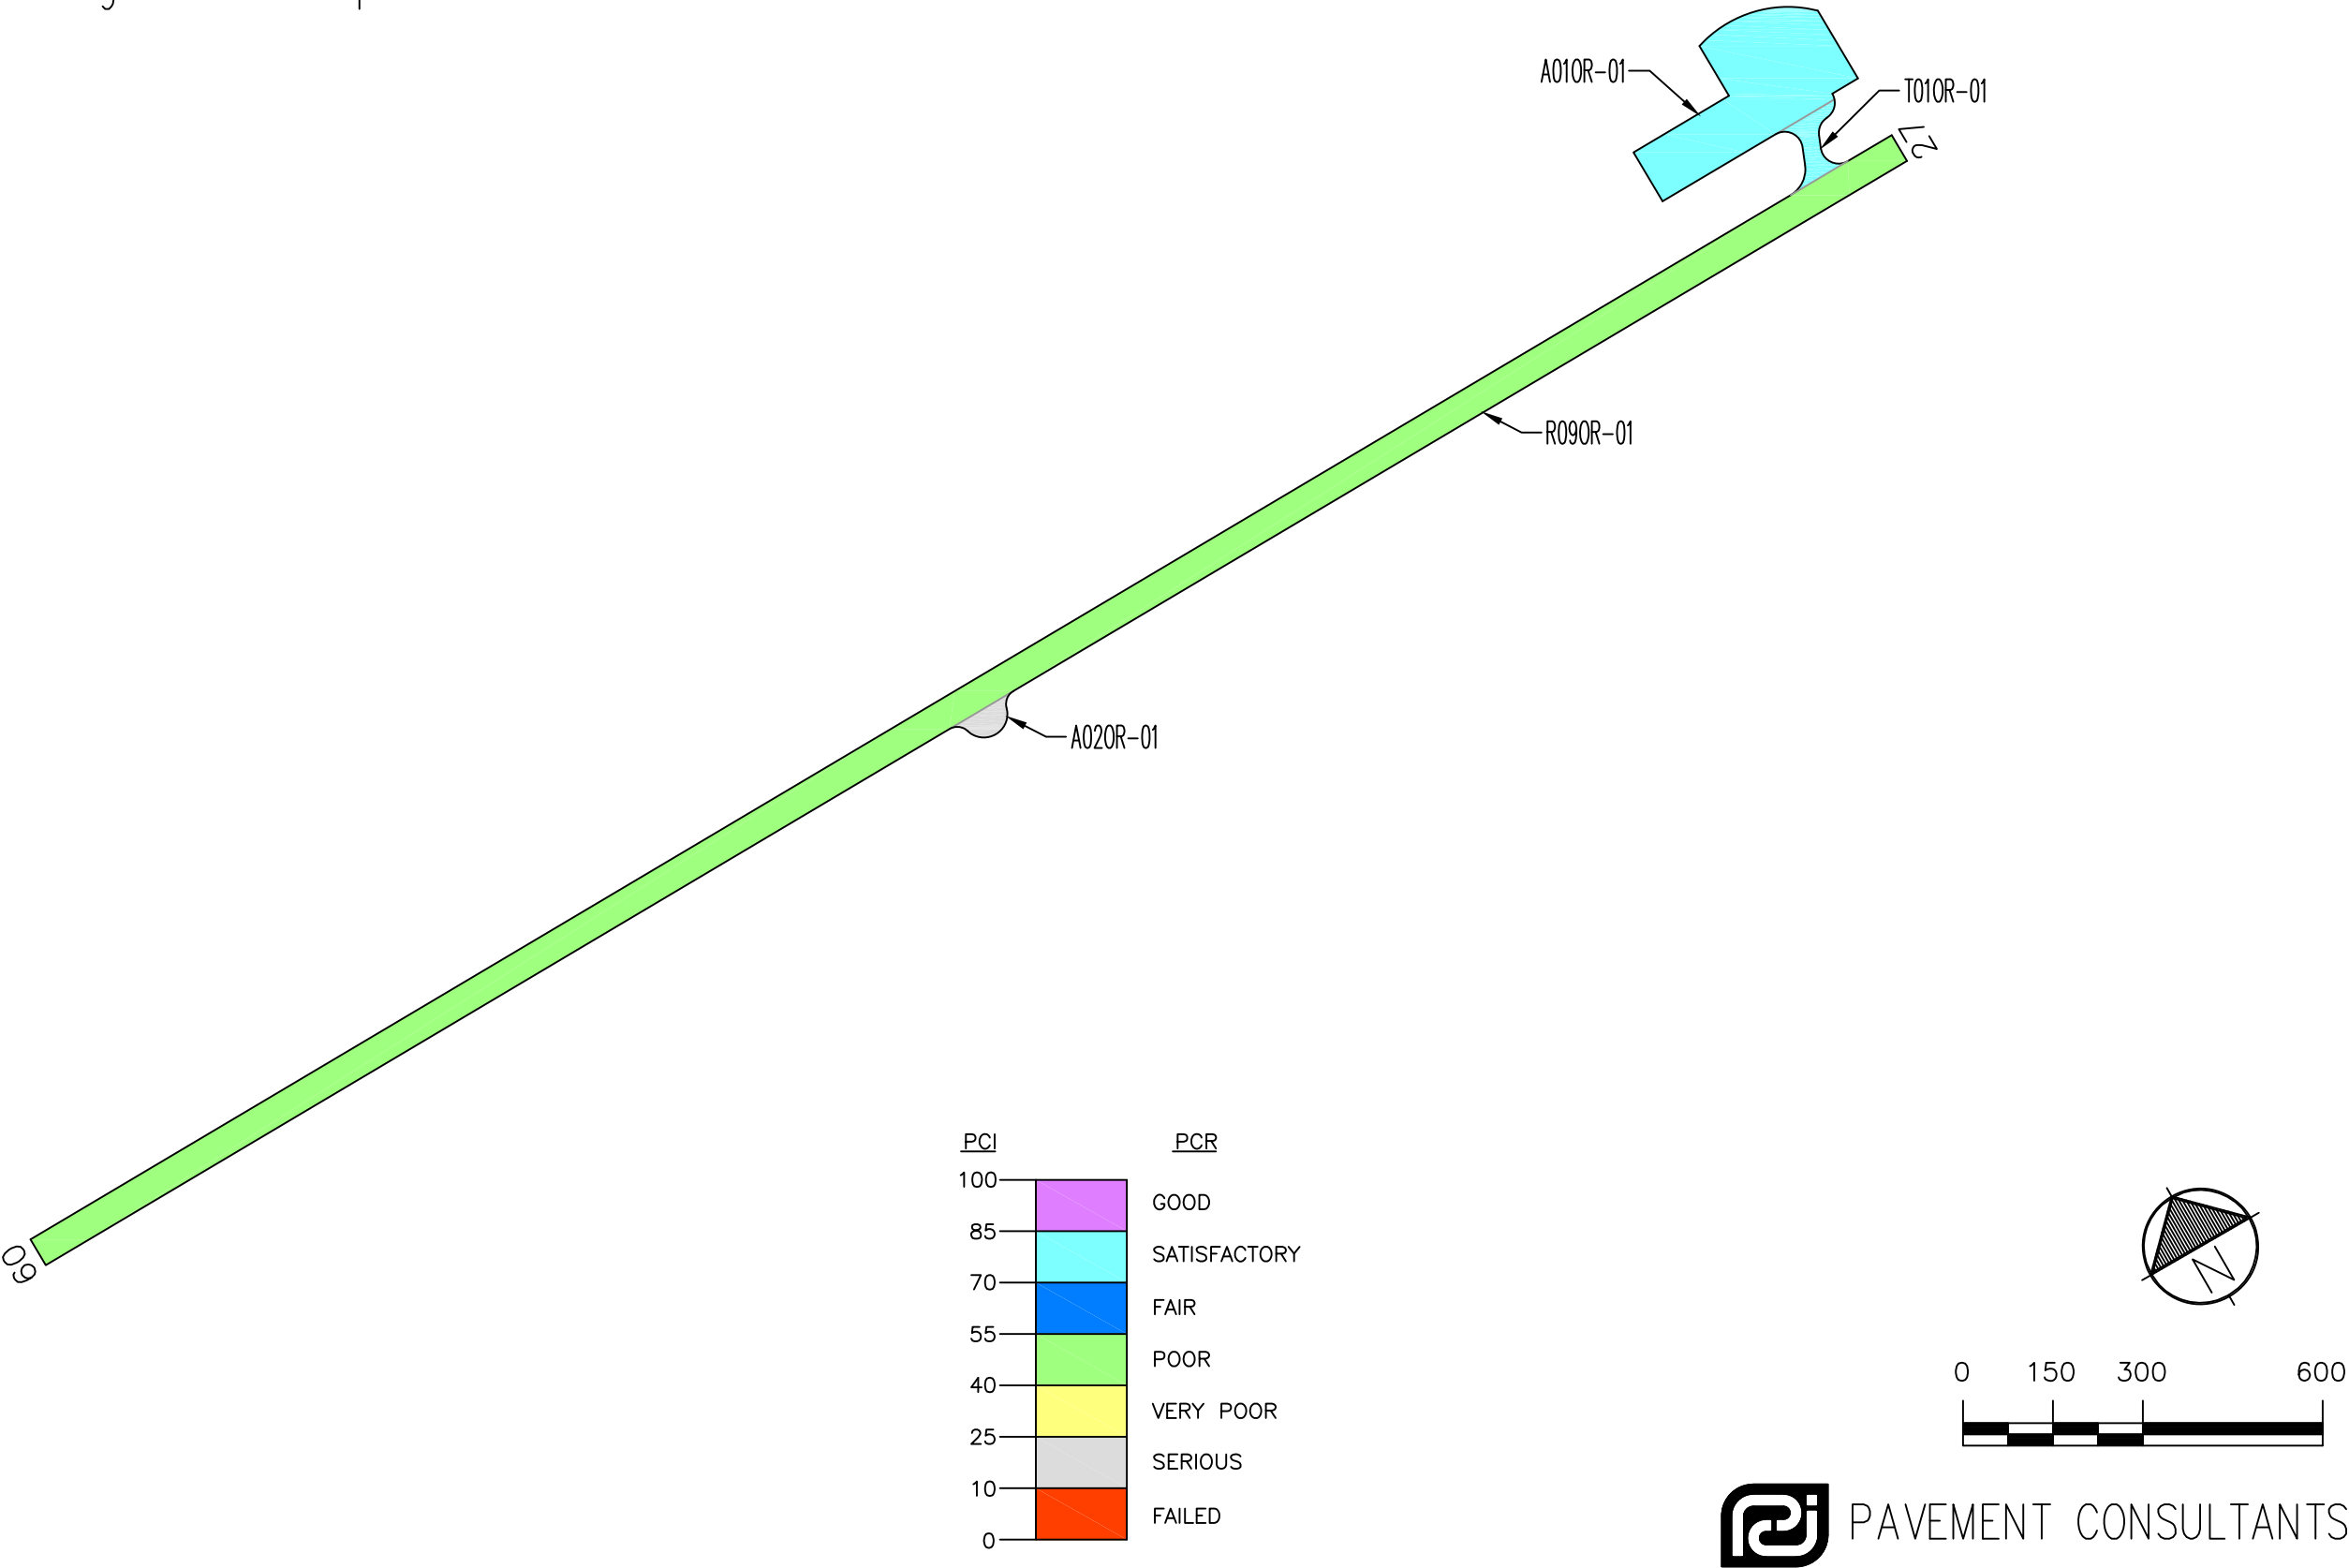
Figure OR-3. Pavement Condition in May 2019.  
Oakridge State Airport

The Branch Condition Report in Appendix 1 summarizes current pavement condition by branch while the Section Condition Report in Appendix 2 lists pavement condition by section. The current Pavement Condition Rating (PCR) is shown graphically in Figure OR-3.

Section PCIs at Oakridge State Airport range from a low of 19 (a PCR of "Serious") to a high of 74 (a PCR of "Satisfactory"). The area-weighted average PCI for all airport pavements is 55, corresponding to an overall PCR of "Poor". Figure OR-4 shows how much pavement area is associated with each Pavement Condition Rating category and also shows pavement condition distribution from the inspections conducted in 2013 and 2016.

The primary distresses observed during the inspection were: patching, block cracking and longitudinal and transverse cracking, with isolated occurrences of alligator cracking, and raveling.

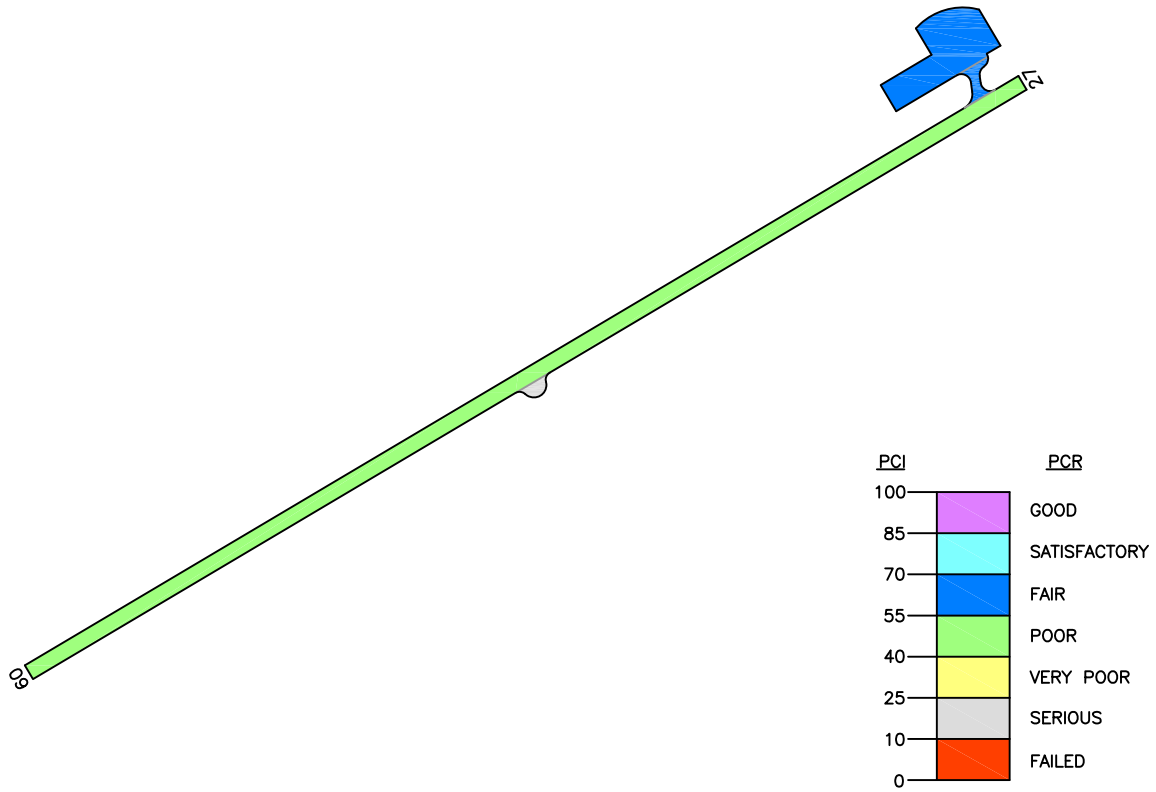
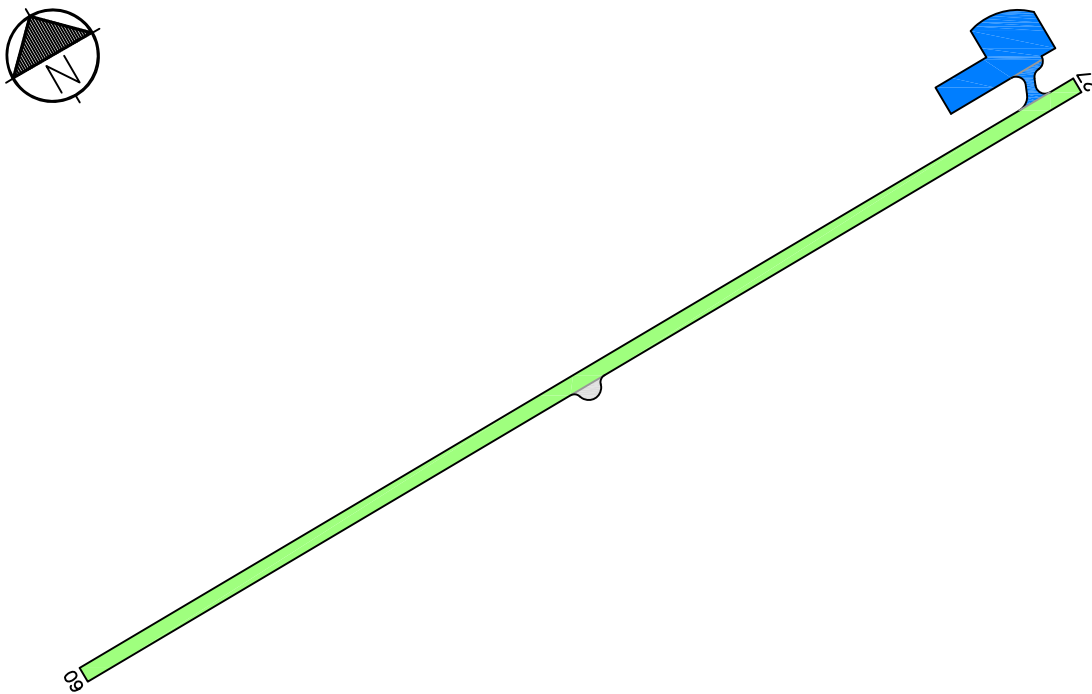
**Figure OR-5. Future Pavement Condition.**

A graphical representation of the projected PCIs listed in Table 1 is shown in Figure OR-5.

### Predicted Condition in 2024.

### Predicted Condition in 2029.

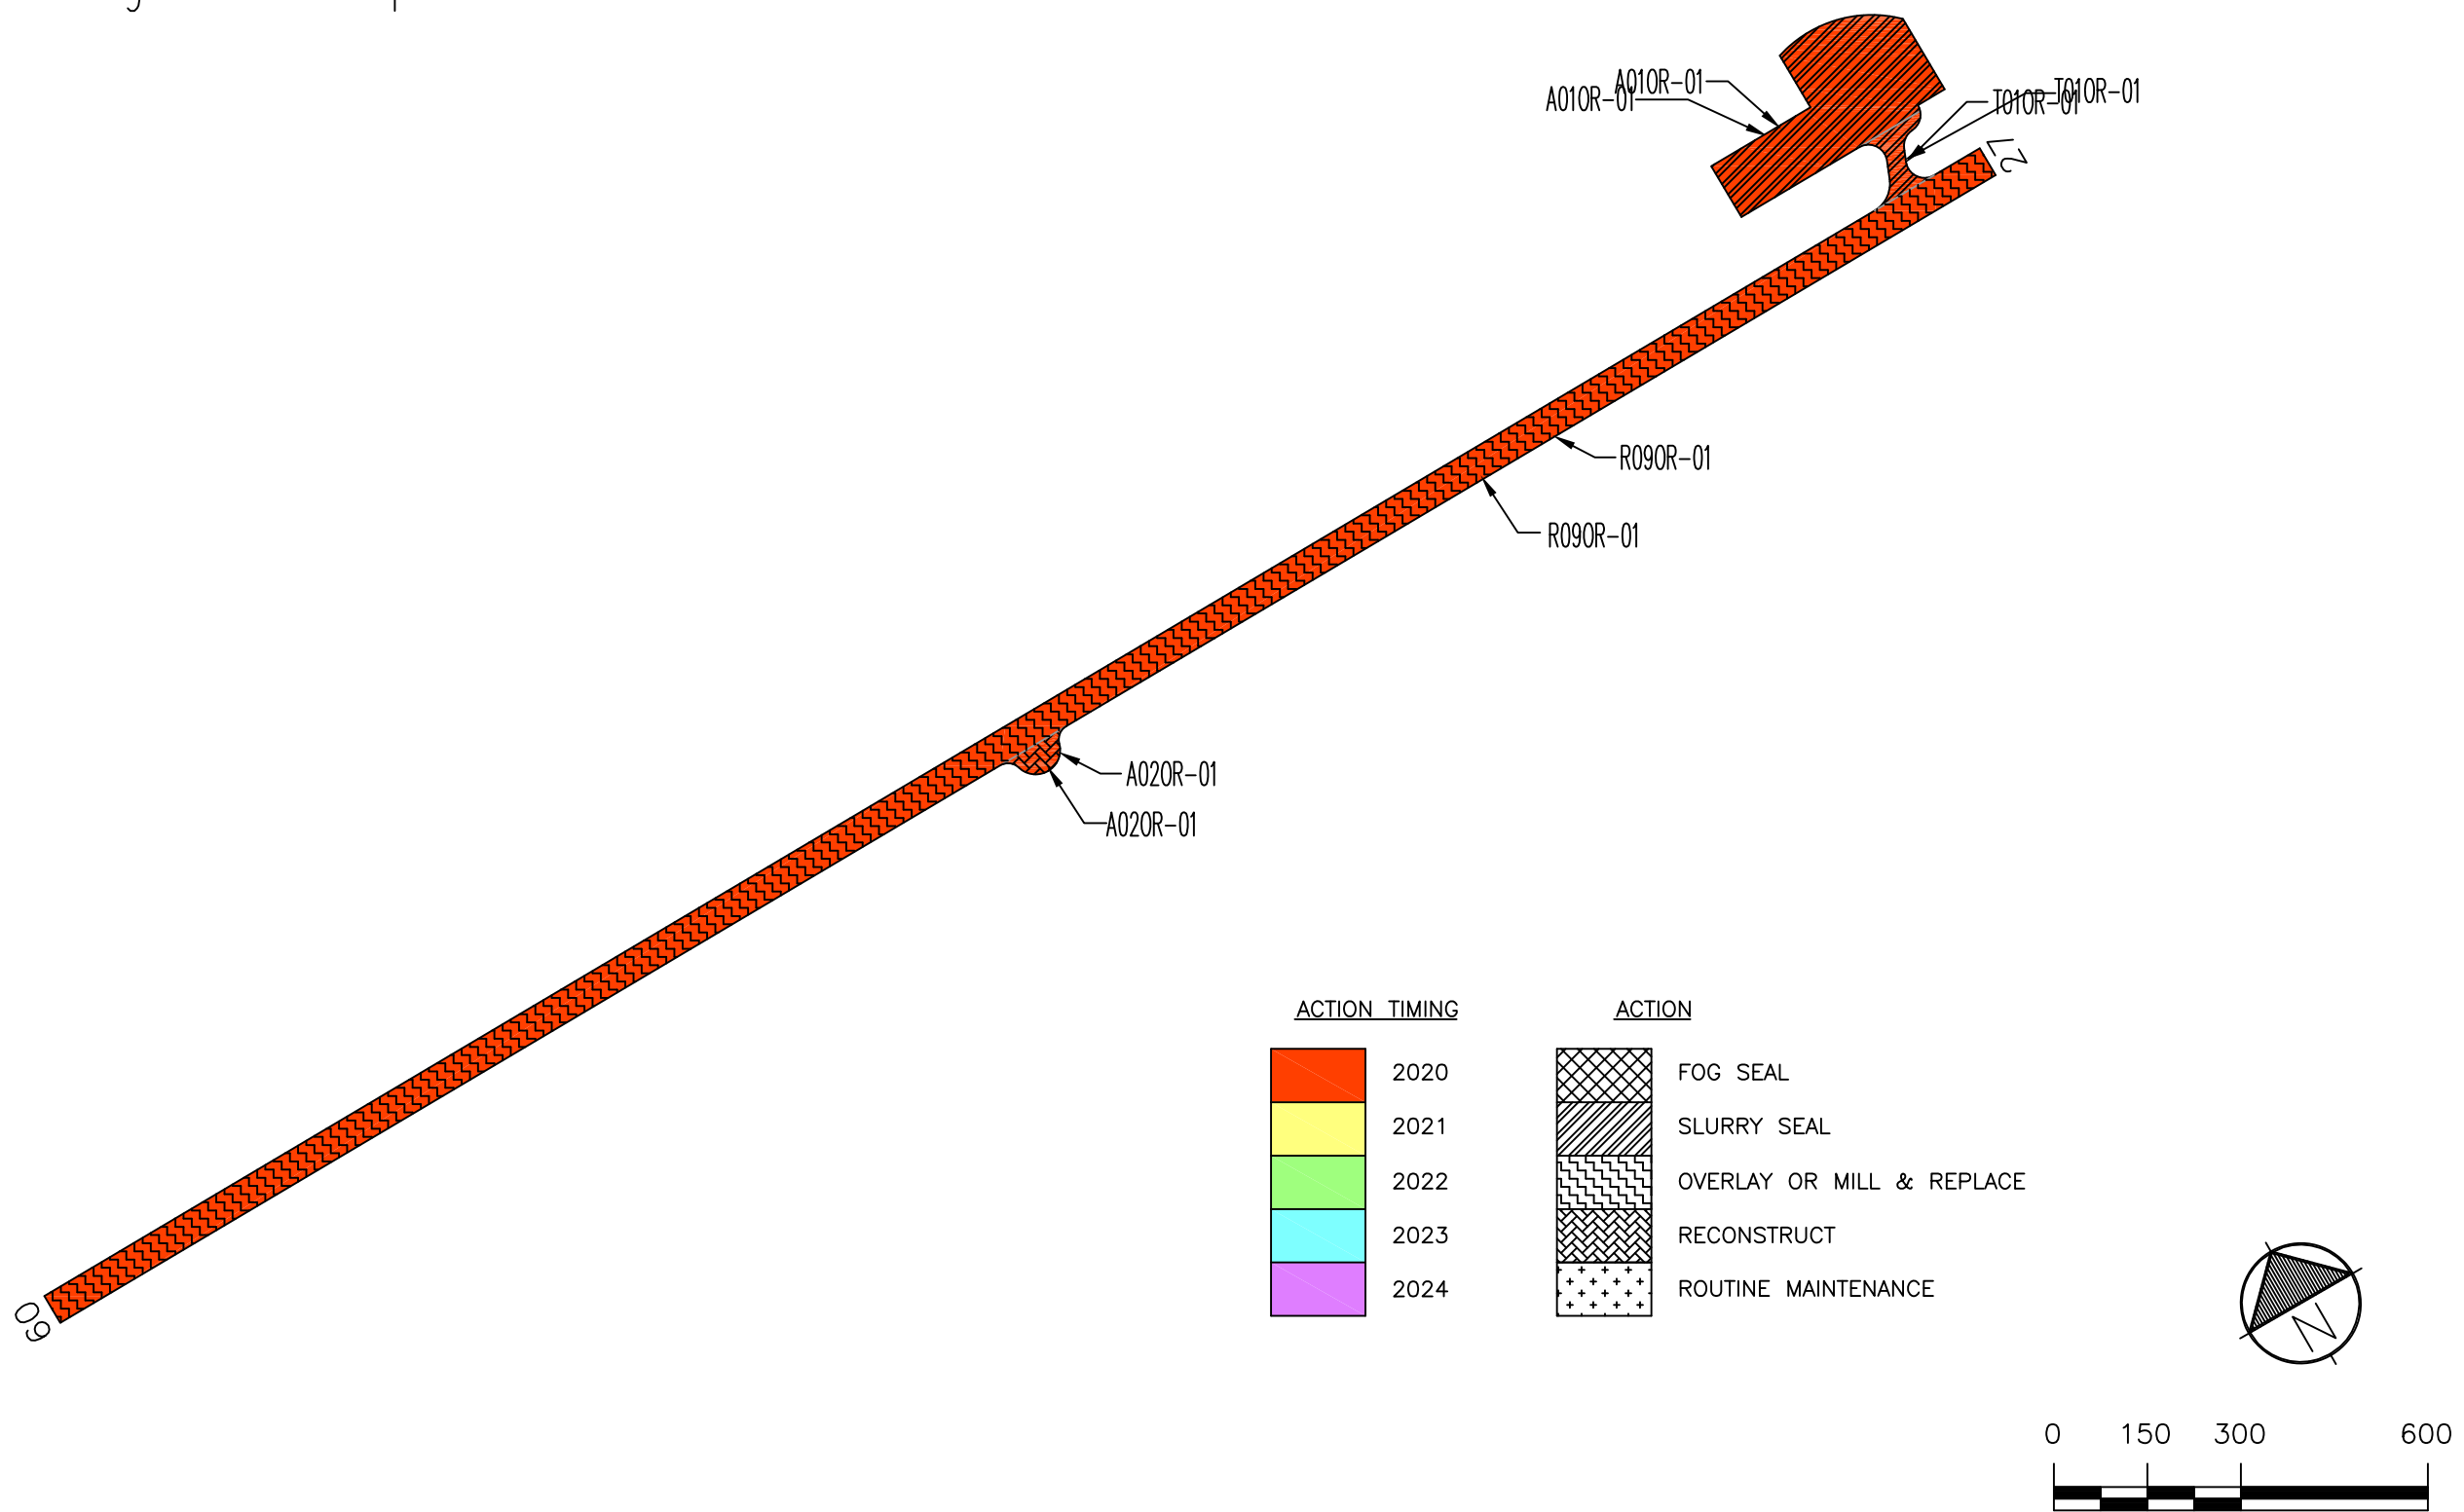
Figure OR-6. Five-Year Pavement Management Plan.  
Oakridge State Airport

During this project a 5-year program outlining recommended global maintenance and rehabilitation was developed. The program begins in the year 2020 to allow time for project development. These recommendations are presented in Table 2, which identifies the pavement section requiring rehabilitation, the year the action should be completed, the type of action, and an associated cost. This information is also presented graphically in Figure OR-6.

If the global maintenance and/or rehabilitation activities recommended in Table 2 are not completed, the localized maintenance activities identified in the Network Maintenance Report (Appendix 3) for that section should be done. Additionally, for those sections not listed in Table 2 as requiring global maintenance or rehabilitation, the localized maintenance activities outlined in the Network Maintenance Report should be completed. By completing the localized maintenance activities, pavement condition is improved, life is extended, deterioration is slowed and the length of time until major repair or rehabilitation is required is increased.
