PROFILE
OF THE
FLAG STAFF
MINE,
Showing Shafts and Drifts:
situated in Baker County
Oregon.
June 16th 1896.
C.M. Foster, Surveyor,
for U.S. Mineral Lands.
Scale 50 Feet to an Inch.

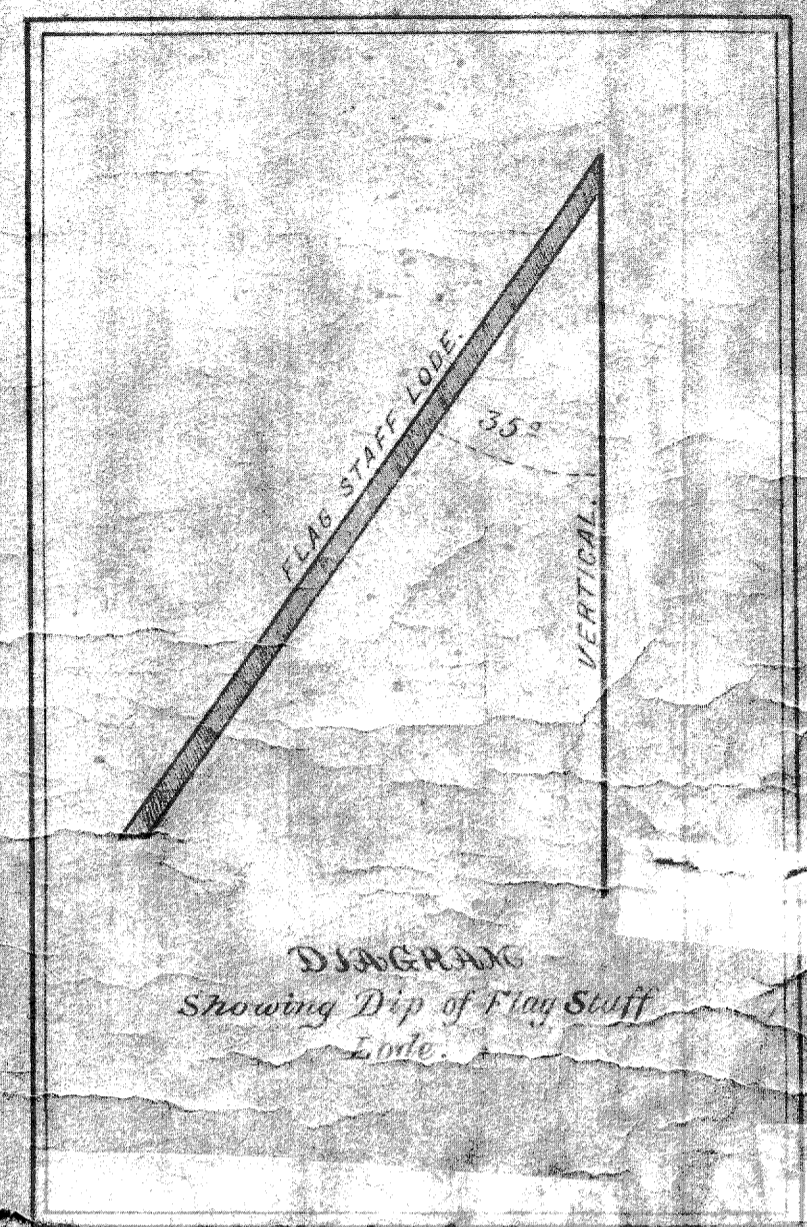
DIAGRAM
Showing Dip of Flag Staff
Lode.

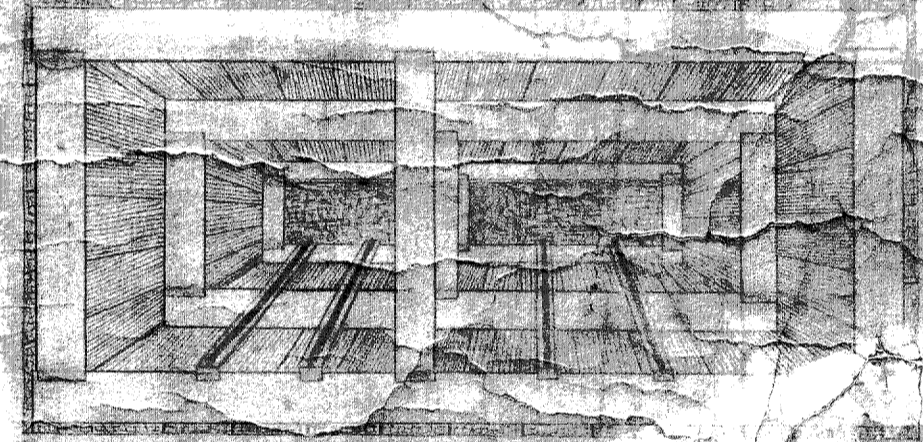
DIAGRAM
showing the Double drifts and
working Incline as constructed.
Scale $2\frac{1}{2}$ to an Inch.
