Unity Fire Department

Building Type		County	
Fire - City		Baker	
Street			
311 Main			
City	State	Zip	
Unity	OR	97884	
Latitude		Longitude	
44.43746		118.18315	
Tracking Code		Inspection Date	
RVS in 2006		8/10/2006

FEMA 154 Rapid Visual Screening Score Card

Rapid Visual Screening - Senate Bill #2 - Seismic Needs Assessment
Oregon Department of Geology and Mineral Industries

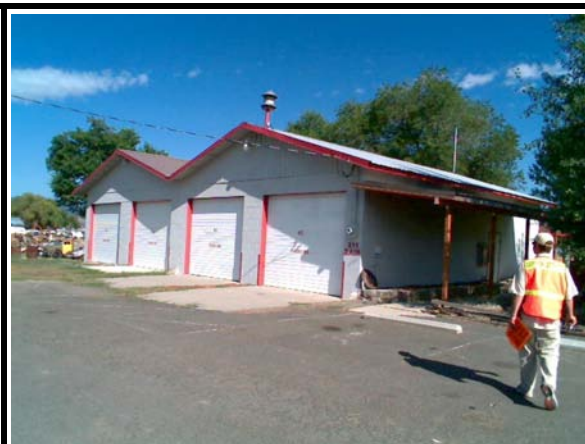
Seismicity Zone: Moderate

Type	Basic Score	Vert Irreg	Plan Irreg	Pre-Code	Post-Bench	Soil C	Soil D	Soil E	RVS Score
Primary	RM1	3.6	-2	-0.5	0	0	0	-1.2	0	-0.1
Secondary		0	0	0	0	0	0	0	0	0
Tertiary		0	0	0	0	0	0	0	0	0

Very High (100%)

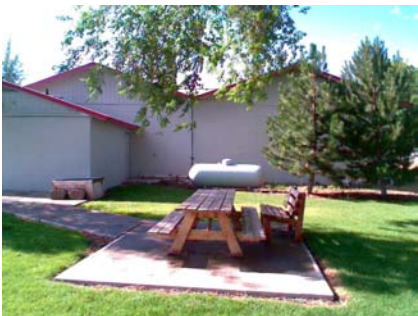
N Elevation View

Plan Irregularities	Vertical Irregularities
Reentrant Corners: L Shaped	Steps in Elevation View: Single Change
None	None
None	None
