St. Elizabeth Hospital - Baker City

Bake_hos01A

FEMA 154 Rapid Visual Screening Score Card

Rapid Visual Screening - Senate Bill #2 - Seismic Needs Assessment
Oregon Department of Geology and Mineral Industries

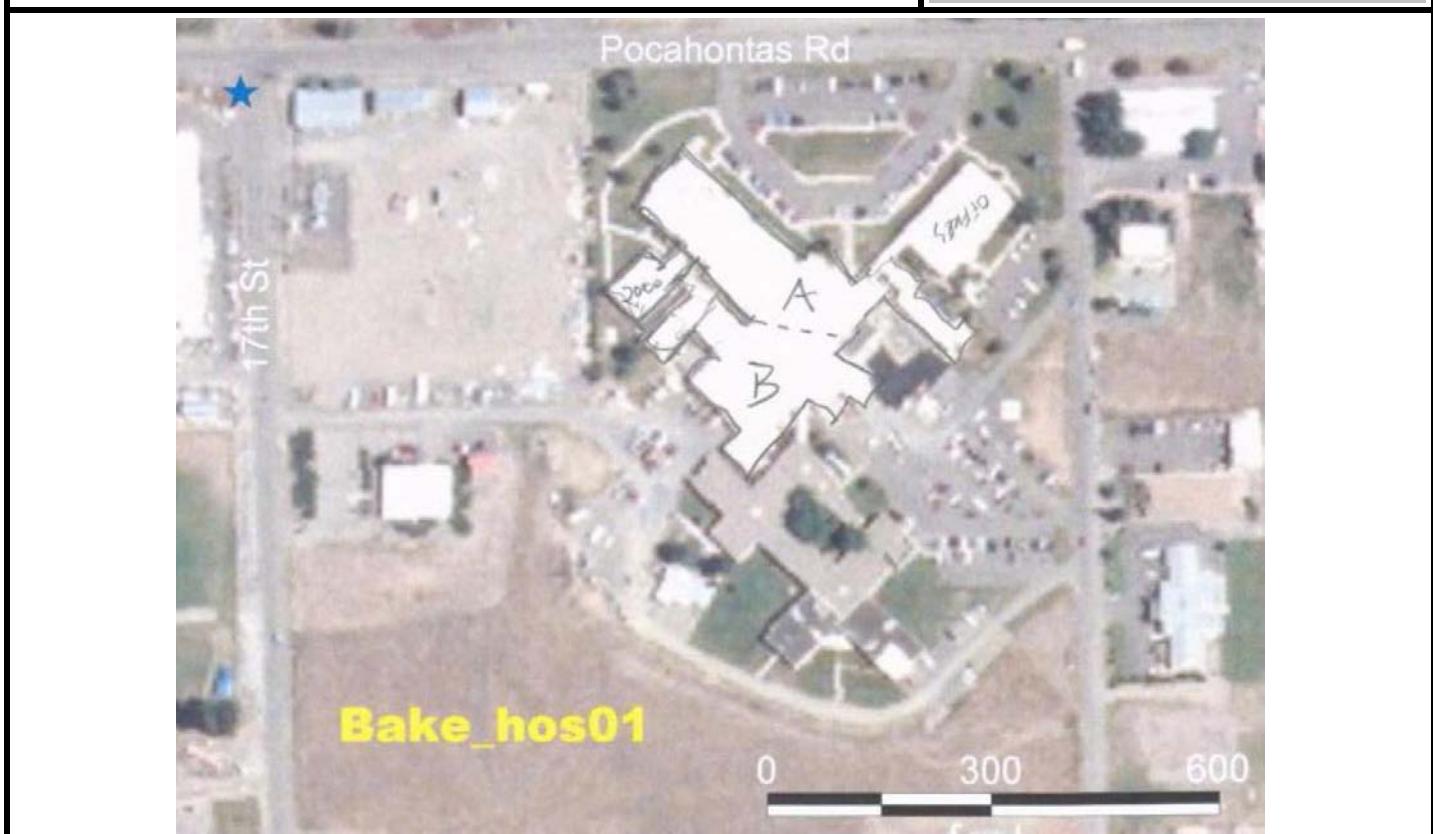
Enrollment	Year Built (Field Verified)	Year Built (Alt. Source)	Est. Decade Built
		1987	1970
Total Area (square ft)	Number of Stories	Basement	Pounding Potential
	1	No	No
Plan Irregularities		Vertical Irregularities	
Reentrant Corners: Other		Steps in Elevation View: Single Change	
Reentrant Corners: Other		None	
None		None	
Falling Hazards		Poor Conditions	
None		None	
None		None	
None		None

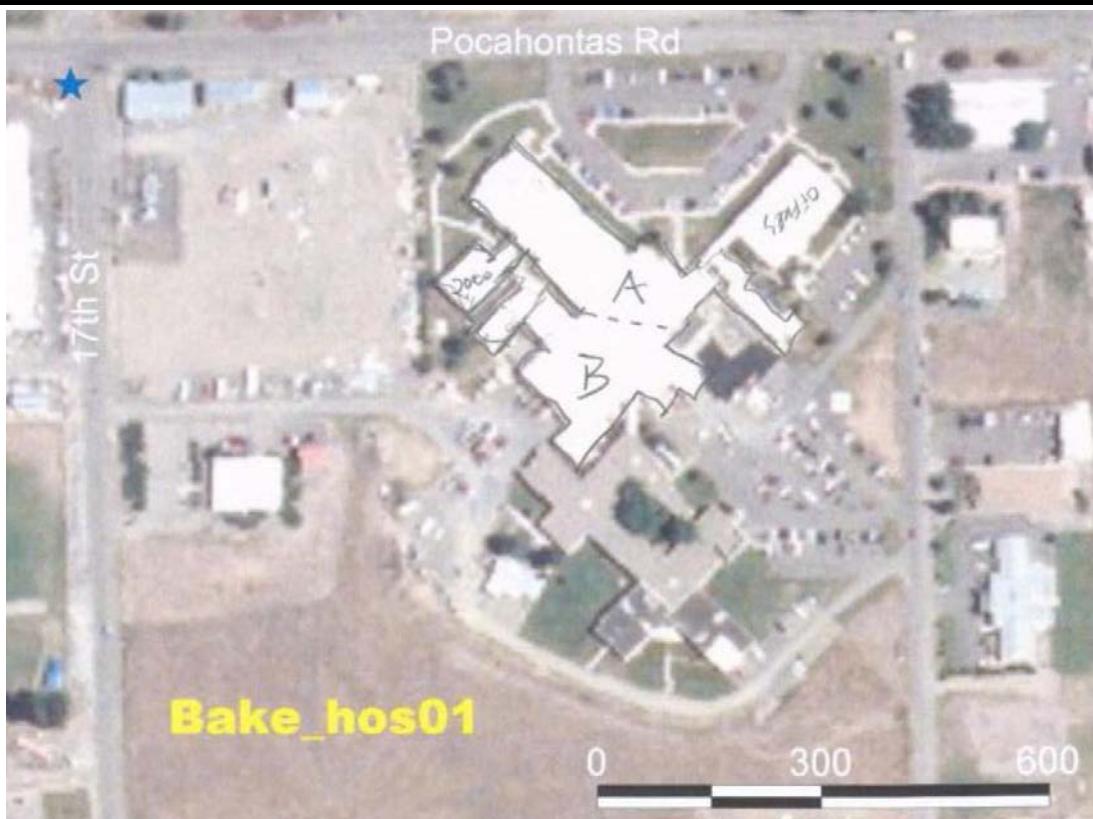
Enrollment	Year Built (Field Verified)	Year Built (Alt. Source)	Est. Decade Built
	1987	1987	1980
Total Area (square ft)	Number of Stories	Basement	Pounding Potential
	1	No	No
Plan Irregularities		Vertical Irregularities	
Reentrant Corners: Other		None	
Reentrant Corners: Other		None	
None		None	
Falling Hazards		Poor Conditions	
None		None	
None		None	
None		None
