Halfway Elementary School

Pine Eagle SD 61

FEMA 154 Rapid Visual Screening Score Card

Rapid Visual Screening - Senate Bill #2 - Seismic Needs Assessment
Oregon Department of Geology and Mineral Industries

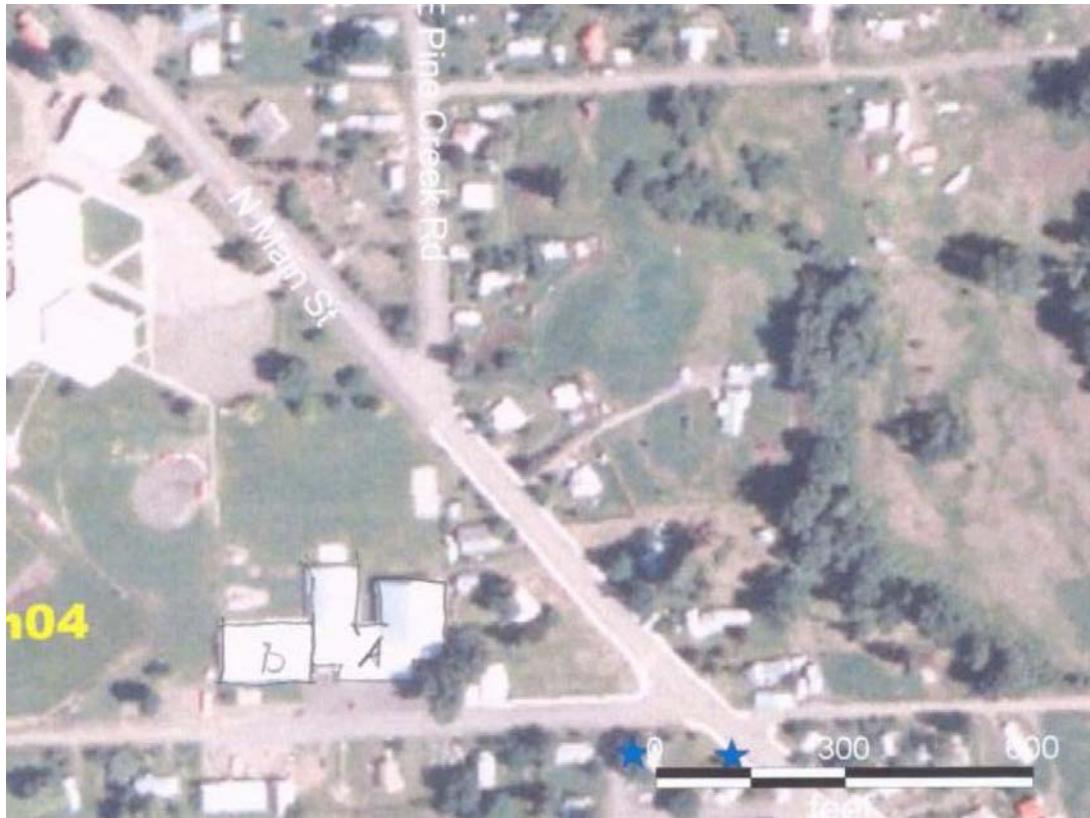
Final Type	Final Score
W2	0.1

High (>10%)

Enrollment 94	Year Built (Field Verified) 1945	Year Built (Alt. Source) 1945	Est. Decade Built 1960
Total Area (square ft) 35600	Number of Stories 1	Basement	Pounding Potential No
Plan Irregularities Reentrant Corners: U shaped Reentrant Corners: Other None		Vertical Irregularities Steps in Elevation View: 2 to 3 Changes None None	
Falling Hazards None None None		Poor Conditions None None None

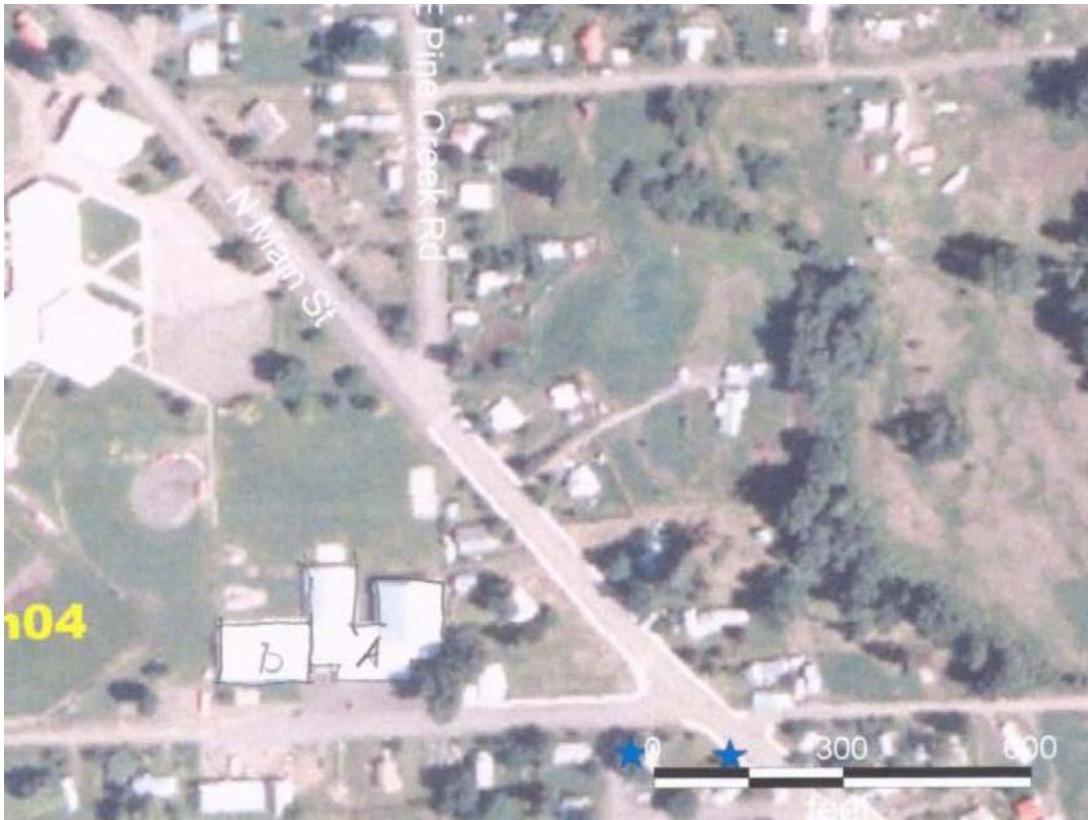
Final Type	Final Score
W2	3.1

Low (<1%)

Enrollment 94	Year Built (Field Verified) 1945	Year Built (Alt. Source) 1945	Est. Decade Built 1970
Total Area (square ft) 35600	Number of Stories 1	Basement	Pounding Potential No
Plan Irregularities Reentrant Corners:L shaped (Adjacent Build/Entity) Reentrant Corners: L Shaped None		Vertical Irregularities None None None	
Falling Hazards None None None		Poor Conditions None None None
