Pine Eagle High School

Bake_sch05A

Rapid Visual Screening - Senate Bill #2 - Seismic Needs Assessment
Oregon Department of Geology and Mineral Industries

Bake_sch05B

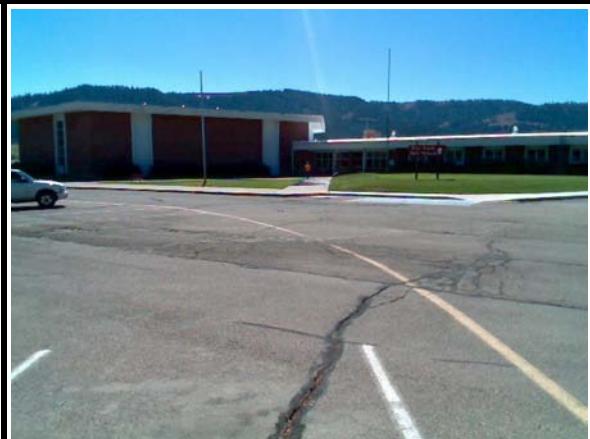
Type	Basic Score	Vert Irreg	Plan Irreg	Pre-Code	Post-Bench	Soil C	Soil D	Soil E	RVS Score
Primary	PC2	3.2	-1.5	-0.5	0	0	0	-1.2	0	0
Secondary	C1	3	-2	-0.5	0	0	0	-1	0	-0.5
Tertiary		0	0	0	0	0	0	0	0	0

Final Type	Final Score
C1	-0.5

Very High (100%)

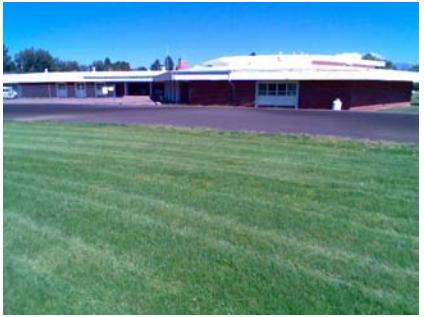
S Elevation View

Enrollment 74	Year Built (Field Verified) 1967	Year Built (Alt. Source) 1960	Est. Decade Built 1960
Total Area (square ft) 38700	Number of Stories 1	Basement	Pounding Potential No
Plan Irregularities Reentrant Corners: Other None None		Vertical Irregularities Steps in Elevation View: Single Change None None	
Falling Hazards None None None		Poor Conditions None None None

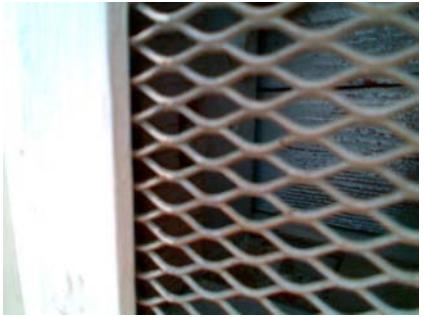
N Primary Structural Type bolt plates at column indicate precast frame

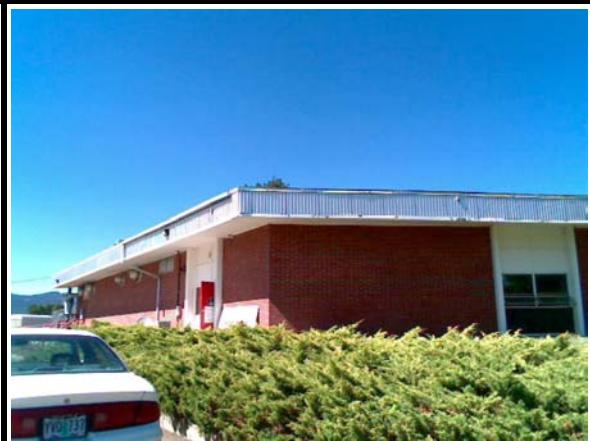
Seismicity Zone: Moderate										
FEMA 154 Rapid Visual Screening Score Card										
	Type	Basic Score	Vert Irreg	Plan Irreg	Pre-Code	Post-Bench	Soil C	Soil D	Soil E	RVS Score
Primary	PC2	3.2	0	0	0	0	0	-1.2	0	2
Secondary	C1	3	0	0	0	0	0	-1	0	2
Tertiary	RM1	3.6	0	0	0	0	0	-1.2	0	2.4

Final Type	Final Score
PC2	2

Moderate (>1%)

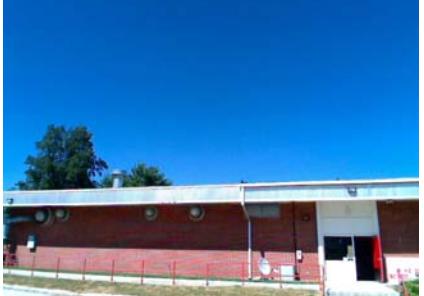
S Elevation View

Enrollment 74	Year Built (Field Verified) 1967	Year Built (Alt. Source) 1967	Est. Decade Built 1960
Total Area (square ft) 38700	Number of Stories 1	Basement	Pounding Potential No
Plan Irregularities None None None		Vertical Irregularities None None None	
Falling Hazards None None None		Poor Conditions None None None
