Burnt River School

Burnt River SD 30J

FEMA 154 Rapid Visual Screening Score Card

Rapid Visual Screening - Senate Bill #2 - Seismic Needs Assessment
Oregon Department of Geology and Mineral Industries

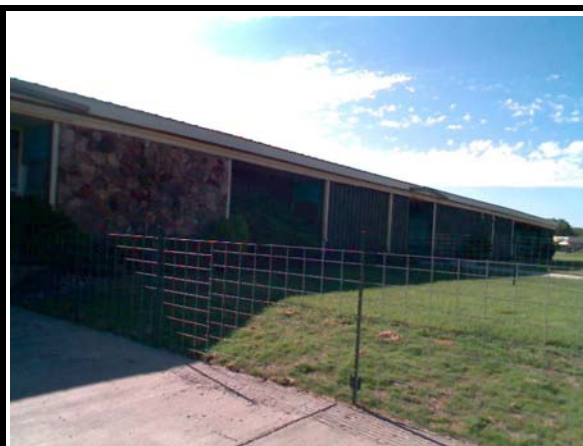
Building Type		County	
School		Baker	
Street			
PO Box 8 Highway 26			
City	State	Zip	
Unity	OR	97884	
Latitude		Longitude	
44.43986		118.19191	
Tracking Code		Inspection Date	
RVS in 2006		8/10/2006

Seismicity Zone: Moderate

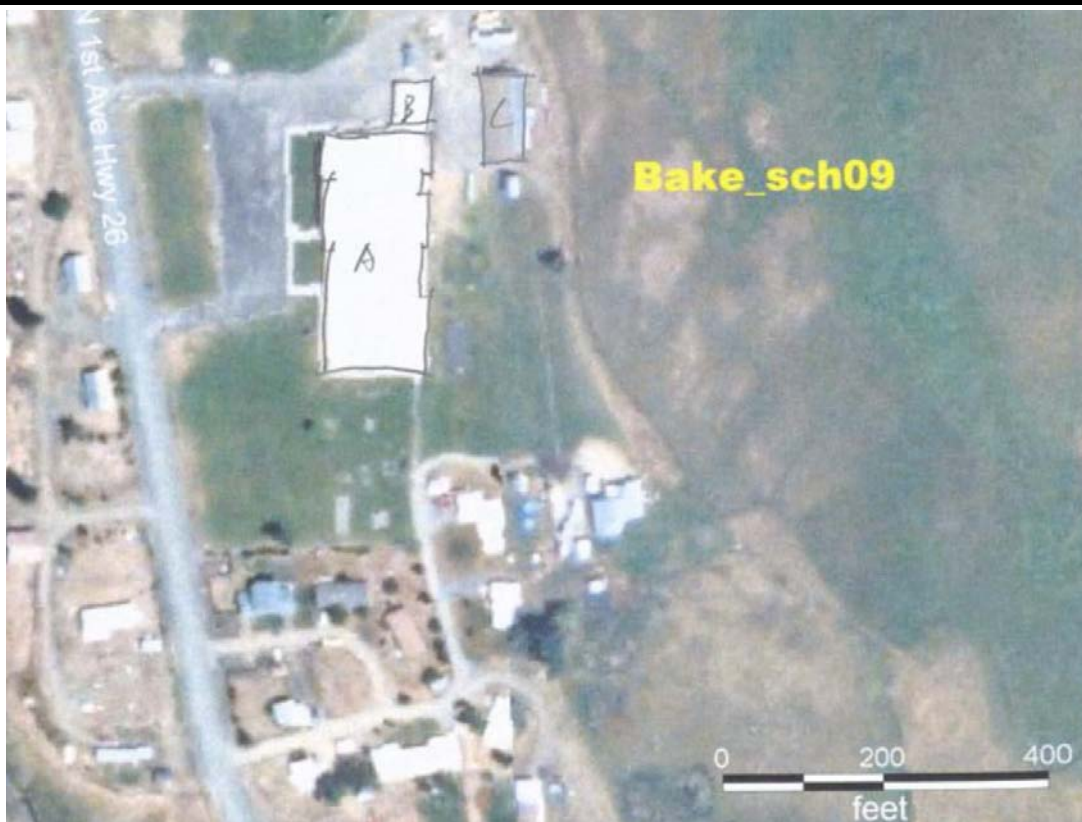
Type	Basic Score	Vert Irreg	Plan Irreg	Pre-Code	Post-Bench	Soil C	Soil D	Soil E	RVS Score
Primary	W2	4.8	-3	-0.5	0	0	0	-1.2	0	0.1
Secondary	RM1	3.6	-2	-0.5	0	0	0	-1.2	0	-0.1
Tertiary		0	0	0	0	0	0	0	0	0

RM1

-0.1

FEMA-154 Collapse Potential

Very High (100%)

Enrollment	Year Built (Field Verified)	Year Built (Alt. Source)	Est. Decade Built
76		1968	1960
Total Area (square ft)	Number of Stories	Basement	Pounding Potential
55000	1	No	No

Plan Irregularities	Vertical Irregularities
Reentrant Corners: Other	Steps in Elevation View: Single Change
None	None
None	None

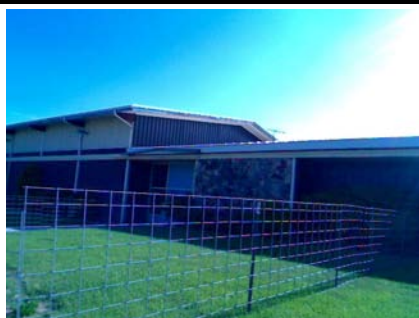
W Vertical Irregularity Primary

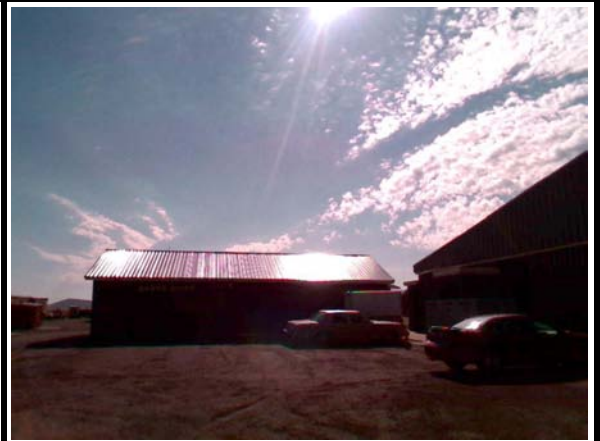
Building Type		County	
School		Baker	
Street			
PO Box 8 Highway 26			
City	State	Zip	
Unity	OR	97884	
Latitude		Longitude	
44.44039		118.19172	
Tracking Code		Inspection Date	
RVS in 2006		8/10/2006

Seismicity Zone: Moderate

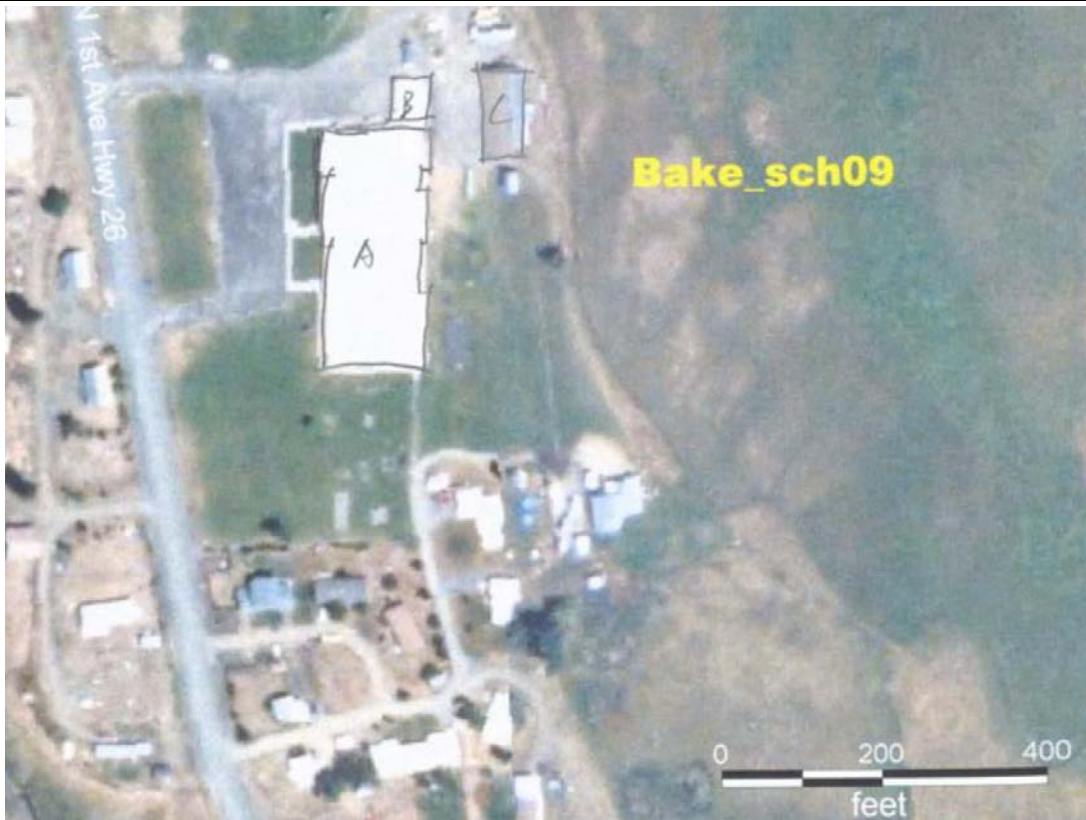
Type	Basic Score	Vert Irreg	Plan Irreg	Pre-Code	Post-Bench	Soil C	Soil D	Soil E	RVS Score
Primary	W2	4.8	0	0	0	0	0	-1.2	0	3.6
Secondary		0	0	0	0	0	0	0	0	0
Tertiary		0	0	0	0	0	0	0	0	0

W2

3.6

FEMA-154 Collapse Potential

Low (<1%)

Enrollment	Year Built (Field Verified)	Year Built (Alt. Source)	Est. Decade Built
76		1968	1960
Total Area (square ft)	Number of Stories	Basement	Pounding Potential
55000	1	No	No

Plan Irregularities	Vertical Irregularities
None	None
None	None
None	None

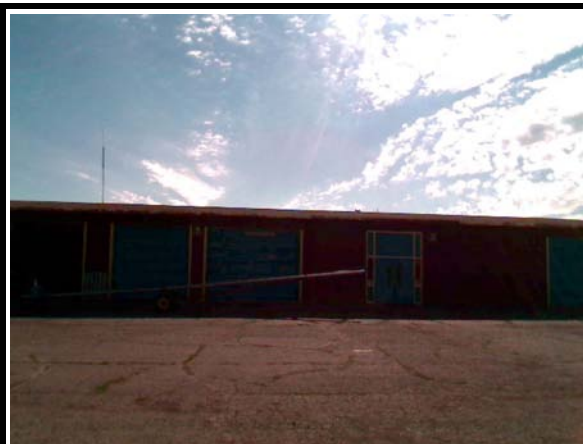
Building Type		County	
School		Baker	
Street			
PO Box 8 Highway 26			
City	State	Zip	
Unity	OR	97884	
Latitude		Longitude	
44.44035		118.19128	
Tracking Code		Inspection Date	
RVS in 2006		8/10/2006

Seismicity Zone: Moderate
