Monroe RFPD

Building Type Fire - RFPD	County Benton	
Street 25483 Bellfountain Rd		
City Monroe	State OR	Zip 97456
Latitude 44.32939	Longitude 123.36027	
Tracking Code RVS in 2006	Inspection Date 6/27/2006

FEMA 154 Rapid Visual Screening Score Card

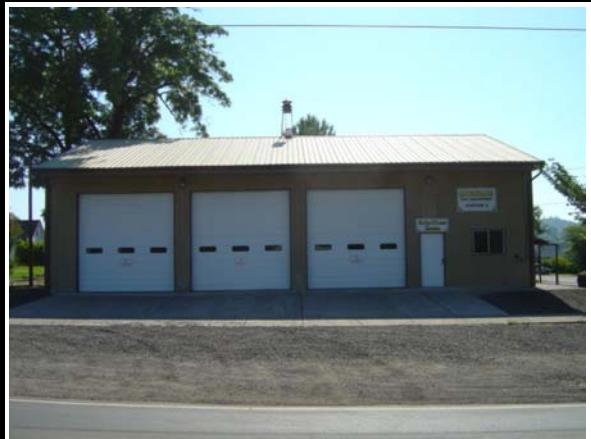
Seismicity Zone: High

Type	Basic Score	Vert Irreg	Plan Irreg	Pre-Code	Post-Bench	Soil C	Soil D	Soil E	RVS Score
Primary	S3	3.2	0	0	0	0	-0.4	0	0	2.8
Secondary		0	0	0	0	0	0	0	0	0
Tertiary		0	0	0	0	0	0	0	0	0

Final Type	Final Score
S3	2.8

Low (<1%)
