Jefferson Elementary School

Corvallis SD 509J

FEMA 154 Rapid Visual Screening Score Card

Rapid Visual Screening - Senate Bill #2 - Seismic Needs Assessment
Oregon Department of Geology and Mineral Industries

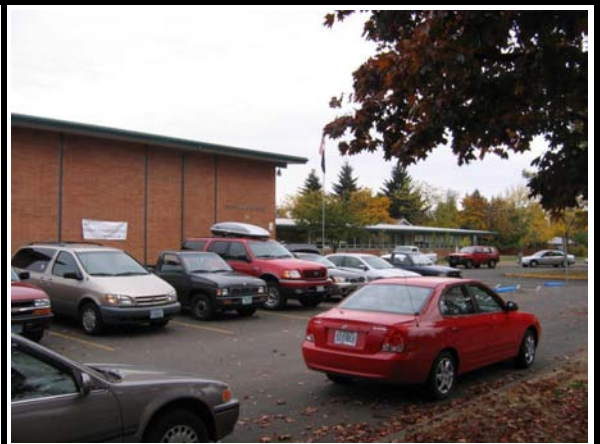
Type	Basic Score	Vert Irreg	Plan Irreg	Pre-Code	Post-Bench	Soil C	Soil D	Soil E	RVS Score
Primary	W2	3.8	-2	-0.5	0	0	-0.4	0	0	0.9
Secondary		0	0	0	0	0	0	0	0	0
Tertiary		0	0	0	0	0	0	0	0	0

FEMA-154 Collapse Potential

High (>10%)
