CCFD Fire Station 8 Clackamas

FEMA 154 Rapid Visual Screening Score Card

Rapid Visual Screening - Senate Bill #2 - Seismic Needs Assessment
Oregon Department of Geology and Mineral Industries

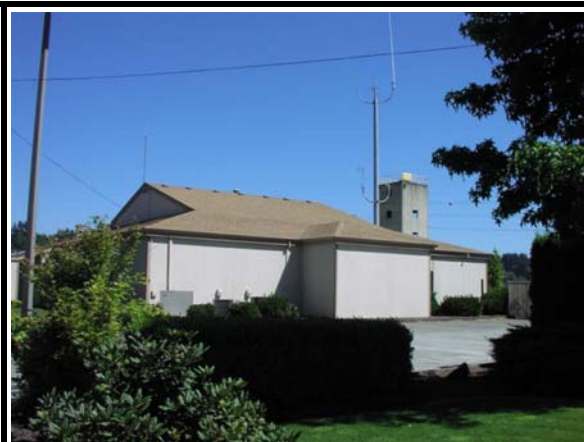
Building Type		County	
Fire - RFPD		Clackamas	
Street			
15990 Se 130Th			
City	State	Zip	
Clackamas	OR	97015	
Latitude		Longitude	
45.40616		122.52988	
Tracking Code		Inspection Date	
Hasenberg 02		9/15/2006
