# Molalla RFPD 73

## FEMA 154 Rapid Visual Screening Score Card

Rapid Visual Screening - Senate Bill #2 - Seismic Needs Assessment  
Oregon Department of Geology and Mineral Industries

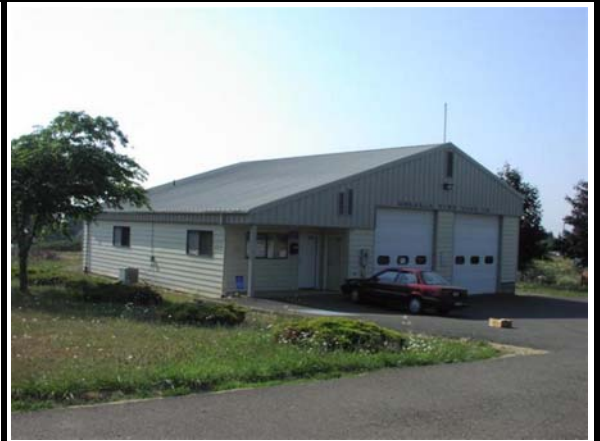
Building Type	County	
Fire - RFPD	Clackamas	
Street		
36715 S Sawtell Rd		
City	State	Zip
Molalla	OR	97038
Latitude	Longitude	
45.07475	122.55499	
Tracking Code	Inspection Date	
Hasenberg 02	9/15/2006

Type	Basic Score	Vert Irreg	Plan Irreg	Pre-Code	Post-Bench	Soil C	Soil D	Soil E	RVS Score
Primary	W1	4.4	0	0	0	0	0	0	0	4.4
Secondary		0	0	0	0	0	0	0	0	0
Tertiary		0	0	0	0	0	0	0	0	0

Low (<1%)
