# Hoodland RFPD 74

Hoodland RFPD

## FEMA 154 Rapid Visual Screening Score Card

Rapid Visual Screening - Senate Bill #2 - Seismic Needs Assessment  
Oregon Department of Geology and Mineral Industries

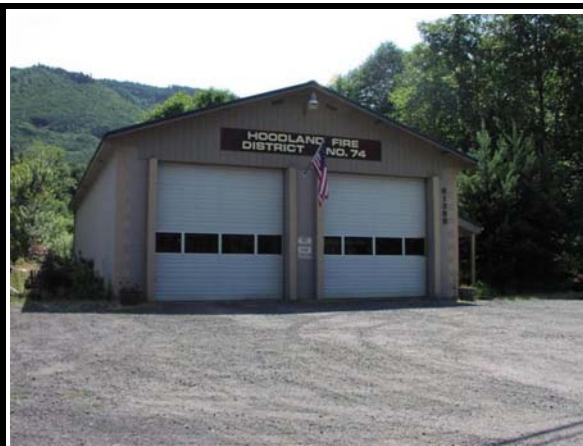
Seismicity Zone: Moderate

| | Type | Basic Score | Vert Irreg | Plan Irreg | Pre-Code | Post-Bench | Soil C | Soil D | Soil E | RVS Score |
| Primary | RM1 | 3.6 | 0 | 0 | 0 | 0 | 0 | -1.2 | 0 | 2.4 |

RM1

2.4

Low (<1%)
