# Gearhart City Police Dept

City of Gearhart

## FEMA 154 Rapid Visual Screening Score Card

Rapid Visual Screening - Senate Bill #2 - Seismic Needs Assessment  
Oregon Department of Geology and Mineral Industries

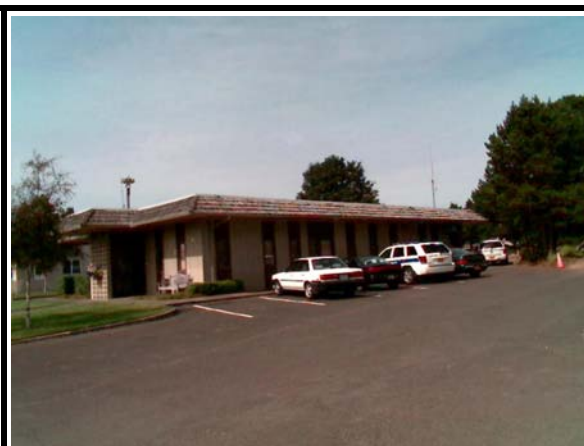
Seismicity Zone: Very High

## Final RVS Score

Final Type

Final Score

W1

4.4

FEMA-154 Collapse Potential

Low (<1%)
