Sitkum Hall

Southwest Oregon CC

FEMA 154 Rapid Visual Screening Score Card

Rapid Visual Screening - Senate Bill #2 - Seismic Needs Assessment
Oregon Department of Geology and Mineral Industries

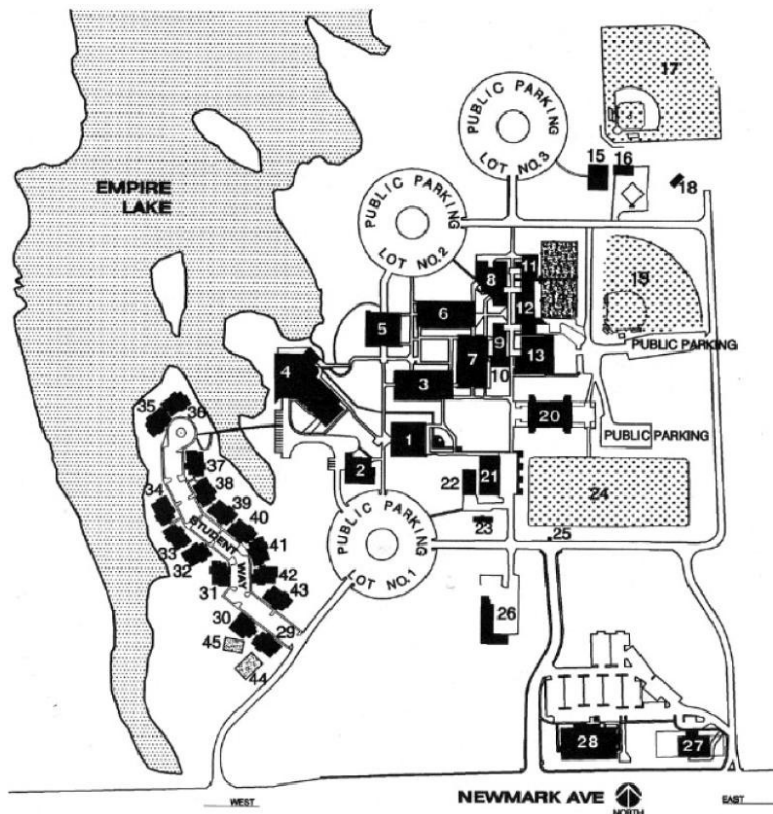
Sitkum Hall

Type	Basic Score	Vert Irreg	Plan Irreg	Pre-Code	Post-Bench	Soil C	Soil D	Soil E	RVS Score
Primary	C2	2.8	-1	-0.5	0	0	0	-0.6	0	0.7
Secondary		0	0	0	0	0	0	0	0	0
Tertiary		0	0	0	0	0	0	0	0	0

C2

0.7

High (>10%)
