Charleston RFPD

FEMA 154 Rapid Visual Screening Score Card

Rapid Visual Screening - Senate Bill #2 - Seismic Needs Assessment
Oregon Department of Geology and Mineral Industries

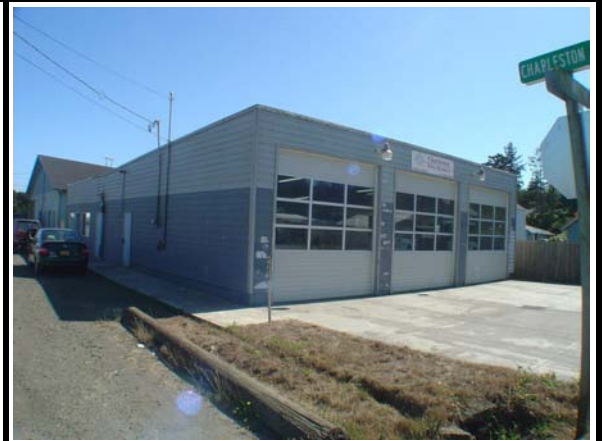
Seismicity Zone: Very High

Type	Basic Score	Vert Irreg	Plan Irreg	Pre-Code	Post-Bench	Soil C	Soil D	Soil E	RVS Score
Primary	W1	4.4	0	-0.5	0	0	0	0	0	3.9
Secondary		0	0	0	0	0	0	0	0	0
Tertiary		0	0	0	0	0	0	0	0	0

3.9

Low (<1%)
