# North Bend Police Dept

City of North Bend

## FEMA 154 Rapid Visual Screening Score Card

Rapid Visual Screening - Senate Bill #2 - Seismic Needs Assessment  
Oregon Department of Geology and Mineral Industries

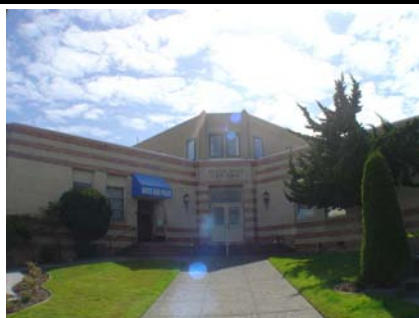
Plan Irregularities	Vertical Irregularities
Reentrant Corners: Other	Steps in Elevation View: Single Change
None	None
None	None

E Vertical Irregularity Primary

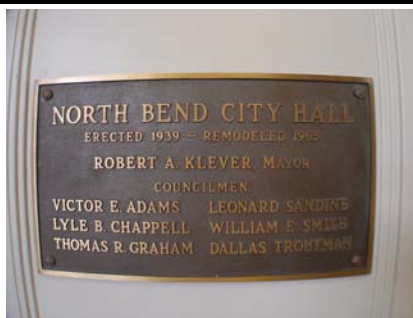
Enrollment	Year Built (Field Verified)	Year Built (Alt. Source)	Est. Decade Built
	1939	1939	1930
Total Area (square ft)	Number of Stories	Basement	Pounding Potential
	2	Yes	No

E Field Verified Year Built

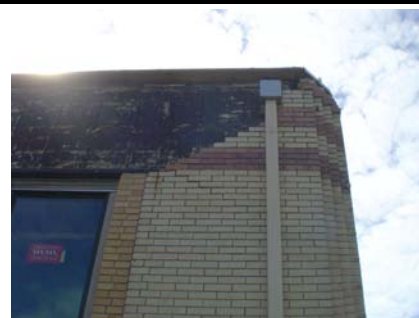
Falling Hazards	Poor Conditions
Other: Brick Veneer	None
None	None
None	None

E Falling Hazard
