Oregon State Police

Coos\_pol04A

Building Type Police - State	County Coos	
Street 155 N Schoneman Ave		
City Coos Bay	State OR	Zip 97420
Latitude 43.39271	Longitude 124.26782	
Tracking Code RVS in 2006	Inspection Date 8/18/2006

Rapid Visual Screening - Senate Bill #2 - Seismic Needs Assessment  
Oregon Department of Geology and Mineral Industries

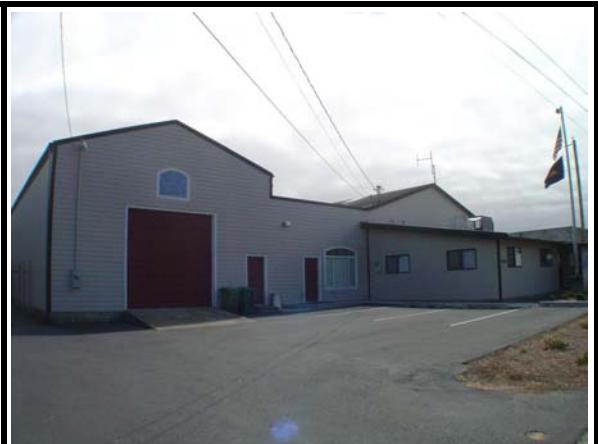
Seismicity Zone: Very High

Type	Basic Score	Vert Irreg	Plan Irreg	Pre-Code	Post-Bench	Soil C	Soil D	Soil E	RVS Score
Primary	S3	3.2	0	-0.5	0	0	-0.4	0	0	2.3
Secondary	W1	4.4	-2.5	-0.5	0	0	0	0	0	1.4
Tertiary		0	0	0	0	0	0	0	0	0

Final Type	Final Score
W1	1.4

Moderate (>1%)

Enrollment	Year Built (Field Verified)	Year Built (Alt. Source)	Est. Decade Built
			1970
Total Area (square ft)	Number of Stories	Basement	Pounding Potential
	1	No	No
Plan Irregularities		Vertical Irregularities	
Reentrant Corners: U shaped		Steps in Elevation View: 2 to 3 Changes	
None		None	
None		None	
Falling Hazards		Poor Conditions	
None		None	
None		None	
None		None

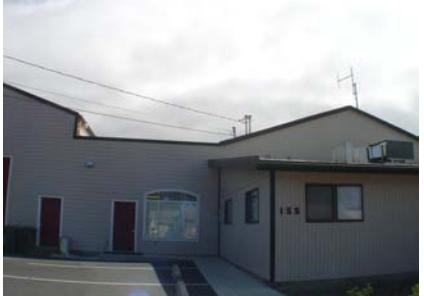
W Vertical Irregularity Primary
