Hillcrest Elementary School

Coos_sch06A

FEMA 154 Rapid Visual Screening Score Card

Rapid Visual Screening - Senate Bill #2 - Seismic Needs Assessment
Oregon Department of Geology and Mineral Industries

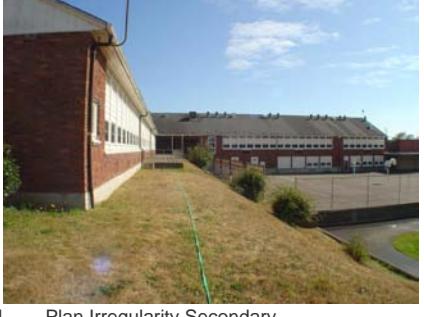
Enrollment 495	Year Built (Field Verified) 1948	Year Built (Alt. Source) 1940	Est. Decade Built 1940
Total Area (square ft) 39484	Number of Stories 2	Basement	Pounding Potential No
Plan Irregularities Reentrant Corners:Other (Adjacent Build/Entity) Reentrant Corners: Other None		Vertical Irregularities Building On Hill or Sloped Site Steps in Elevation View: Single Change (Adjacent Building/Entity) None	
Falling Hazards None None None		Poor Conditions None None None

N Plan Irregularity Secondary		N Vertical Irregularity Primary

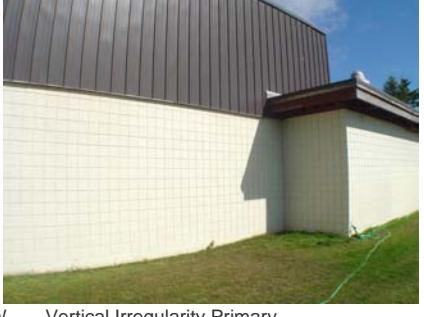
Enrollment 495	Year Built (Field Verified) 1948	Year Built (Alt. Source) 1948	Est. Decade Built 1950
Total Area (square ft) 39484	Number of Stories 1	Basement	Pounding Potential No
Plan Irregularities Out of Plane Lateral-Force-Resistance Elements None		Vertical Irregularities Steps in Elevation View: Single Change Steps in Elevation View: Single Change (Adjacent Building/Entity) None	
Falling Hazards None		Poor Conditions None	
None		None	
None		None

W Vertical Irregularity Primary		S General Site
