# Crook County Middle School

Croo\_sch05A

## FEMA 154 Rapid Visual Screening Score Card

Rapid Visual Screening - Senate Bill #2 - Seismic Needs Assessment  
Oregon Department of Geology and Mineral Industries

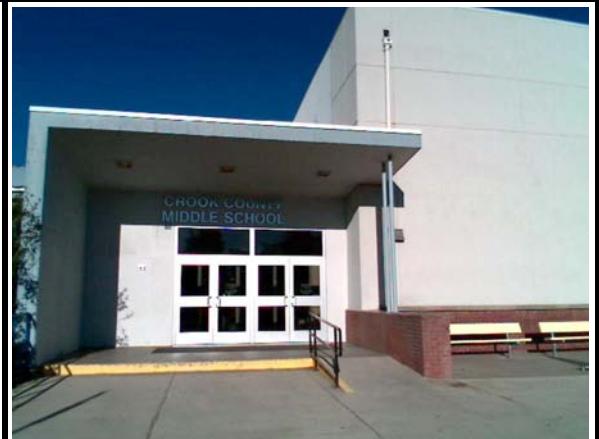
Type	Basic Score	Vert Irreg	Plan Irreg	Pre-Code	Post-Bench	Soil C	Soil D	Soil E	RVS Score
Primary	C2	3.6	-2	-0.5	0	0	0	-1.2	0	-0.1
Secondary	RM1	3.6	-2	-0.5	0	0	0	-1.2	0	-0.1
Tertiary	URM	3.4	-1.5	-0.5	0	0	0	-0.8	0	0.6

Final Type	Final Score
C2	-0.1

Very High (100%)

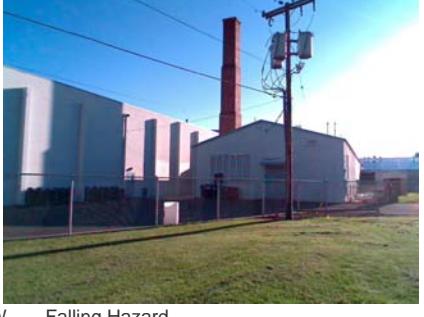
Enrollment 726	Year Built (Field Verified) 1952	Year Built (Alt. Source) 1952	Est. Decade Built 1950
Total Area (square ft) 83238	Number of Stories 1	Basement	Pounding Potential No
Plan Irregularities Reentrant Corners: U shaped Reentrant Corners: Other None		Vertical Irregularities Steps in Elevation View: Single Change None None	
Falling Hazards Unreinforced Chimneys None None		Poor Conditions None None None

W Falling Hazard

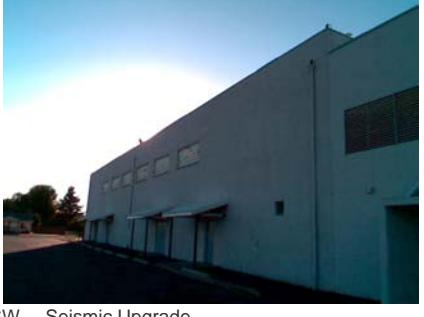
SW Seismic Upgrade

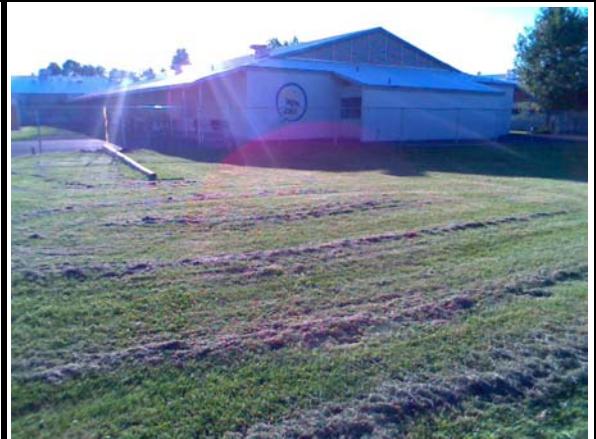
Croo\_sch05B

Type	Basic Score	Vert Irreg	Plan Irreg	Pre-Code	Post-Bench	Soil C	Soil D	Soil E	RVS Score
Primary	RM1	3.6	0	-0.5	0	0	0	-1.2	0	1.9
Secondary		0	0	0	0	0	0	0	0	0
Tertiary		0	0	0	0	0	0	0	0	0

Final Type	Final Score
RM1	1.9

Moderate (>1%)

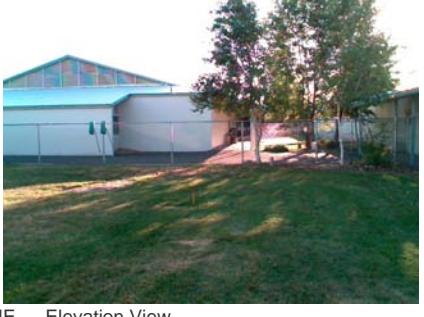
NE Elevation View

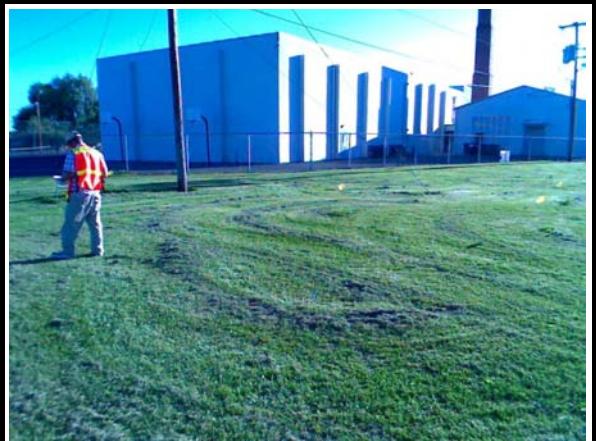
Croo\_sch05C

Type	Basic Score	Vert Irreg	Plan Irreg	Pre-Code	Post-Bench	Soil C	Soil D	Soil E	RVS Score
Primary	RM1	3.6	-2	-0.5	0	0	0	-1.2	0	-0.1
Secondary		0	0	0	0	0	0	0	0	0
Tertiary		0	0	0	0	0	0	0	0	0

Final Type	Final Score
RM1	-0.1

Very High (100%)

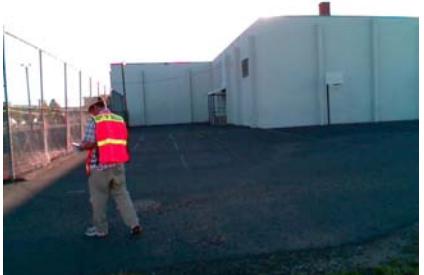
Enrollment 726	Year Built (Field Verified) 1952	Year Built (Alt. Source) 1952	Est. Decade Built 1970
Total Area (square ft) 83238	Number of Stories 1	Basement	Pounding Potential No
Plan Irregularities Reentrant Corners: L Shaped None None		Vertical Irregularities Steps in Elevation View: Single Change None None	
Falling Hazards None None None		Poor Conditions None None None

SW Plan Irregularity Primary
