Sixes RFPD

Building Type		County	
Fire - RFPD		Curry	
Street			
93343 Crystal Creek Rd.			
City	State	Zip	
Sixes	OR	97476	
Latitude		Longitude	
42.83192		124.47833	
Tracking Code		Inspection Date	
RVS in 2006		8/4/2006

FEMA 154 Rapid Visual Screening Score Card

Rapid Visual Screening - Senate Bill #2 - Seismic Needs Assessment
Oregon Department of Geology and Mineral Industries

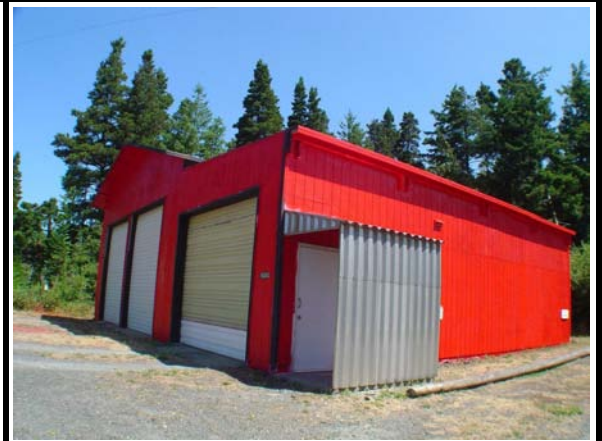
Seismicity Zone: Very High

Type	Basic Score	Vert Irreg	Plan Irreg	Pre-Code	Post-Bench	Soil C	Soil D	Soil E	RVS Score
Primary	W1	4.4	-2.5	-0.5	0	0	0	0	0	1.4
Secondary		0	0	0	0	0	0	0	0	0
Tertiary		0	0	0	0	0	0	0	0	0

FEMA-154 Collapse Potential

Moderate (>1%)

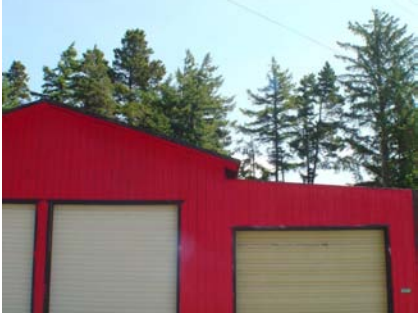
Plan Irregularities	Vertical Irregularities
Torsion: Eccentric Stiffness	Steps in Elevation View: Single Change
None	None
None	None

W Vertical Irregularity Primary
