Upper Chetco Charter School

Curr_sch11A

Rapid Visual Screening - Senate Bill #2 - Seismic Needs Assessment
Oregon Department of Geology and Mineral Industries

Curr_sch11C

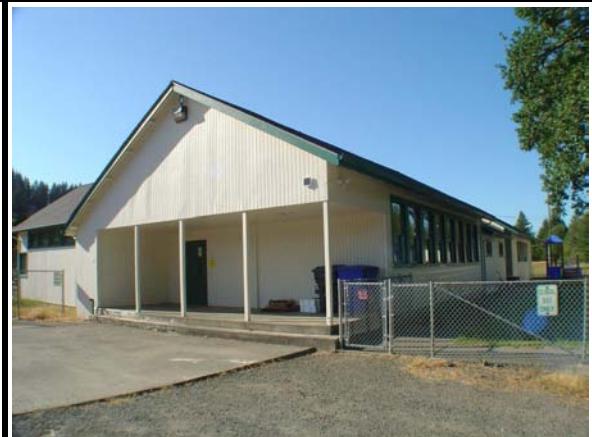
Building Type	County
School	Curry
Street	
99603 North Band Chetco River Rd	
City	State Zip
Brookings	OR 97415
Latitude	Longitude
42.08137	124.20036
Tracking Code	Inspection Date
RVS in 2006	8/4/2006

Seismicity Zone: Very High

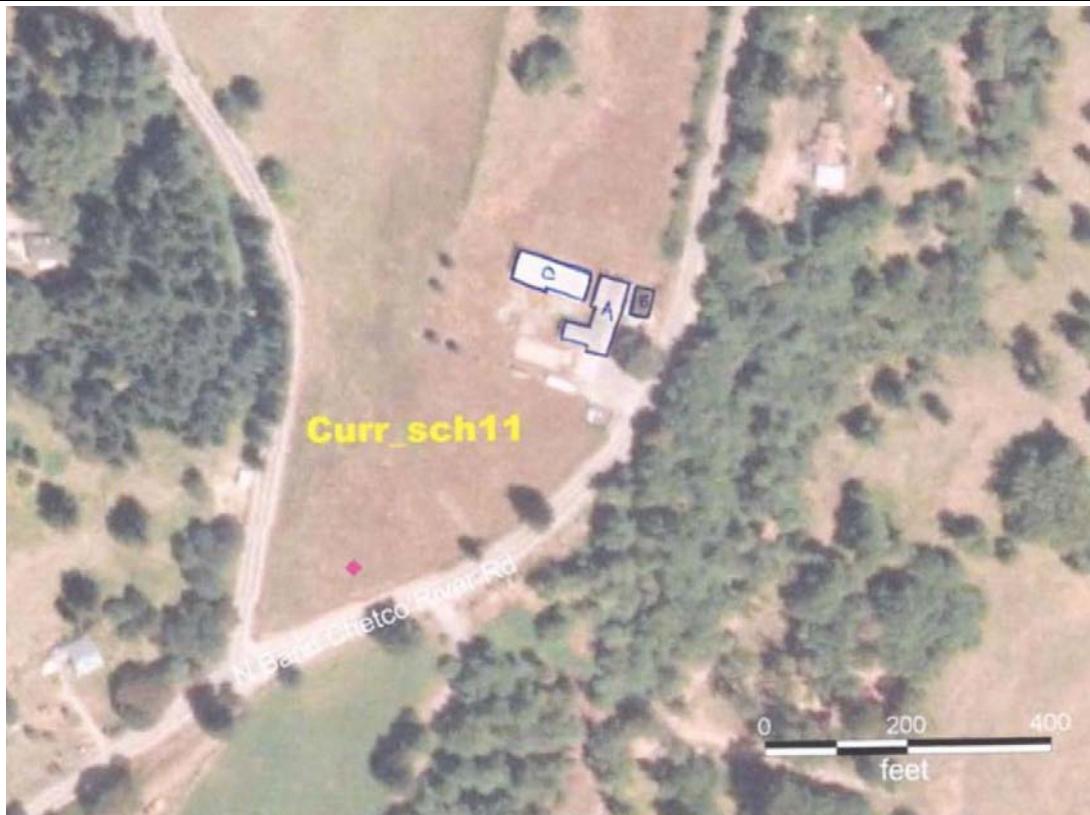
Type	Basic Score	Vert Irreg	Plan Irreg	Pre-Code	Post-Bench	Soil C	Soil D	Soil E	RVS Score
Primary	W2	3.8	-2	-0.5	-1	0	-0.4	0	0	-0.1
Secondary		0	0	0	0	0	0	0	0	0
Tertiary		0	0	0	0	0	0	0	0	0

Final Type	Final Score
W2	-0.1

Very High (100%)

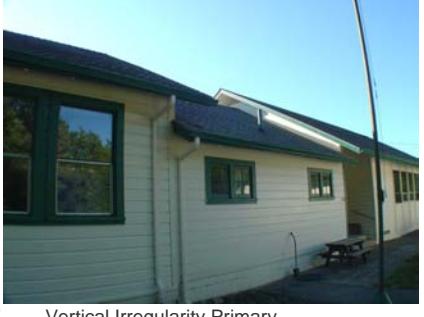
Enrollment 27	Year Built (Field Verified) 1938	Year Built (Alt. Source) 1930	Est. Decade Built 1930
Total Area (square ft) 7749	Number of Stories 1	Basement	Pounding Potential No
Plan Irregularities		Vertical Irregularities	
Reentrant Corners: L Shaped		Steps in Elevation View: 2 to 3 Changes	
Out of Plane Lateral-Force-Resistance Elements		None	
None		None	
Falling Hazards		Poor Conditions	
None		None	
None		None	
None		None

E	Vertical Irregularity Primary	W	Plan Irregularity Primary

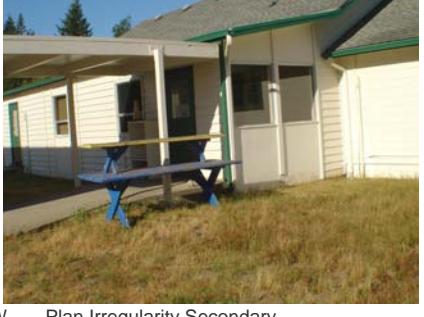
W	Plan Irregularity Secondary

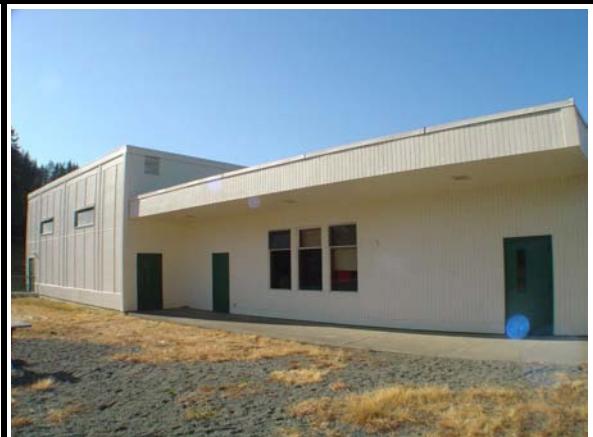
Building Type	County
School	Curry
Street	
99603 North Band Chetco River Rd	
City	State Zip
Brookings	OR 97415
Latitude	Longitude
42.08153	124.20067
Tracking Code	Inspection Date
RVS in 2006	8/4/2006

Seismicity Zone: Very High

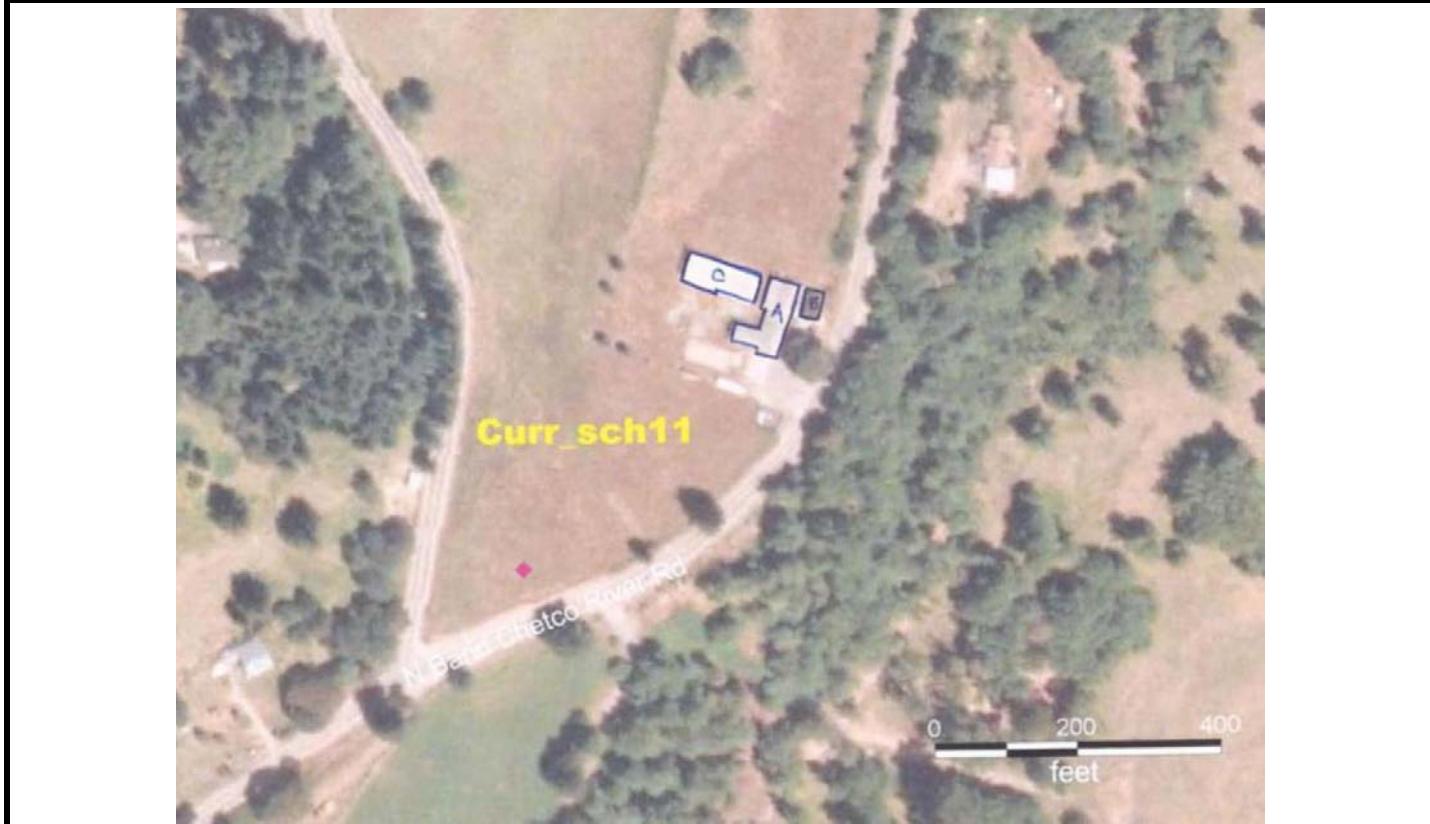
Type	Basic Score	Vert Irreg	Plan Irreg	Pre-Code	Post-Bench	Soil C	Soil D	Soil E	RVS Score
Primary	W2	3.8	-2	-0.5	0	0	-0.4	0	0	0.9
Secondary		0	0	0	0	0	0	0	0	0
Tertiary		0	0	0	0	0	0	0	0	0

0.9

High (>10%)

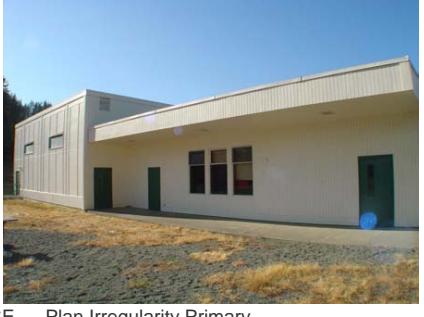
Enrollment 27	Year Built (Field Verified) 1938	Year Built (Alt. Source) 1960	Est. Decade Built
Total Area (square ft) 7749	Number of Stories 1	Basement	Pounding Potential No
Plan Irregularities Out of Plane Lateral-Force-Resistance Elements None None		Vertical Irregularities Steps in Elevation View: Single Change None None	
Falling Hazards None None None		Poor Conditions None None None

SE Plan Irregularity Primary
