Redmond F & R - Station 404 Cline Falls

FEMA 154 Rapid Visual Screening Score Card

Rapid Visual Screening - Senate Bill #2 - Seismic Needs Assessment
Oregon Department of Geology and Mineral Industries

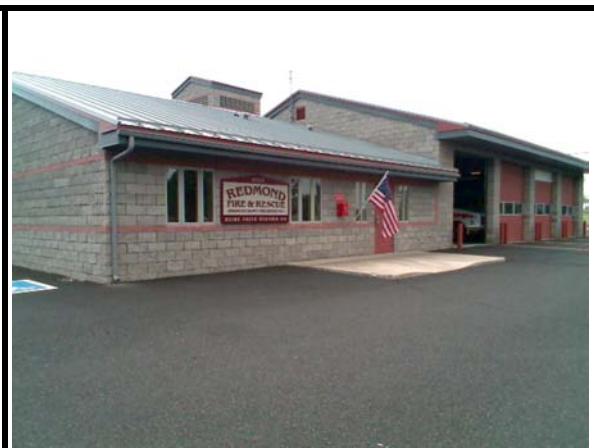
Building Type	County	
Fire - City	Deschutes	
Street		
100 SW 67th		
City	State	Zip
Redmond	OR	97756
Latitude	Longitude	
44.27701	121.25032	
Tracking Code	Inspection Date	
New Building	6/28/2006

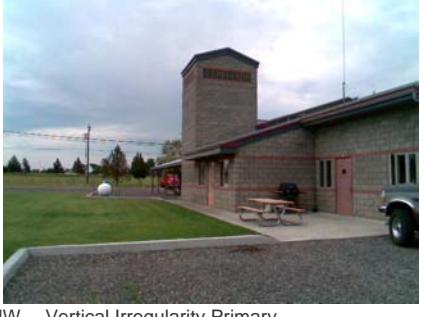
Enrollment	Year Built (Field Verified)	Year Built (Alt. Source)	Est. Decade Built
		1994	1990
Total Area (square ft)	Number of Stories	Basement	Pounding Potential
7384	1	No	No
Plan Irregularities		Vertical Irregularities	
Reentrant Corners: T shaped		Steps in Elevation View: 2 to 3 Changes	
None		None	
None		None	
Falling Hazards		Poor Conditions	
None		None	
None		None	
None		None

NW Vertical Irregularity Primary
