Bend FD - Tumalo Station 302

Building Type	County	
Fire - City	Deschutes	
Street		
19850 4th St		
City	State	Zip
Bend	OR	97701
Latitude	Longitude	
44.15001	121.33158	
Tracking Code	Inspection Date	
RVS in 2006	6/29/2006

FEMA 154 Rapid Visual Screening Score Card

Rapid Visual Screening - Senate Bill #2 - Seismic Needs Assessment
Oregon Department of Geology and Mineral Industries

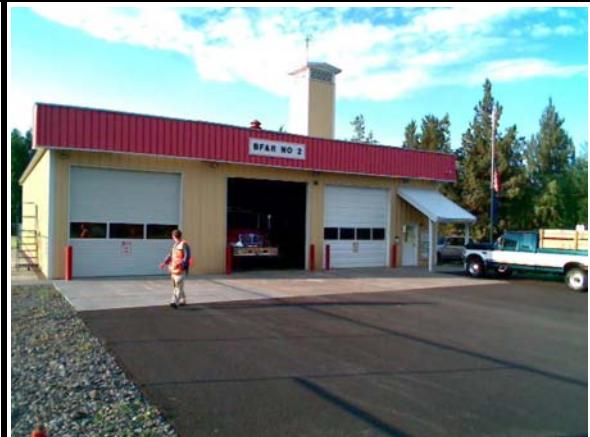
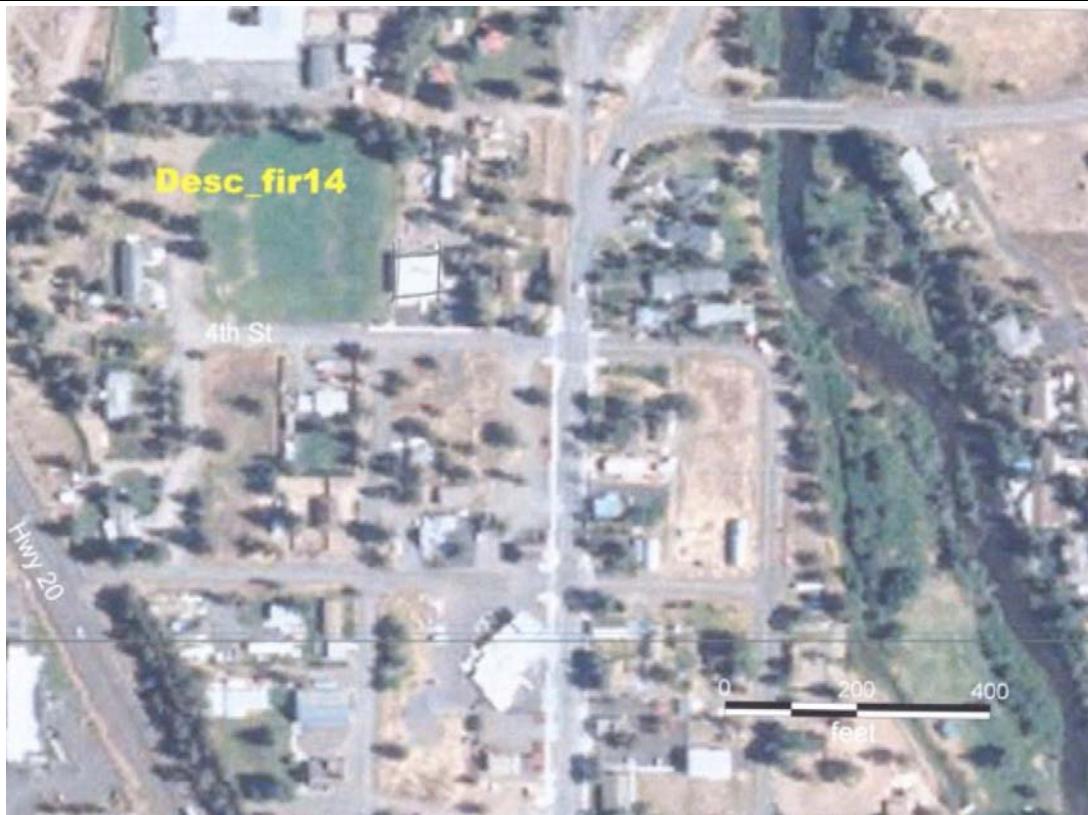
Type	Basic Score	Vert Irreg	Plan Irreg	Pre-Code	Post-Bench	Soil C	Soil D	Soil E	RVS Score
Primary	S3	3.8	0	-0.5	0	0	-0.6	0	0	2.7
Secondary		0	0	0	0	0	0	0	0	0
Tertiary		0	0	0	0	0	0	0	0	0

Final Type	Final Score
S3	2.7

Low (<1%)

Enrollment	Year Built (Field Verified)	Year Built (Alt. Source)	Est. Decade Built
			1980
Total Area (square ft)	Number of Stories	Basement	Pounding Potential
2400	1	No	No
Plan Irregularities		Vertical Irregularities	
Torsion: Eccentric Stiffness		Steps in Elevation View: Single Change	
None		None	
None		None	
Falling Hazards		Poor Conditions	
None		None	
None		None	
None		None
