# St. Charles Medical Center - Bend

Desc\_hos01A

## FEMA 154 Rapid Visual Screening Score Card

Rapid Visual Screening - Senate Bill #2 - Seismic Needs Assessment  
Oregon Department of Geology and Mineral Industries

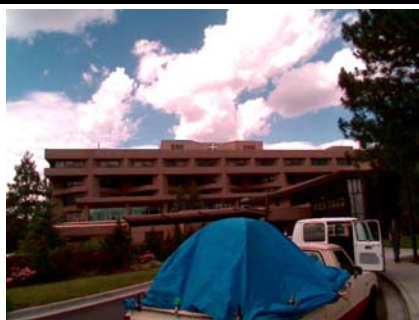
Plan Irregularities	Vertical Irregularities
Reentrant Corners: Other (Adjacent Build/Entity)	Steps in Elevation View: Very Irregular Changes (Adjacent Building/Ent
None	None
None	None

W Elevation View

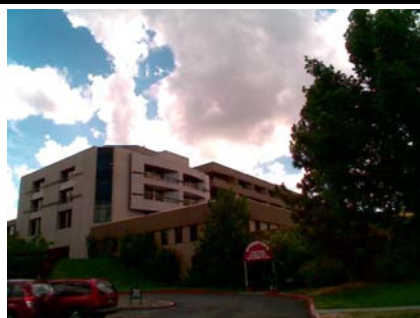
Plan Irregularities	Vertical Irregularities
Reentrant Corners: Other (Adjacent Build/Entity)	Steps in Elevation View: Very Irregular Changes (Adjacent Building/Ent
None	Building On Hill or Sloped Site
None	None

SE Vertical Irregularity Secondary
