# Terrebonne Community School

Desc\_sch10A

## FEMA 154 Rapid Visual Screening Score Card

Rapid Visual Screening - Senate Bill #2 - Seismic Needs Assessment  
Oregon Department of Geology and Mineral Industries

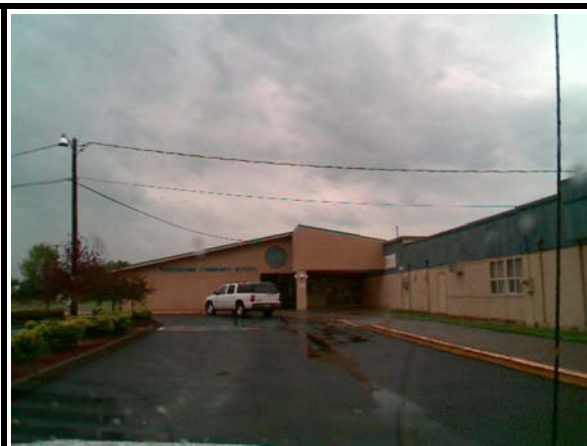
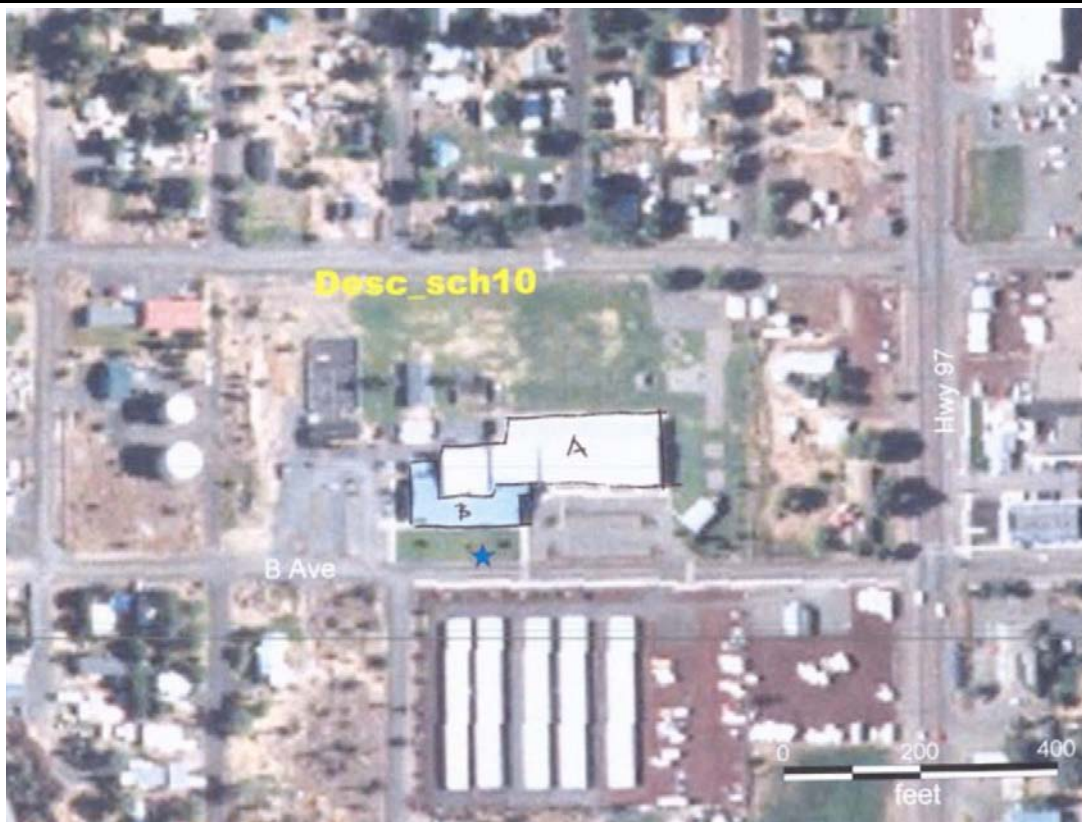
Type	Basic Score	Vert Irreg	Plan Irreg	Pre-Code	Post-Bench	Soil C	Soil D	Soil E	RVS Score
Primary	RM1	3.6	-2	-0.5	0	0	-0.8	0	0	0.3
Secondary		0	0	0	0	0	0	0	0	0
Tertiary		0	0	0	0	0	0	0	0	0

RM1

0.3

High (>10%)

Plan Irregularities	Vertical Irregularities
Reentrant Corners: L Shaped	Steps in Elevation View: 2 to 3 Changes
None	None
None	None

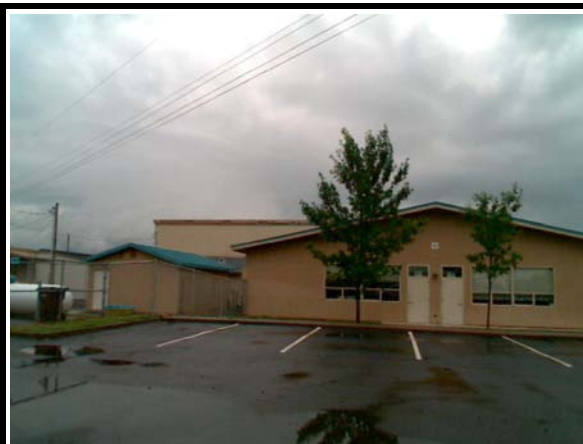
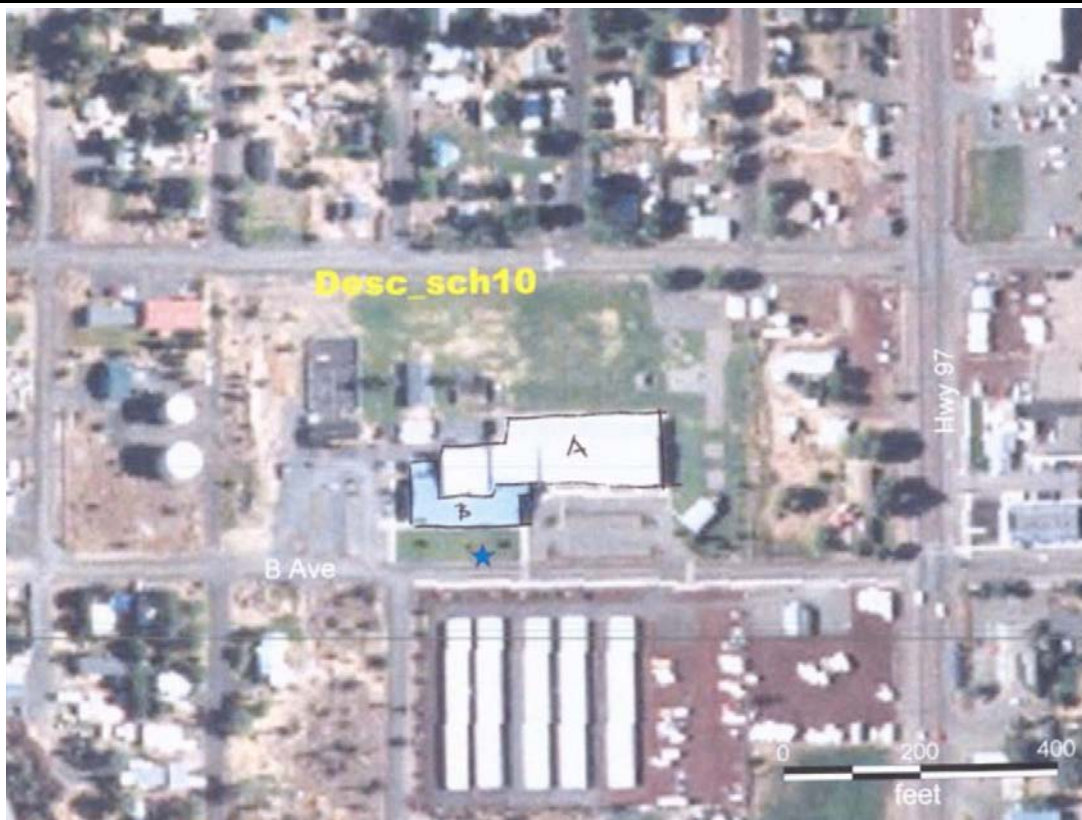
Desc\_sch10B

Type	Basic Score	Vert Irreg	Plan Irreg	Pre-Code	Post-Bench	Soil C	Soil D	Soil E	RVS Score
Primary	W2	4.8	-3	-0.5	0	1.6	-0.8	0	0	2.1
Secondary		0	0	0	0	0	0	0	0	0
Tertiary		0	0	0	0	0	0	0	0	0

W2

2.1

Low (<1%)

Plan Irregularities	Vertical Irregularities
Reentrant Corners:L shaped (Adjacent Build/Entity)	Steps in Elevation View: Single Change (Adjacent Building/Entity)
None	None
None	None
