Bear Creek Elementary School

Bend-LaPine SD 1

FEMA 154 Rapid Visual Screening Score Card

Rapid Visual Screening - Senate Bill #2 - Seismic Needs Assessment
Oregon Department of Geology and Mineral Industries

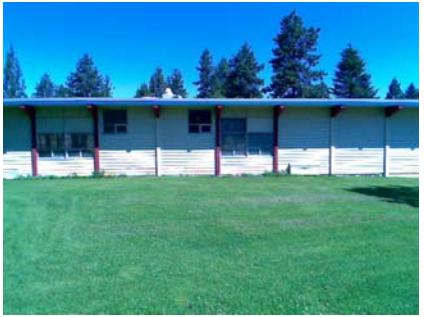
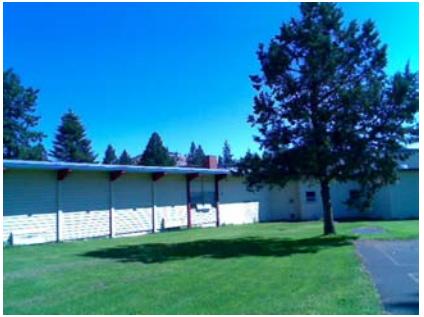
S Elevation View		S Vertical Irregularity Primary

Enrollment 574	Year Built (Field Verified) 1963	Year Built (Alt. Source) 1963	Est. Decade Built 1960
Total Area (square ft) 52469	Number of Stories 1	Basement	Pounding Potential No
Plan Irregularities Reentrant Corners:Other (Adjacent Build/Entity) None None		Vertical Irregularities Steps in Elevation View: Single Change (Adjacent Building/Entity) None None	
Falling Hazards None None None		Poor Conditions None None None

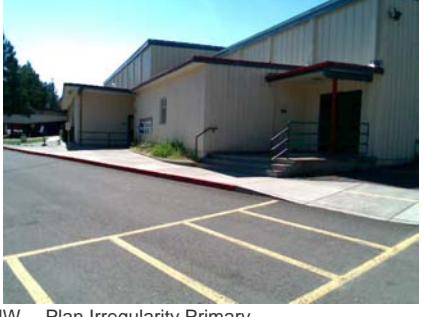
NW Plan Irregularity Primary

Enrollment 574	Year Built (Field Verified) 1963	Year Built (Alt. Source) 1963	Est. Decade Built 1970
Total Area (square ft) 52469	Number of Stories 1	Basement	Pounding Potential No
Plan Irregularities Reentrant Corners:L shaped (Adjacent Build/Entity) None None		Vertical Irregularities Steps in Elevation View: 2 to 3 Changes (Adjacent Building/Entity) None None	
Falling Hazards None None None		Poor Conditions None None None

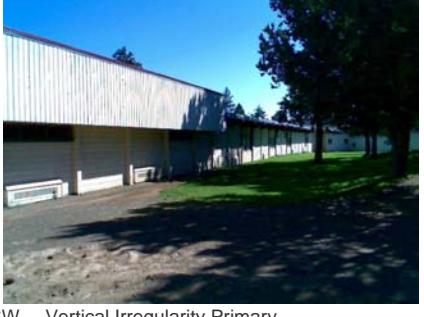
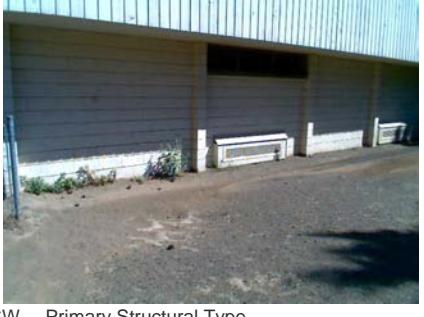
SW Vertical Irregularity Primary		SW Primary Structural Type

Enrollment 574	Year Built (Field Verified) 1963	Year Built (Alt. Source) 1963	Est. Decade Built 1970
Total Area (square ft) 52469	Number of Stories 1	Basement	Pounding Potential No
Plan Irregularities Reentrant Corners:L shaped (Adjacent Build/Entity) None None		Vertical Irregularities Steps in Elevation View: Single Change (Adjacent Building/Entity) None None	
Falling Hazards None None None		Poor Conditions None None None
