# Roseburg FD

| 801 NW Garden Valley Blvd | | | |

## FEMA 154 Rapid Visual Screening Score Card

Rapid Visual Screening - Senate Bill #2 - Seismic Needs Assessment  
Oregon Department of Geology and Mineral Industries

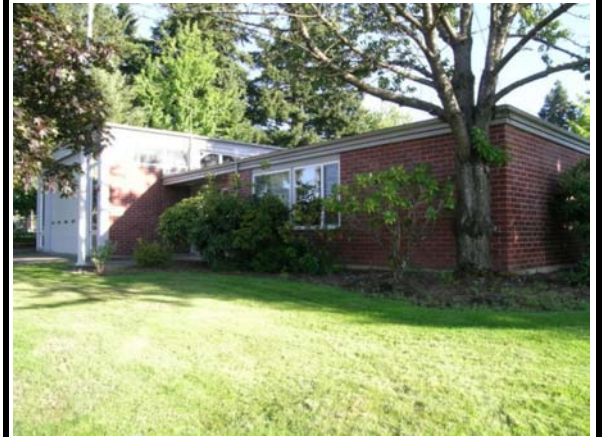
Seismicity Zone: High

| | Type | Basic Score | Vert Irreg | Plan Irreg | Pre-Code | Post-Bench | Soil C | Soil D | Soil E | RVS Score |
|---|---|---|---|---|---|---|---|---|---|---|
| Primary | RM1 | 2.8 | -1 | -0.5 | 0 | 0 | -0.4 | 0 | 0 | 0.9 |

High (>10%)
