# Roseburg Police Dept

Doug\_pol03A

## FEMA 154 Rapid Visual Screening Score Card

Rapid Visual Screening - Senate Bill #2 - Seismic Needs Assessment  
Oregon Department of Geology and Mineral Industries

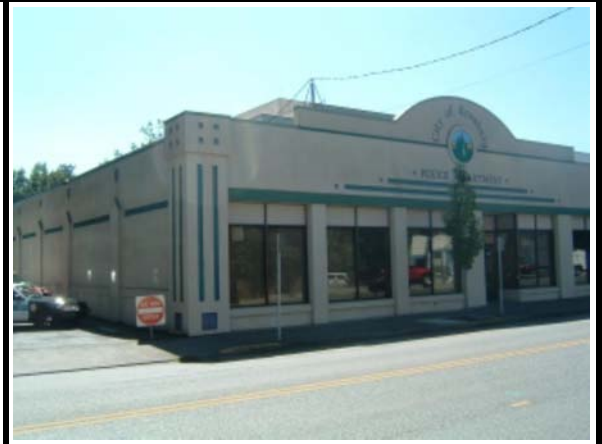
Seismicity Zone: High

| | Type | Basic Score | Vert Irreg | Plan Irreg | Pre-Code | Post-Bench | Soil C | Soil D | Soil E | RVS Score |
| Primary | RM1 | 2.8 | 0 | 0 | 0 | 0 | -0.4 | 0 | 0 | 2.4 |
| Secondary | W1 | 4.4 | 0 | 0 | 0 | 2.4 | 0 | 0 | 0 | 6.8 |

## Final RVS Score

RM1

2.4

## FEMA-154 Collapse Potential

Low (<1%)
