# Tri City Elementary School

Doug\_sch16A

## FEMA 154 Rapid Visual Screening Score Card

Rapid Visual Screening - Senate Bill #2 - Seismic Needs Assessment  
Oregon Department of Geology and Mineral Industries

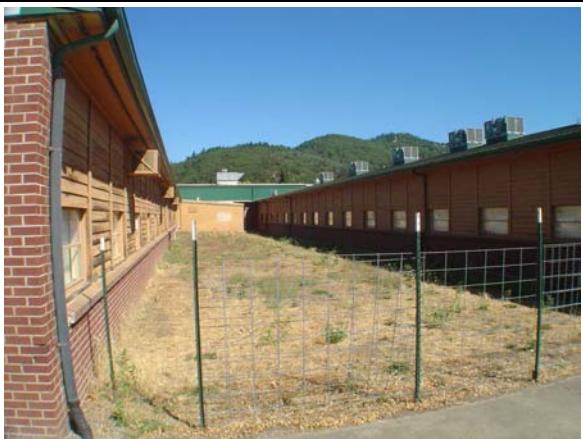
Type	Basic Score	Vert Irreg	Plan Irreg	Pre-Code	Post-Bench	Soil C	Soil D	Soil E	RVS Score
Primary	W2	3.8	-2	-0.5	0	0	-0.4	0	0	0.9
Secondary		0	0	0	0	0	0	0	0	0
Tertiary		0	0	0	0	0	0	0	0	0

Final Type	Final Score
W2	0.9

High (>10%)

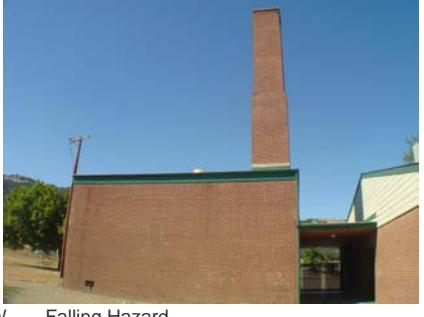
W Falling Hazard This is the boiler room which is near an entrance of the main building.	NE Vertical Irregularity Primary	N General Site
