West Sutherlin Intermediate

Doug_sch29A

FEMA 154 Rapid Visual Screening Score Card

Rapid Visual Screening - Senate Bill #2 - Seismic Needs Assessment
Oregon Department of Geology and Mineral Industries

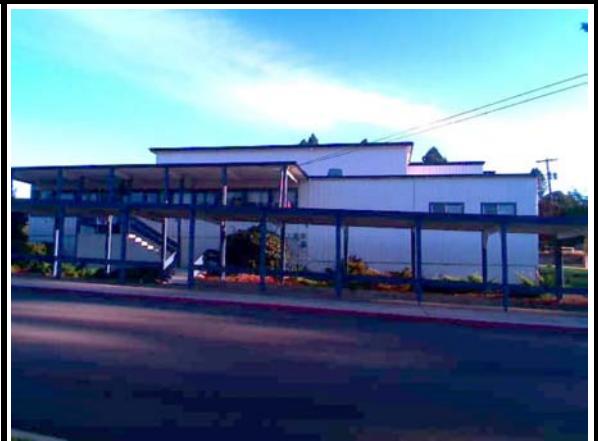
Type	Basic Score	Vert Irreg	Plan Irreg	Pre-Code	Post-Bench	Soil C	Soil D	Soil E	RVS Score
Primary	W2	3.8	-2	-0.5	0	0	0	0	0	1.3
Secondary		0	0	0	0	0	0	0	0	0
Tertiary		0	0	0	0	0	0	0	0	0

Moderate (>1%)

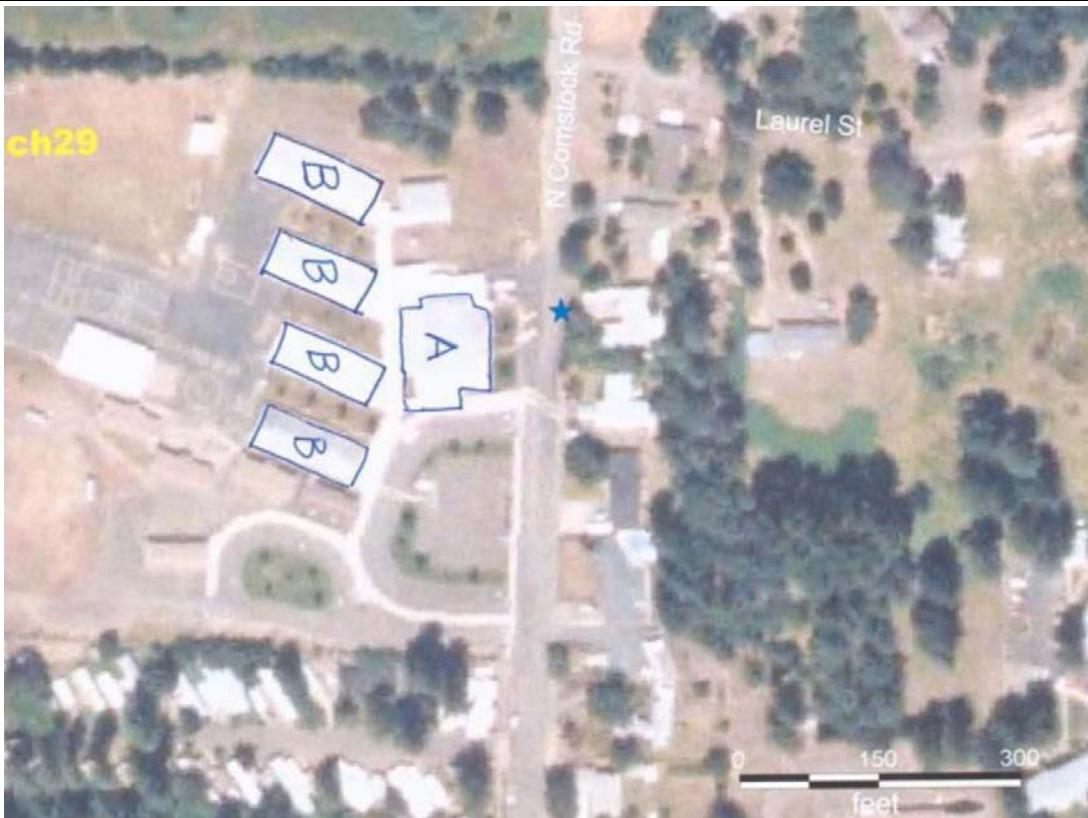
Final Type	Final Score
W2	1.3

Enrollment 377	Year Built (Field Verified) 1953	Year Built (Alt. Source) 1953	Est. Decade Built 1950
Total Area (square ft) 34065	Number of Stories 1	Basement	Pounding Potential No
Plan Irregularities Reentrant Corners: Other None None		Vertical Irregularities Steps in Elevation View: Very Irregular Changes Building On Hill or Sloped Site None	
Falling Hazards None None None		Poor Conditions None None None

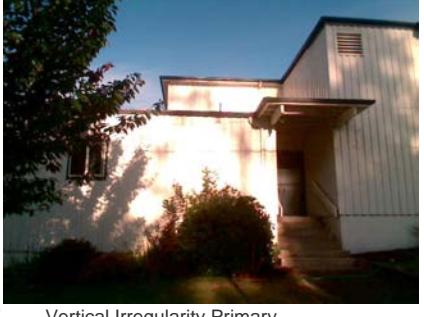
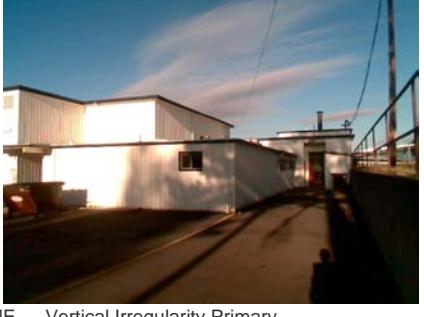
E Vertical Irregularity Primary		NE Vertical Irregularity Primary also shows a reentrant corner and a sloped site	
		SW Plan Irregularity Primary

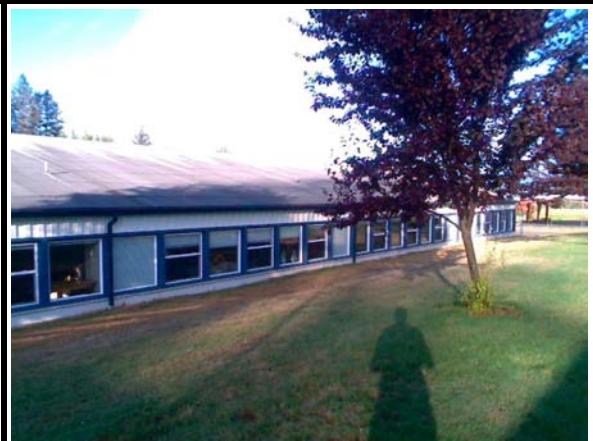
Type	Basic Score	Vert Irreg	Plan Irreg	Pre-Code	Post-Bench	Soil C	Soil D	Soil E	RVS Score
Primary	W2	3.8	0	0	0	0	0	0	0	3.8
Secondary		0	0	0	0	0	0	0	0	0
Tertiary		0	0	0	0	0	0	0	0	0

Low (<1%)

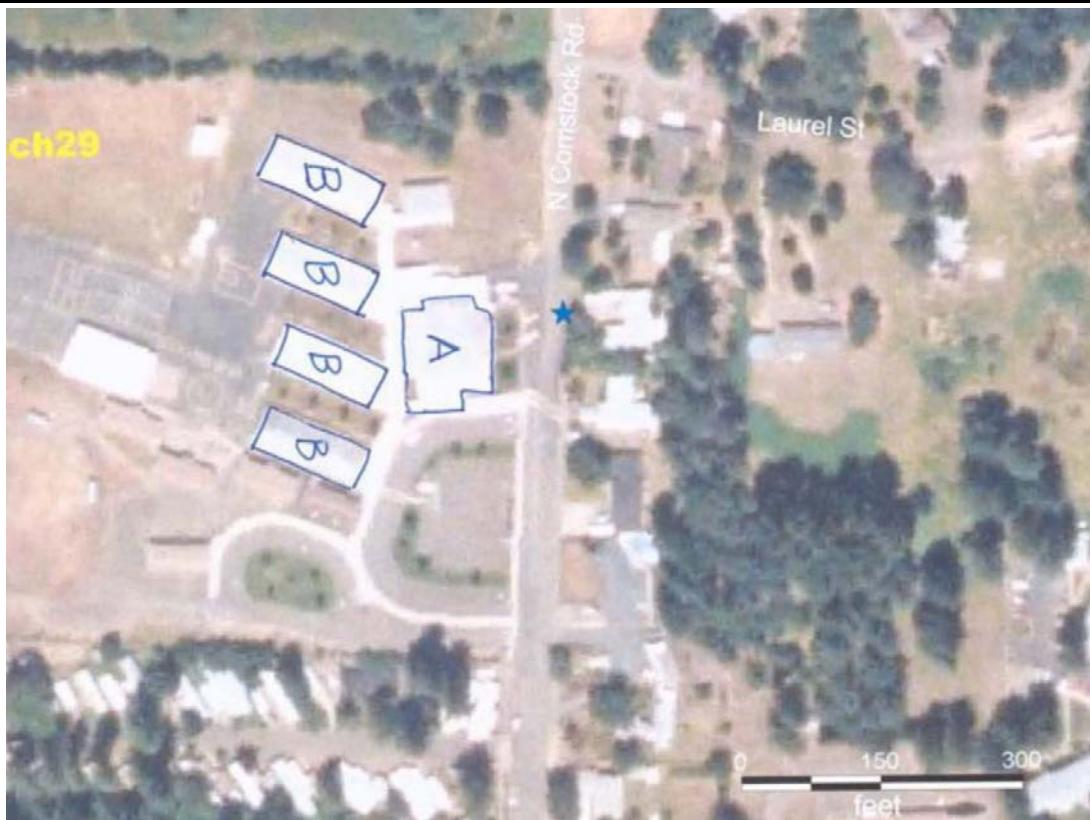
Final Type	Final Score
W2	3.8

Enrollment 349	Year Built (Field Verified) 1953	Year Built (Alt. Source) 1953	Est. Decade Built 1950
Total Area (square ft) 34065	Number of Stories 1	Basement	Pounding Potential No
Plan Irregularities None None None		Vertical Irregularities Building On Hill or Sloped Site Steps in Elevation View: Single Change None	
Falling Hazards None None None		Poor Conditions None None None

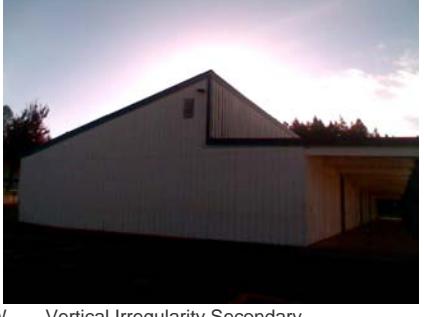
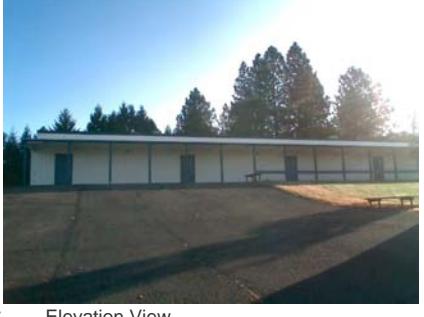
W	Vertical Irregularity Secondary	S	Elevation View

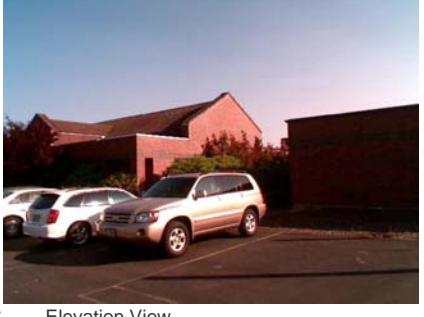
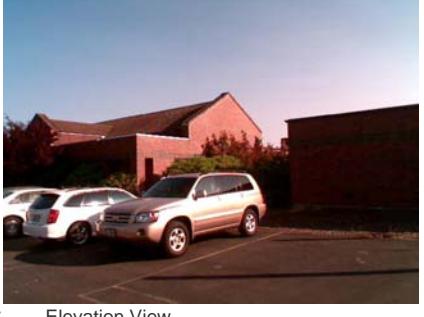
S	Elevation View	S	Elevation View

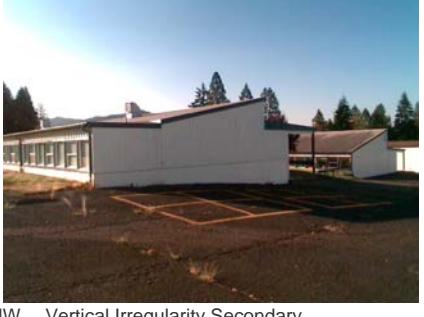
NW Vertical Irregularity Secondary and sloped site.
