| Police - State | | Gilliam | |
| Hwy 19 & Columbia St | | | |
| RVS in 2006 | 8/29/2006 | | |

## FEMA 154 Rapid Visual Screening Score Card

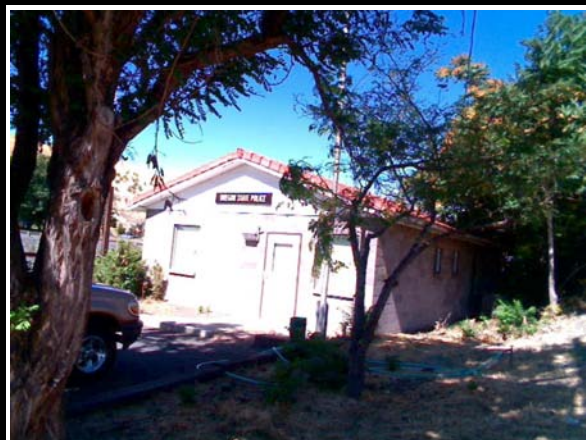
Seismicity Zone: Moderate

| | Type | Basic Score | Vert Irreg | Plan Irreg | Pre-Code | Post-Bench | Soil C | Soil D | Soil E | RVS Score |
|---|---|---|---|---|---|---|---|---|---|---|
| Primary | RM1 | 3.6 | 0 | 0 | 0 | 0 | -0.8 | 0 | 0 | 2.8 |

Low (&lt;1%)

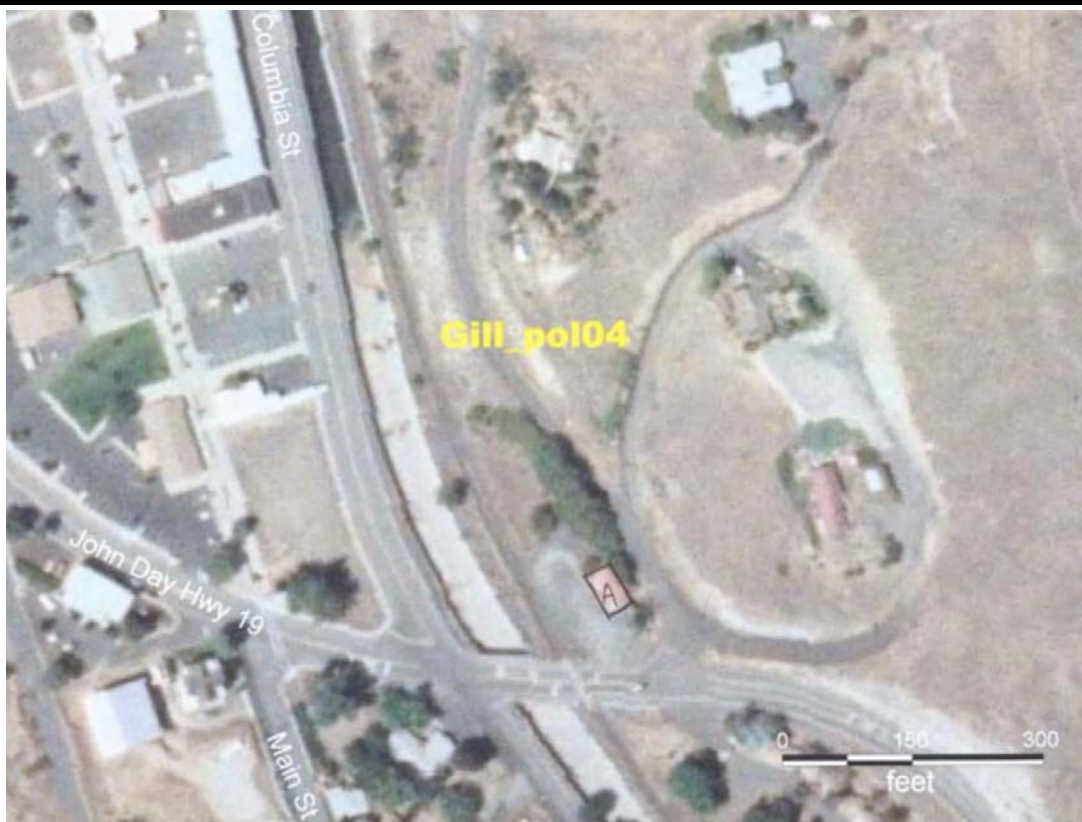
| | 1977 | 1977 | 1970 |
| 960 | 1 | No | No |
