Seneca Volunteer FD

FEMA 154 Rapid Visual Screening Score Card

Rapid Visual Screening - Senate Bill #2 - Seismic Needs Assessment
Oregon Department of Geology and Mineral Industries

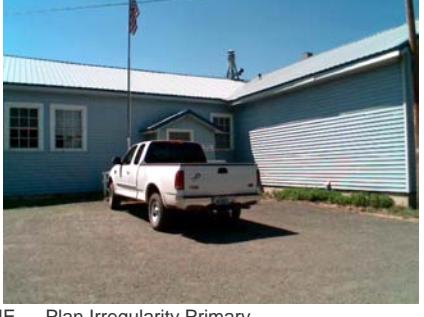
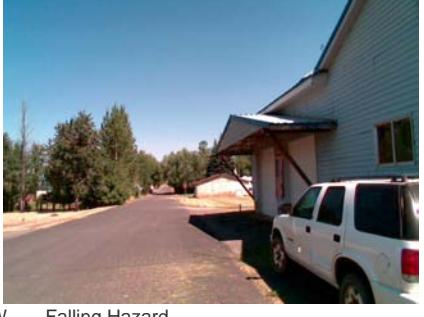
Enrollment	Year Built (Field Verified)	Year Built (Alt. Source)	Est. Decade Built
			1950
Total Area (square ft)	Number of Stories	Basement	Pounding Potential
	1	No	No
Plan Irregularities		Vertical Irregularities	
Reentrant Corners: L Shaped		Steps in Elevation View: Single Change	
None		None	
None		None	
Falling Hazards		Poor Conditions	
Other: Ornamental Hazard Over Exit		None	
None		None	
None		None

NE Plan Irregularity Primary		W Falling Hazard

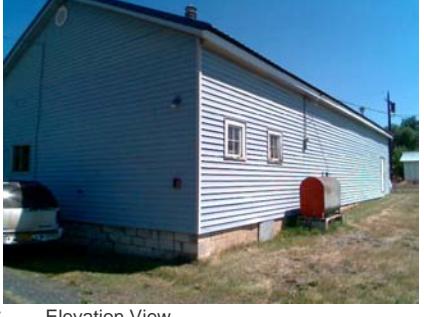
S Elevation View
