Long Creek FD

Gran_fir06A

FEMA 154 Rapid Visual Screening Score Card

Gran_fir06B

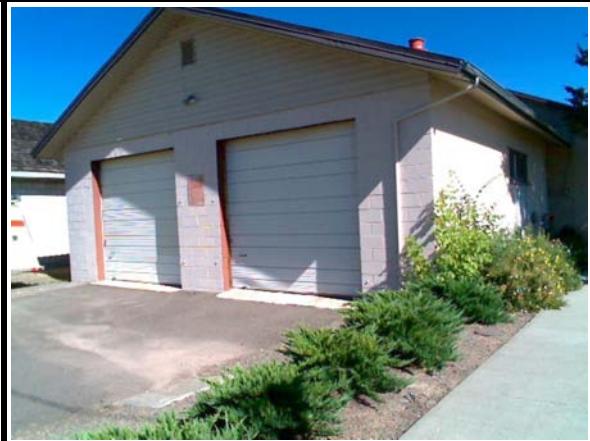
Building Type Fire - RFPD	County Grant	
Street 250 Hardisty St		
City Long Creek	State OR	Zip 97856
Latitude 44.71293	Longitude 119.10507	
Tracking Code RVS in 2006	Inspection Date 7/28/2006

Type	Basic Score	Vert Irreg	Plan Irreg	Pre-Code	Post-Bench	Soil C	Soil D	Soil E	RVS Score
Primary	RM1	3.6	-2	-0.5	0	0	-0.8	0	0	0.3
Secondary		0	0	0	0	0	0	0	0	0
Tertiary		0	0	0	0	0	0	0	0	0

High (>10%)

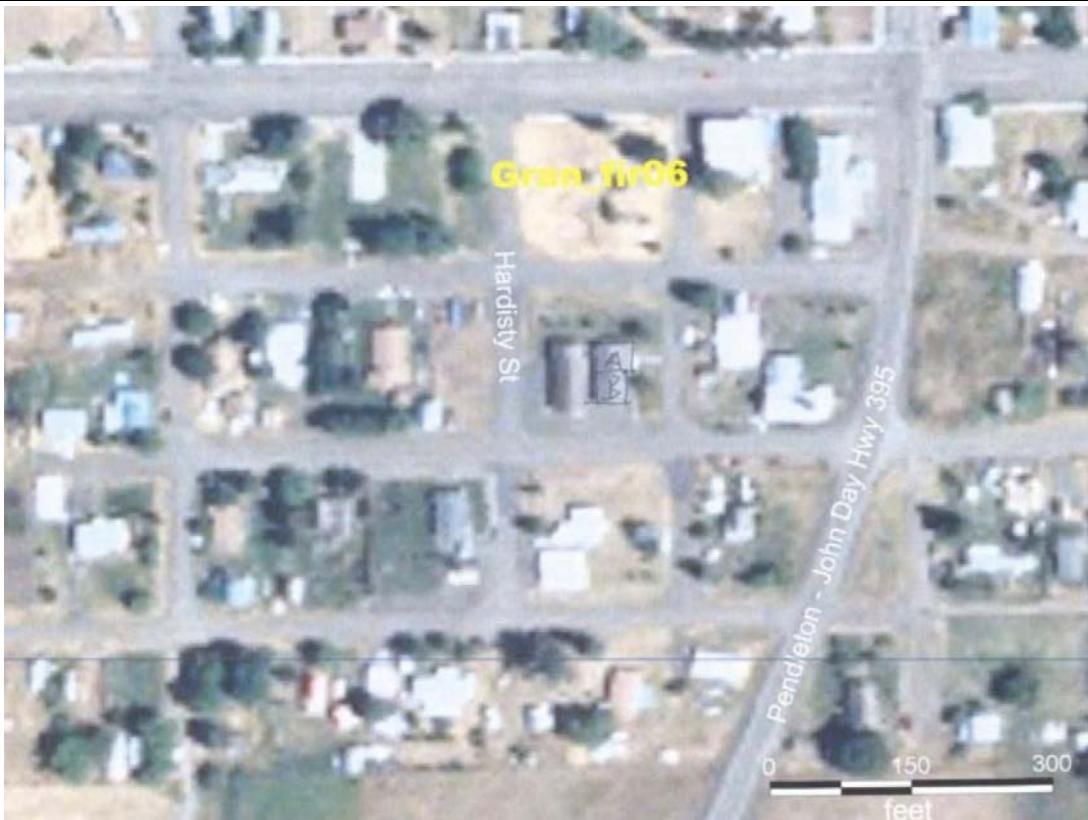
FEMA-154 Collapse Potential

Enrollment	Year Built (Field Verified)	Year Built (Alt. Source)	Est. Decade Built
			1980
Total Area (square ft)	Number of Stories	Basement	Pounding Potential
	1	No	No
Plan Irregularities		Vertical Irregularities	
Reentrant Corners:L shaped (Adjacent Build/Entity)		Steps in Elevation View: Single Change (Adjacent Building/Entity)	
None		None	
None		None	
Falling Hazards		Poor Conditions	
None		None	
None		None	
None		None

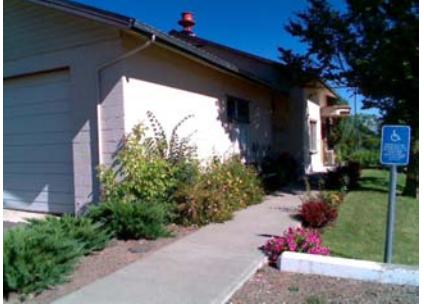
SE Plan Irregularity Primary

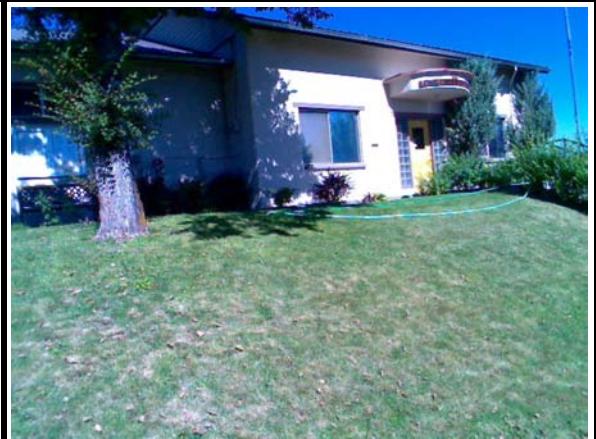
Building Type Fire - RFPD	County Grant	
Street 250 Hardisty St		
City Long Creek	State OR	Zip 97856
Latitude 44.71284	Longitude 119.10508	
Tracking Code RVS in 2006	Inspection Date 7/28/2006

Type	Basic Score	Vert Irreg	Plan Irreg	Pre-Code	Post-Bench	Soil C	Soil D	Soil E	RVS Score
Primary	RM1	3.6	-2	-0.5	0	0	-0.8	0	0	0.3
Secondary		0	0	0	0	0	0	0	0	0
Tertiary		0	0	0	0	0	0	0	0	0

High (>10%)

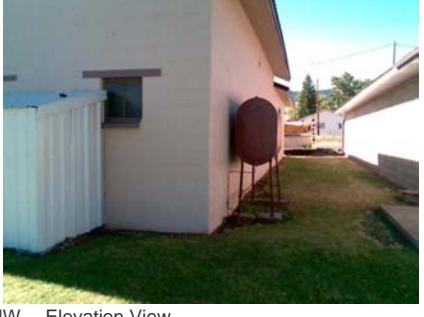
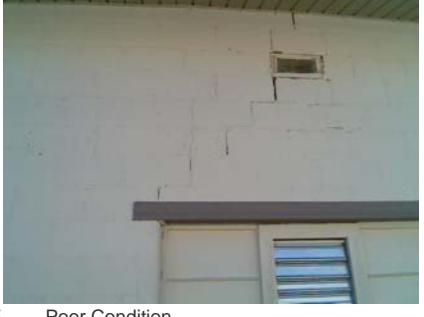
Enrollment	Year Built (Field Verified)	Year Built (Alt. Source)	Est. Decade Built
			1950
Total Area (square ft)	Number of Stories	Basement	Pounding Potential
	1	No	No
Plan Irregularities		Vertical Irregularities	
Reentrant Corners:L shaped (Adjacent Build/Entity)		Steps in Elevation View: Single Change (Adjacent Building/Entity)	
None		None	
None		None	
Falling Hazards		Poor Conditions	
None		Differential Settlement	
None		None	
None		None

NW Elevation View		E Poor Condition
