Oregon State Police

Building Type Police - State	County Grant	
Street 420 W Main St.		
City John Day	State OR	Zip 97845
Latitude 44.41752	Longitude 118.95787	
Tracking Code RVS in 2006	Inspection Date 7/27/2006

FEMA 154 Rapid Visual Screening Score Card

Rapid Visual Screening - Senate Bill #2 - Seismic Needs Assessment
Oregon Department of Geology and Mineral Industries

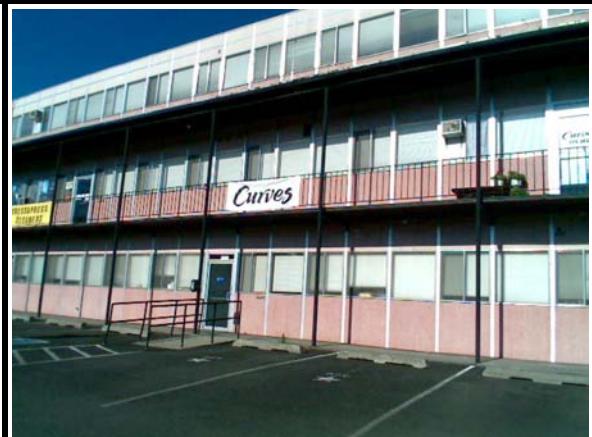
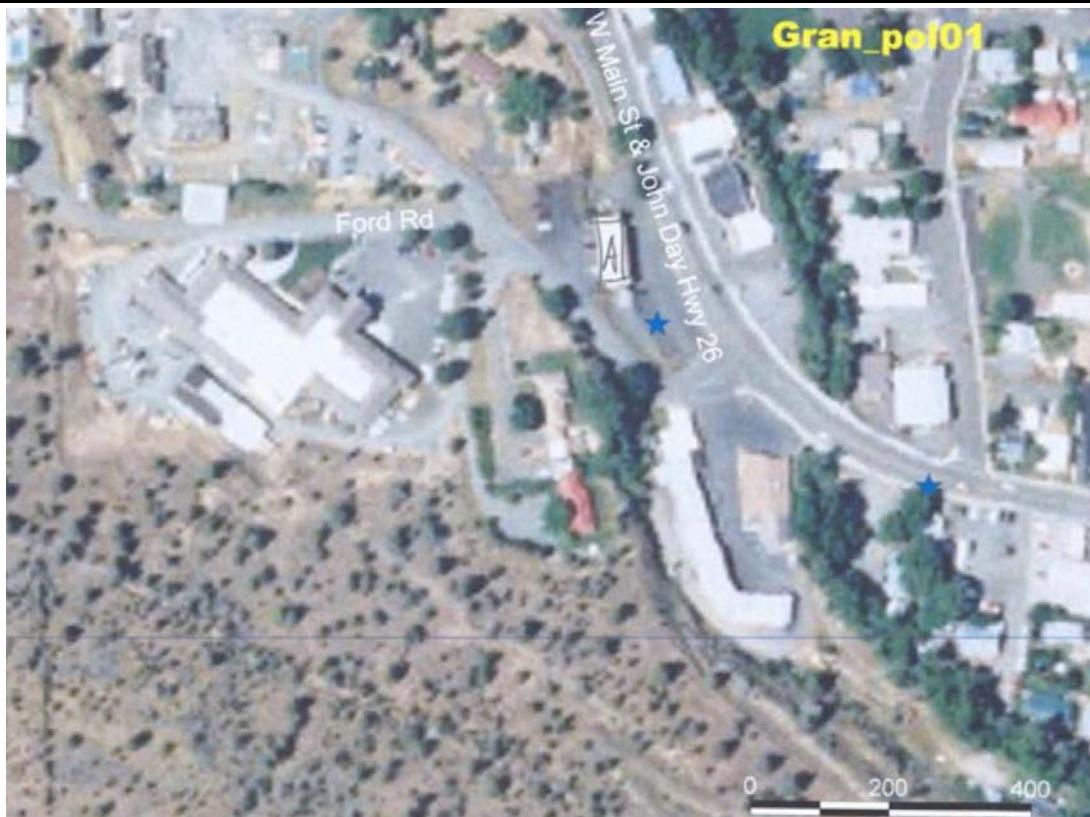
Type	Basic Score	Vert Irreg	Plan Irreg	Pre-Code	Post-Bench	Soil C	Soil D	Soil E	RVS Score
Primary	C2	3.6	-2	0	0	0	0	-1.2	0	0.4
Secondary		0	0	0	0	0	0	0	0	0
Tertiary		0	0	0	0	0	0	0	0	0

Final Type	Final Score
C2	0.4

High (>10%)

Enrollment	Year Built (Field Verified)	Year Built (Alt. Source)	Est. Decade Built
			1960
Total Area (square ft)	Number of Stories	Basement	Pounding Potential
	3	No	No
Plan Irregularities		Vertical Irregularities	
None		Building On Hill or Sloped Site	
None		None	
None		None	
Falling Hazards		Poor Conditions	
None		None	
None		None	
None		None

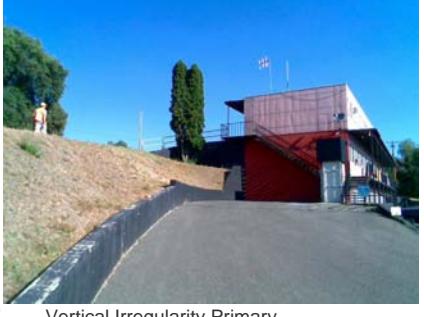
E Vertical Irregularity Primary
