# Harney County Sheriff Department

Harn\_pol02A

## FEMA 154 Rapid Visual Screening Score Card

Rapid Visual Screening - Senate Bill #2 - Seismic Needs Assessment  
Oregon Department of Geology and Mineral Industries

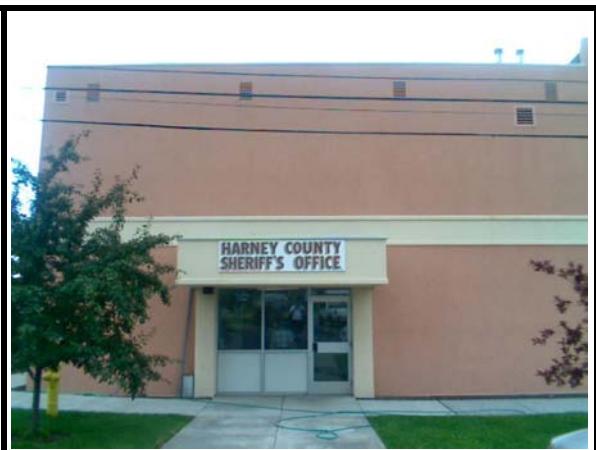
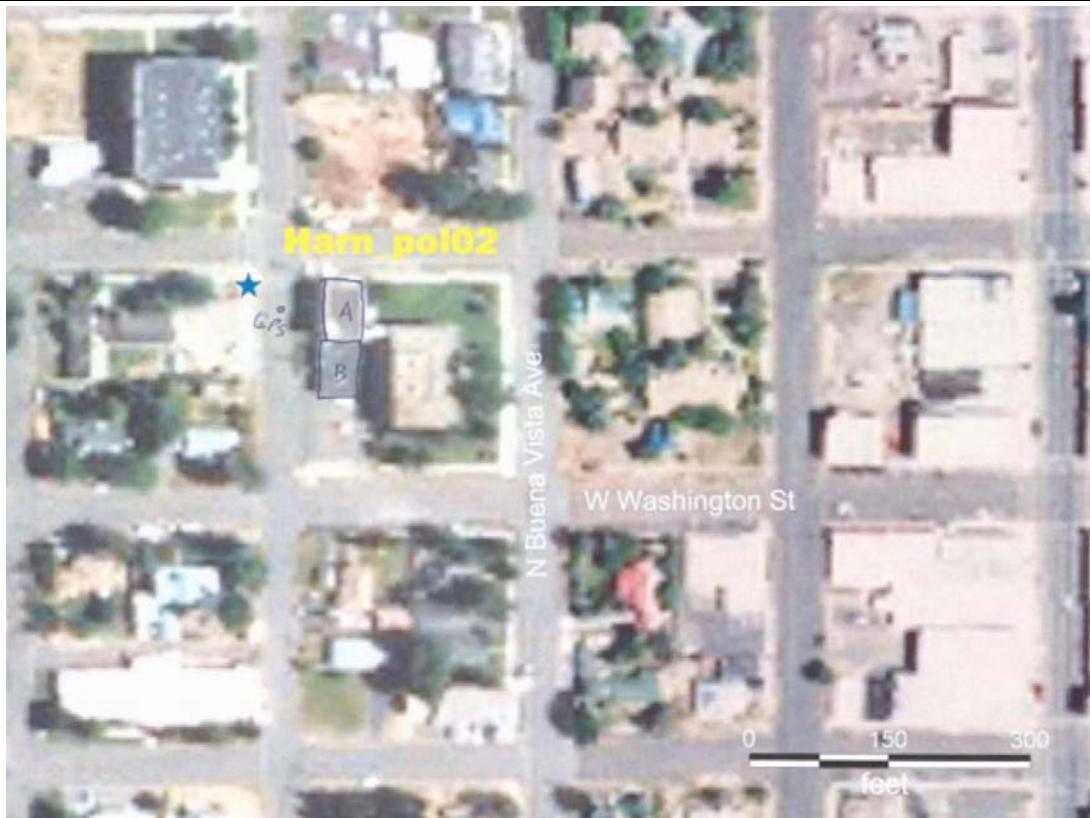
Type	Basic Score	Vert Irreg	Plan Irreg	Pre-Code	Post-Bench	Soil C	Soil D	Soil E	RVS Score
Primary	S2	3.6	-2	0	0	1.4	-0.8	0	0	2.2
Secondary	S3	3.8	0	0	0	0	-0.6	0	0	3.2
Tertiary	S4	3.6	-2	0	0	1.2	-0.8	0	0	2

Final Type	Final Score
S4	2

Moderate (>1%)

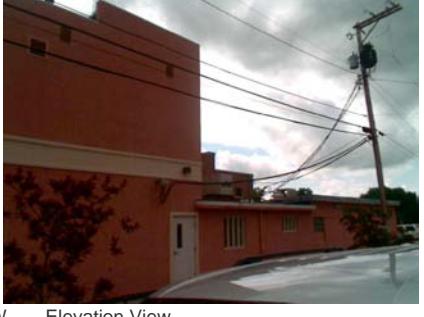
W	Elevation View	E	Elevation View

Enrollment	Year Built (Field Verified)	Year Built (Alt. Source)	Est. Decade Built
	1998	1941	1990
Total Area (square ft)	Number of Stories	Basement	Pounding Potential
	2	No	Yes
Plan Irregularities		Vertical Irregularities	
None		Steps in Elevation View: Single Change (Adjacent Building/Entity)	
None		None	
None		None	
Falling Hazards		Poor Conditions	
Other: General		None	
None		None	
None		None

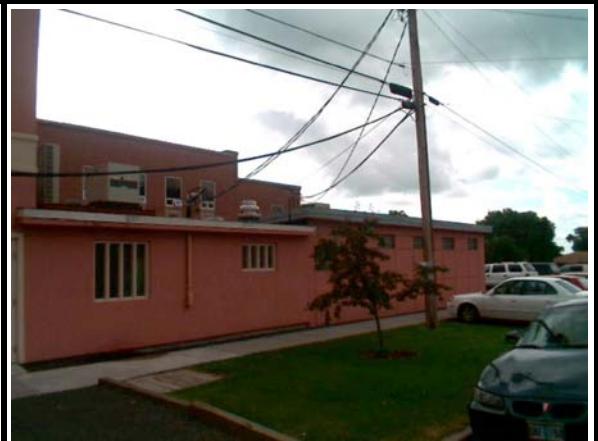
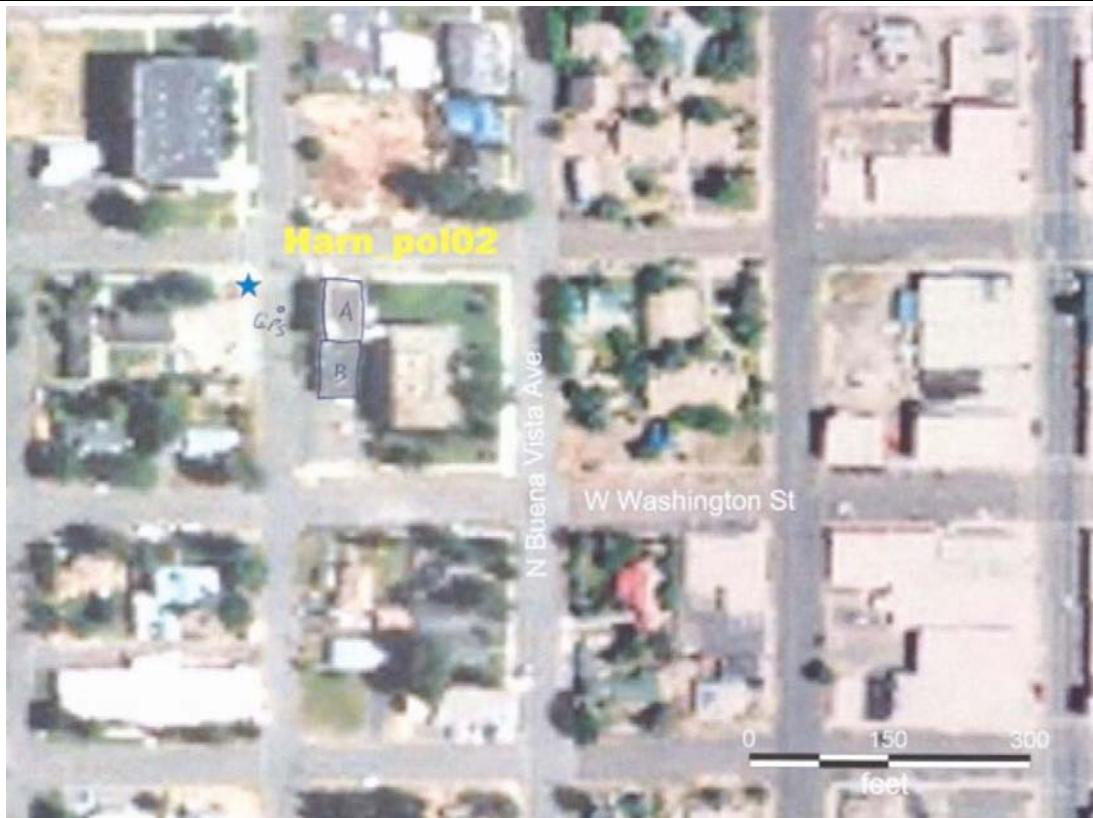
Harn\_pol02B

Type	Basic Score	Vert Irreg	Plan Irreg	Pre-Code	Post-Bench	Soil C	Soil D	Soil E	RVS Score
Primary	C2	3.6	-2	0	0	0	-0.8	0	0	0.8
Secondary		0	0	0	0	0	0	0	0	0
Tertiary		0	0	0	0	0	0	0	0	0

Final Type	Final Score
C2	0.8

High (>10%)
-------------

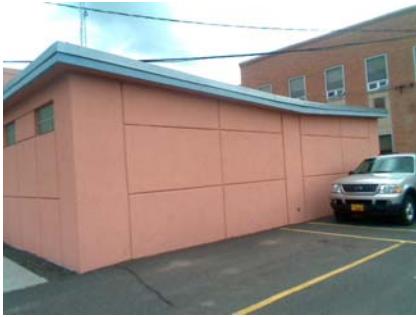
S Elevation View		W Elevation View inmate

Enrollment	Year Built (Field Verified)	Year Built (Alt. Source)	Est. Decade Built
	1962	1941	1960
Total Area (square ft)	Number of Stories	Basement	Pounding Potential
	1	No	Yes
Plan Irregularities		Vertical Irregularities	
None		Steps in Elevation View: Single Change (Adjacent Building/Entity)	
None		None	
None		None	
Falling Hazards		Poor Conditions	
None		None	
None		None	
None		None
