Henry L Slater Elementary School

Harn sch03A

FEMA 154 Rapid Visual Screening Score Card

Rapid Visual Screening - Senate Bill #2 - Seismic Needs Assessment
Oregon Department of Geology and Mineral Industries

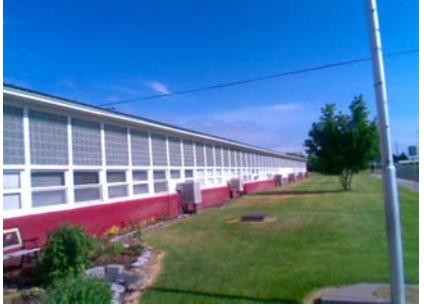
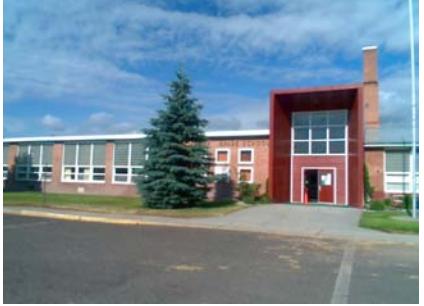
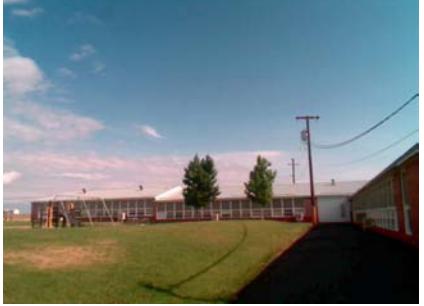
E Elevation View	E Elevation View	S Elevation View

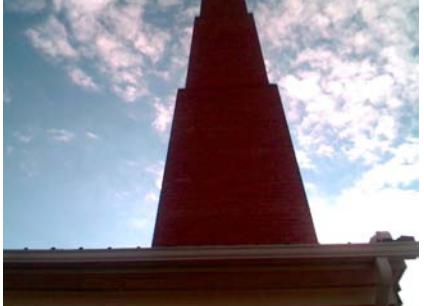
Enrollment 428	Year Built (Field Verified) 1948	Year Built (Alt. Source) 1917	Est. Decade Built 1940
Total Area (square ft) 45595	Number of Stories 1	Basement	Pounding Potential Yes
Plan Irregularities Reentrant Corners: L Shaped None None		Vertical Irregularities Steps in Elevation View: Single Change None None	
Falling Hazards Other: Smokestack None None		Poor Conditions None None None

W Falling Hazard

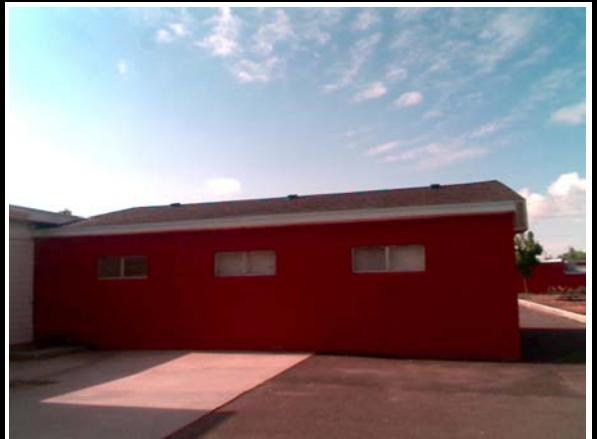
Harn_sch03B

Type	Basic Score	Vert Irreg	Plan Irreg	Pre-Code	Post-Bench	Soil C	Soil D	Soil E	RVS Score
Primary	RM1	3.6	0	-0.5	0	0	-0.8	0	0	2.3
Secondary		0	0	0	0	0	0	0	0	0
Tertiary		0	0	0	0	0	0	0	0	0

Final Type	Final Score
RM1	2.3

Low (<1%)

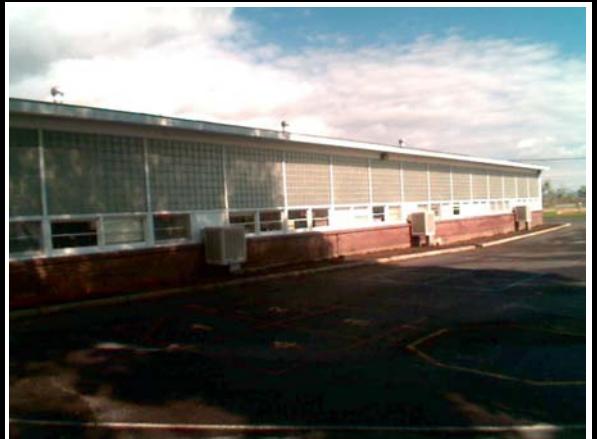
Harn_sch03C

Type	Basic Score	Vert Irreg	Plan Irreg	Pre-Code	Post-Bench	Soil C	Soil D	Soil E	RVS Score
Primary	W2	4.8	-3	-0.5	0	0	-0.8	0	0	0.5
Secondary		0	0	0	0	0	0	0	0	0
Tertiary		0	0	0	0	0	0	0	0	0

Final Type	Final Score
W2	0.5

High (>10%)

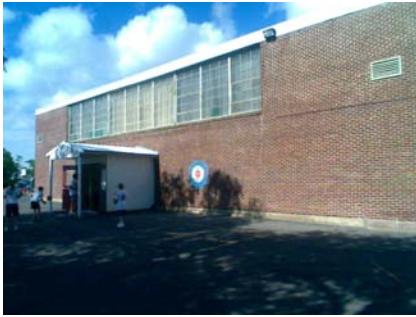
E Elevation View

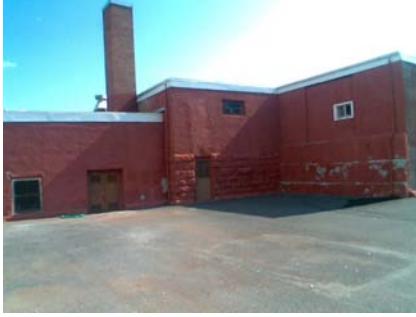
Enrollment 428	Year Built (Field Verified) 1917	Year Built (Alt. Source) 1917	Est. Decade Built 1950
Total Area (square ft) 45595	Number of Stories 1	Basement	Pounding Potential No
Plan Irregularities None None None		Vertical Irregularities Steps in Elevation View: Single Change None None	
Falling Hazards Other: Smokestack Other: Brick Veneer None		Poor Conditions None None None

SW Falling Hazard
