Westside RFPD

Hood_fir07A

FEMA 154 Rapid Visual Screening Score Card

Rapid Visual Screening - Senate Bill #2 - Seismic Needs Assessment
Oregon Department of Geology and Mineral Industries

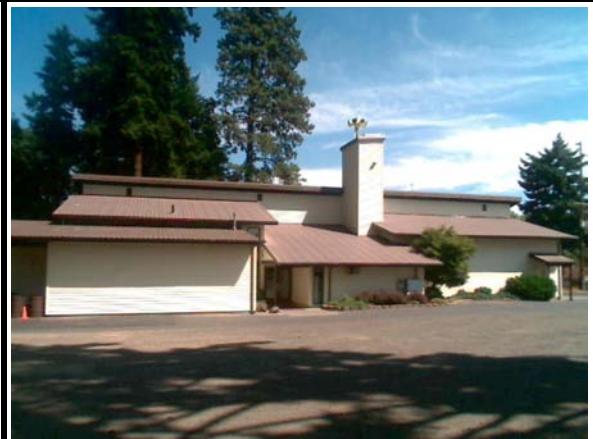
High (>10%)

Enrollment	Year Built (Field Verified)	Year Built (Alt. Source)	Est. Decade Built
	1946	1946	1940
Total Area (square ft)	Number of Stories	Basement	Pounding Potential
	1	No	No
Plan Irregularities		Vertical Irregularities	
Reentrant Corners: L Shaped		Steps in Elevation View: 2 to 3 Changes	
Torsion: Eccentric Stiffness		None	
None		None	
Falling Hazards		Poor Conditions	
None		None	
None		None	
None		None

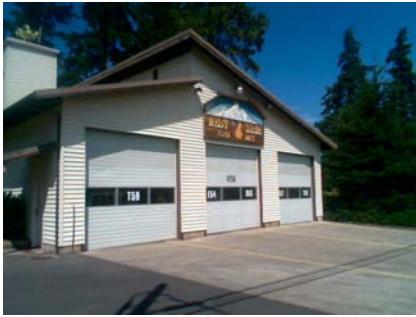
S	Elevation View	SW	General Site

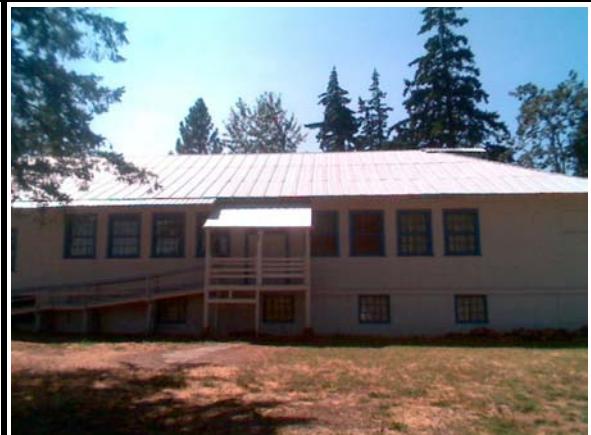
Low (<1%)

Enrollment	Year Built (Field Verified)	Year Built (Alt. Source)	Est. Decade Built
	1889	1946	Pre 1900
Total Area (square ft)	Number of Stories	Basement	Pounding Potential
	1	Yes	No
Plan Irregularities		Vertical Irregularities	
None		None	
None		None	
None		None	
Falling Hazards		Poor Conditions	
None		None	
None		None	
None		None

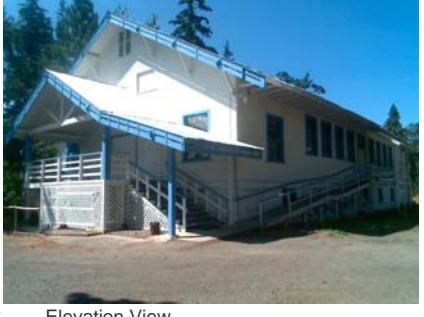
S Elevation View
