White City Elementary School

Eagle Point SD 9

FEMA 154 Rapid Visual Screening Score Card

Rapid Visual Screening - Senate Bill #2 - Seismic Needs Assessment
Oregon Department of Geology and Mineral Industries

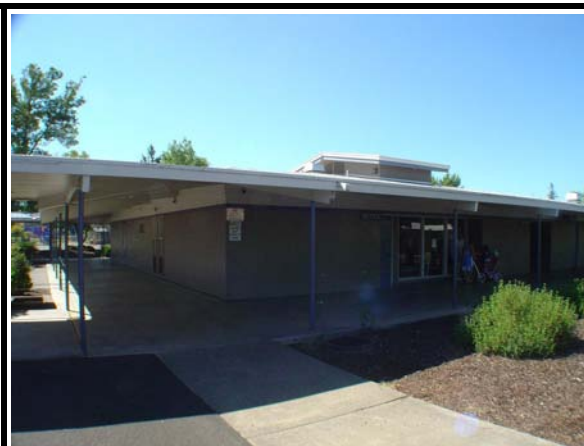
Jack_sch16A

Type	Basic Score	Vert Irreg	Plan Irreg	Pre-Code	Post-Bench	Soil C	Soil D	Soil E	RVS Score
Primary	W2	4.8	0	0	0	0	-0.8	0	0	4
Secondary		0	0	0	0	0	0	0	0	0
Tertiary		0	0	0	0	0	0	0	0	0

FEMA-154 Collapse Potential

Low (<1%)

Plan Irregularities	Vertical Irregularities
None	None
None	None
None	None

Falling Hazards	Poor Conditions
None	None
None	None
None	None

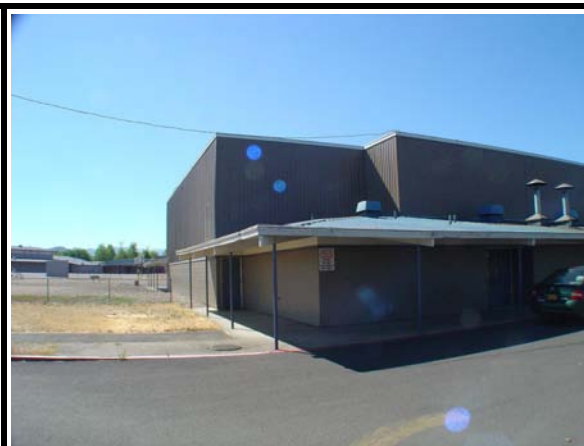
Jack_sch16B

Type	Basic Score	Vert Irreg	Plan Irreg	Pre-Code	Post-Bench	Soil C	Soil D	Soil E	RVS Score
Primary	W2	4.8	-3	-0.5	0	0	-0.8	0	0	0.5
Secondary	RM1	3.6	-2	-0.5	0	0	-0.8	0	0	0.3
Tertiary	S3	3.8	0	-0.5	0	0	-0.6	0	0	2.7

FEMA-154 Collapse Potential

High (>10%)

Plan Irregularities	Vertical Irregularities
Out of Plane Lateral-Force-Resistance Elements	Steps in Elevation View: 2 to 3 Changes
None	None
None	None

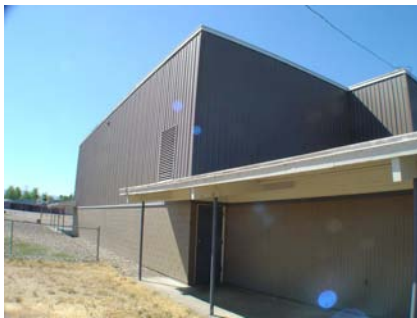
N Vertical Irregularity Primary
also shows two lateral systems.

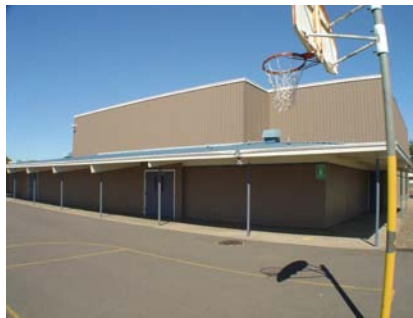
NE Vertical Irregularity Primary
also shows out of plan irregularity.

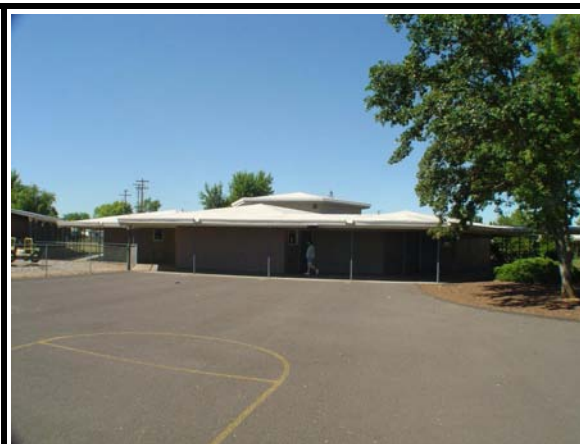
Jack_sch16C

Type	Basic Score	Vert Irreg	Plan Irreg	Pre-Code	Post-Bench	Soil C	Soil D	Soil E	RVS Score
Primary	W2	4.8	0	-0.5	0	0	-0.8	0	0	3.5
Secondary		0	0	0	0	0	0	0	0	0
Tertiary		0	0	0	0	0	0	0	0	0

FEMA-154 Collapse Potential

Low (<1%)

Plan Irregularities	Vertical Irregularities
Non-Parallel System	None
None	None
None	None

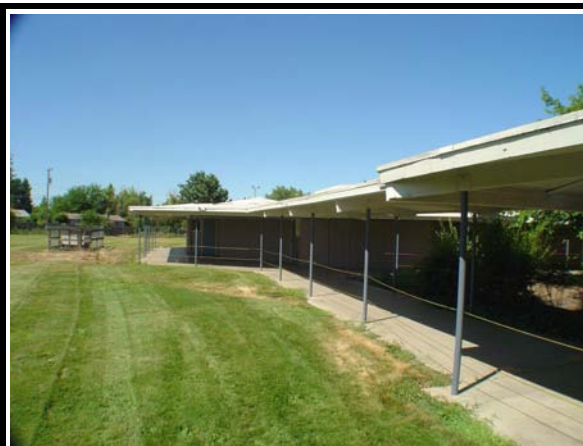
Jack_sch16D

Type	Basic Score	Vert Irreg	Plan Irreg	Pre-Code	Post-Bench	Soil C	Soil D	Soil E	RVS Score
Primary	W2	4.8	0	-0.5	0	0	-0.8	0	0	3.5
Secondary		0	0	0	0	0	0	0	0	0
Tertiary		0	0	0	0	0	0	0	0	0

FEMA-154 Collapse Potential

Low (<1%)

Plan Irregularities	Vertical Irregularities
Non-Parallel System	None
None	None
None	None

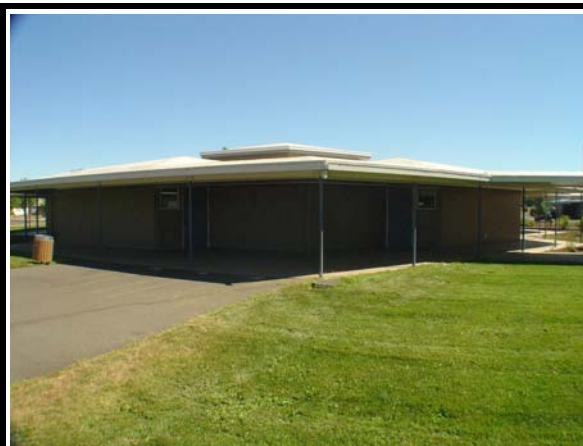
Jack_sch16E

Type	Basic Score	Vert Irreg	Plan Irreg	Pre-Code	Post-Bench	Soil C	Soil D	Soil E	RVS Score
Primary	W2	4.8	0	-0.5	0	0	-0.8	0	0	3.5
Secondary		0	0	0	0	0	0	0	0	0
Tertiary		0	0	0	0	0	0	0	0	0

FEMA-154 Collapse Potential

Low (<1%)

Plan Irregularities	Vertical Irregularities
Non-Parallel System	None
None	None
None	None
