Eagle Point High School

Jack_sch19A

FEMA 154 Rapid Visual Screening Score Card

Rapid Visual Screening - Senate Bill #2 - Seismic Needs Assessment
Oregon Department of Geology and Mineral Industries

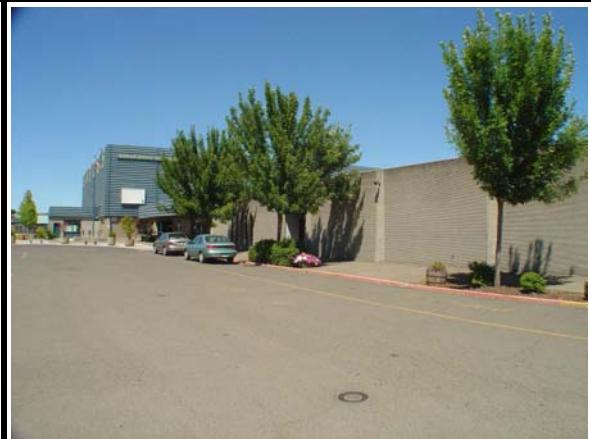
Type	Basic Score	Vert Irreg	Plan Irreg	Pre-Code	Post-Bench	Soil C	Soil D	Soil E	RVS Score
Primary	C2	3.6	-2	-0.5	0	0	-0.8	0	0	0.3
Secondary		0	0	0	0	0	0	0	0	0
Tertiary		0	0	0	0	0	0	0	0	0

Final Type	Final Score
C2	0.3

High (>10%)

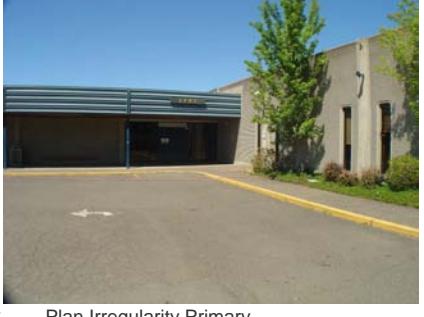
Enrollment 1218	Year Built (Field Verified) 1982	Year Built (Alt. Source) 1982	Est. Decade Built 1970
Total Area (square ft) 177000	Number of Stories 1	Basement	Pounding Potential No
Plan Irregularities Reentrant Corners: Other None None		Vertical Irregularities Steps in Elevation View: Single Change None None	
Falling Hazards None None None		Poor Conditions None None None

<p>S Plan Irregularity Primary also show elevation step.</p>

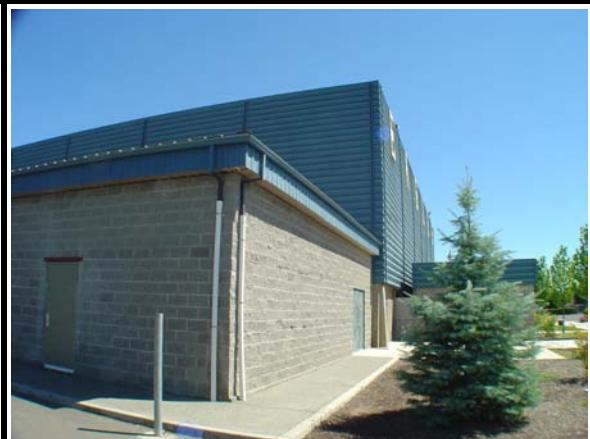
Jack_sch19B

Type	Basic Score	Vert Irreg	Plan Irreg	Pre-Code	Post-Bench	Soil C	Soil D	Soil E	RVS Score
Primary	C2	3.6	-2	0	0	0	-0.8	0	0	0.8
Secondary	RM1	3.6	-2	0	0	0	-0.8	0	0	0.8
Tertiary	S3	3.8	0	0	0	0	-0.6	0	0	3.2

Final Type	Final Score
C2	0.8

High (>10%)

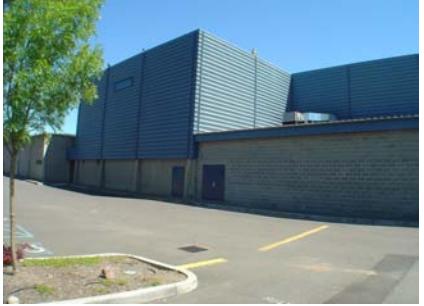
Enrollment 1218	Year Built (Field Verified) 1982	Year Built (Alt. Source) 1982	Est. Decade Built 1970
Total Area (square ft) 177000	Number of Stories 1	Basement	Pounding Potential No
Plan Irregularities Reentrant Corners: Other None None		Vertical Irregularities Steps in Elevation View: 2 to 3 Changes None None	
Falling Hazards None None None		Poor Conditions None None None

N Primary Structural Type and plan irregularity.

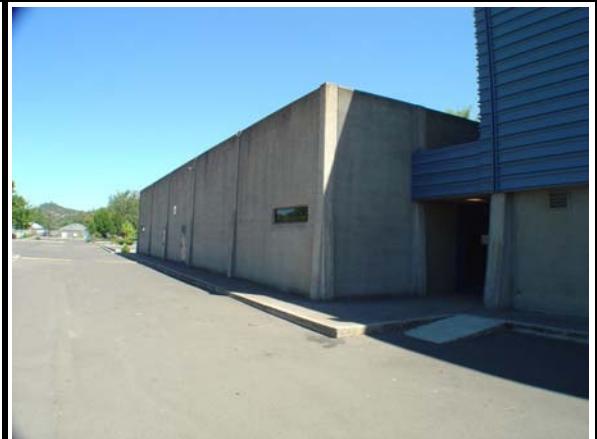
Jack_sch19C

Type	Basic Score	Vert Irreg	Plan Irreg	Pre-Code	Post-Bench	Soil C	Soil D	Soil E	RVS Score
Primary	C2	3.6	0	0	0	0	-0.8	0	0	2.8
Secondary		0	0	0	0	0	0	0	0	0
Tertiary		0	0	0	0	0	0	0	0	0

Final Type	Final Score
C2	2.8

Low (<1%)

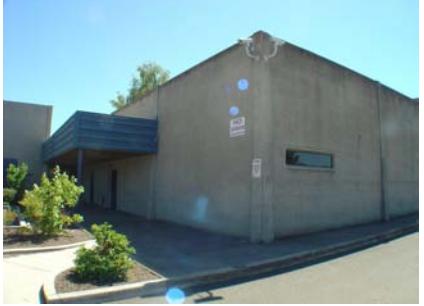
NE General Site

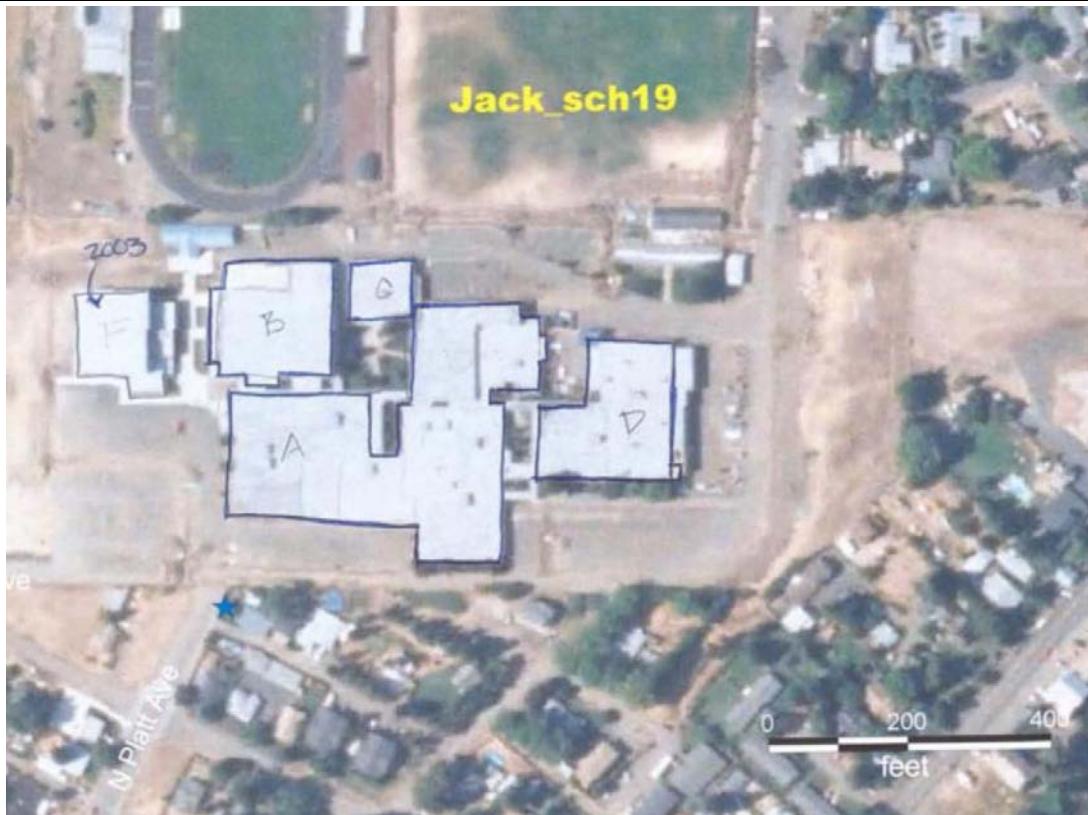
Type	Basic Score	Vert Irreg	Plan Irreg	Pre-Code	Post-Bench	Soil C	Soil D	Soil E	RVS Score
Primary	C2	3.6	-2	-0.5	0	0	-0.8	0	0	0.3
Secondary		0	0	0	0	0	0	0	0	0
Tertiary		0	0	0	0	0	0	0	0	0

High (>10%)

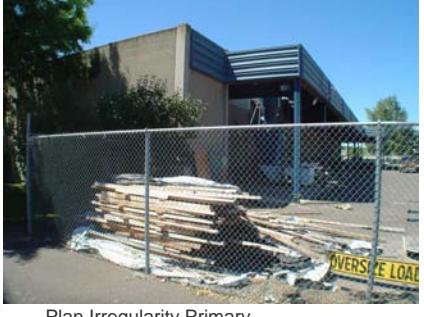
Enrollment 1218	Year Built (Field Verified) 1982	Year Built (Alt. Source) 1982	Est. Decade Built 1970
Total Area (square ft) 177000	Number of Stories 1	Basement	Pounding Potential No
Plan Irregularities		Vertical Irregularities	
Reentrant Corners: Other		Steps in Elevation View: Single Change	
Out of Plane Lateral-Force-Resistance Elements		None	
None		None	
Falling Hazards		Poor Conditions	
None		None	
None		None	
None		None

E Plan Irregularity Primary
