# Prospect School

Jack\_sch49A

## FEMA 154 Rapid Visual Screening Score Card

Rapid Visual Screening - Senate Bill #2 - Seismic Needs Assessment  
Oregon Department of Geology and Mineral Industries

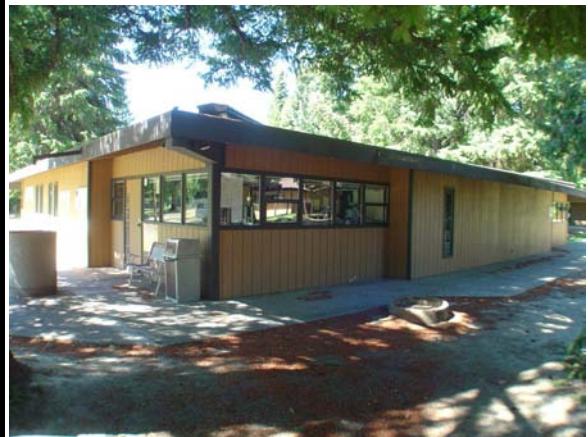
Type	Basic Score	Vert Irreg	Plan Irreg	Pre-Code	Post-Bench	Soil C	Soil D	Soil E	RVS Score
Primary	W2	4.8	0	-0.5	0	1.6	-0.8	0	0	5.1
Secondary		0	0	0	0	0	0	0	0	0
Tertiary		0	0	0	0	0	0	0	0	0

Low (<1%)

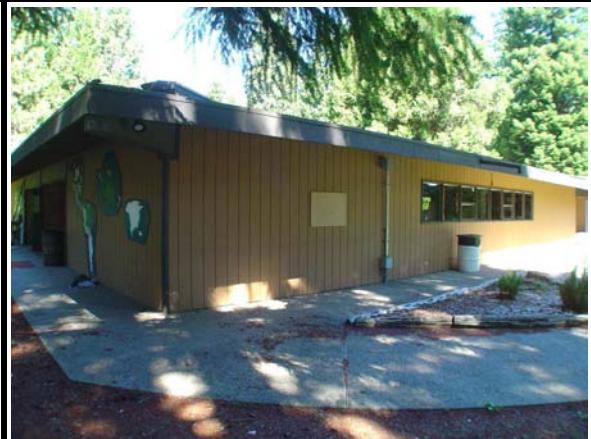
Jack\_sch49B

Type	Basic Score	Vert Irreg	Plan Irreg	Pre-Code	Post-Bench	Soil C	Soil D	Soil E	RVS Score
Primary	W2	4.8	0	0	0	1.6	-0.8	0	0	5.6
Secondary		0	0	0	0	0	0	0	0	0
Tertiary		0	0	0	0	0	0	0	0	0

Low (<1%)

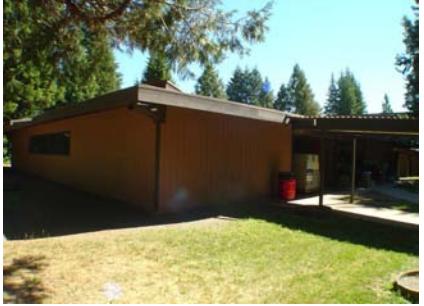
SW General Site

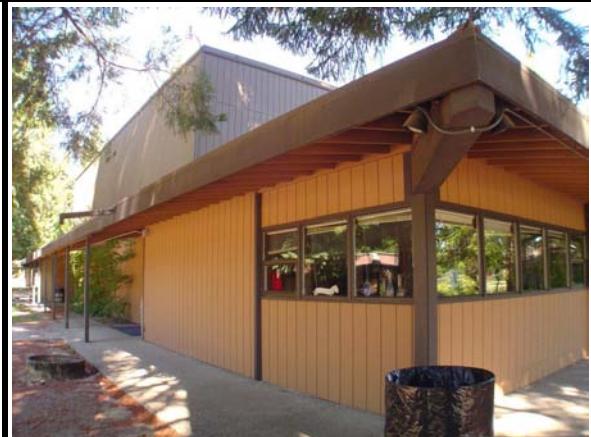
Jack\_sch49C

Type	Basic Score	Vert Irreg	Plan Irreg	Pre-Code	Post-Bench	Soil C	Soil D	Soil E	RVS Score
Primary	W2	4.8	-3	-0.5	0	1.6	-0.8	0	0	2.1
Secondary		0	0	0	0	0	0	0	0	0
Tertiary		0	0	0	0	0	0	0	0	0

Low (<1%)

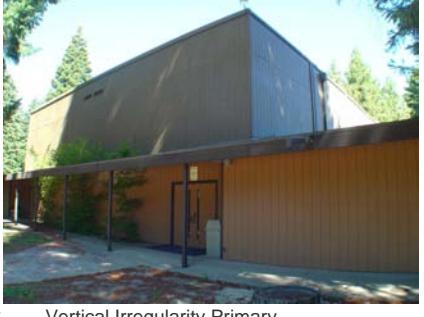
Enrollment 187	Year Built (Field Verified) 1980	Year Built (Alt. Source) 1980	Est. Decade Built 1980
Total Area (square ft) 33513	Number of Stories 1	Basement	Pounding Potential No
Plan Irregularities Out of Plane Lateral-Force-Resistance Elements None None		Vertical Irregularities Steps in Elevation View: Single Change None None	
Falling Hazards None None None		Poor Conditions None None None

S Vertical Irregularity Primary

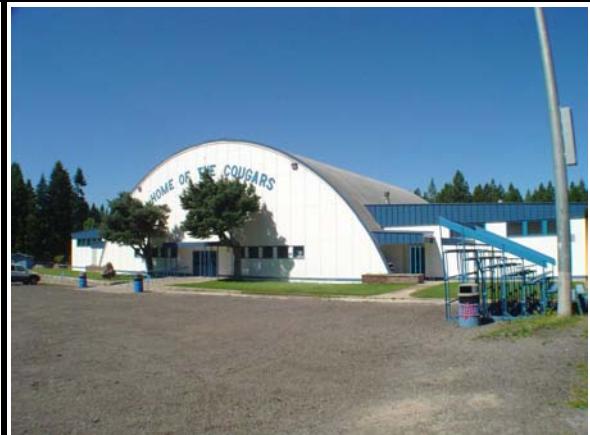
Jack\_sch49D

Type	Basic Score	Vert Irreg	Plan Irreg	Pre-Code	Post-Bench	Soil C	Soil D	Soil E	RVS Score
Primary	W2	4.8	-3	-0.5	0	0	-0.8	0	0	0.5
Secondary		0	0	0	0	0	0	0	0	0
Tertiary		0	0	0	0	0	0	0	0	0

High (>10%)

Enrollment 187	Year Built (Field Verified) 1980	Year Built (Alt. Source) 1980	Est. Decade Built 1970
Total Area (square ft) 33513	Number of Stories 1	Basement	Pounding Potential No
Plan Irregularities		Vertical Irregularities	
Reentrant Corners: Other		Steps in Elevation View: Single Change	
Out of Plane Lateral-Force-Resistance Elements		None	
None		None	
Falling Hazards		Poor Conditions	
None		None	
None		None	
None		None

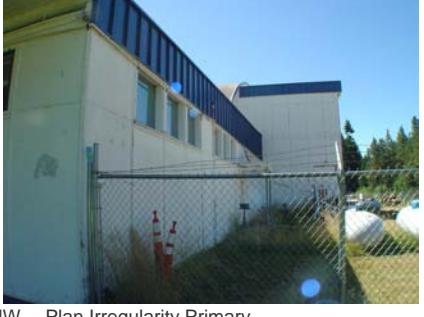
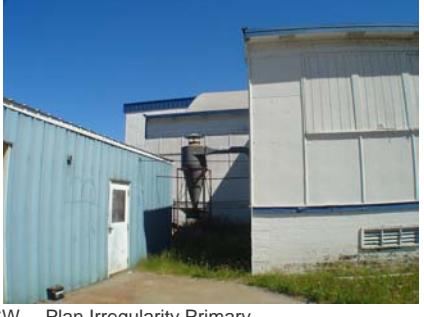
NW Plan Irregularity Primary		SW Plan Irregularity Primary
