Building Type Police - City	County Jefferson	
Street 71 SE D St		
City Madras	State OR	Zip 97741
Latitude 44.63325	Longitude 121.1281	
Tracking Code RVS in 2006	Inspection Date 8/9/2006

## FEMA 154 Rapid Visual Screening Score Card

# Madras Police Dept

Rapid Visual Screening - Senate Bill #2 - Seismic Needs Assessment  
Oregon Department of Geology and Mineral Industries

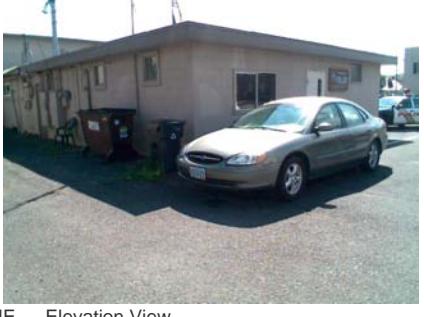
NE Elevation View

Enrollment	Year Built (Field Verified)	Year Built (Alt. Source)	Est. Decade Built
		1965	1960
Total Area (square ft)	Number of Stories	Basement	Pounding Potential
5818	1	No	No
Plan Irregularities		Vertical Irregularities	
Reentrant Corners:L shaped (Adjacent Build/Entity)		Steps in Elevation View: Single Change (Adjacent Building/Entity)	
None		None	
None		None	
Falling Hazards		Poor Conditions	
None		None	
None		None	
None		None
