# Warm Springs Elementary School

Jeff\_sch01A

## FEMA 154 Rapid Visual Screening Score Card

Rapid Visual Screening - Senate Bill #2 - Seismic Needs Assessment  
Oregon Department of Geology and Mineral Industries

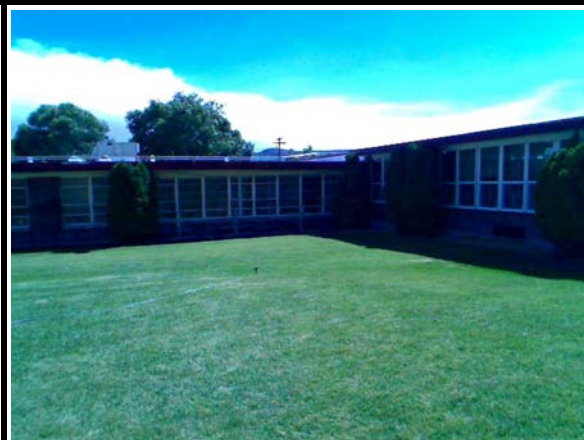
Type	Basic Score	Vert Irreg	Plan Irreg	Pre-Code	Post-Bench	Soil C	Soil D	Soil E	RVS Score
Primary	C2	3.6	-2	-0.5	0	0	-0.8	0	0	0.3
Secondary	RM1	3.6	-2	-0.5	0	0	-0.8	0	0	0.3
Tertiary		0	0	0	0	0	0	0	0	0

0.3

High (>10%)

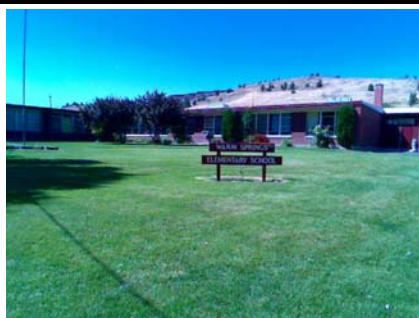
S Elevation View

Plan Irregularities	Vertical Irregularities
Reentrant Corners:T shaped (Adjacent Build/Entity)	Steps in Elevation View: Single Change (Adjacent Building/Entity)
None	None
None	None

Falling Hazards	Poor Conditions
None	None
None	None
None	None

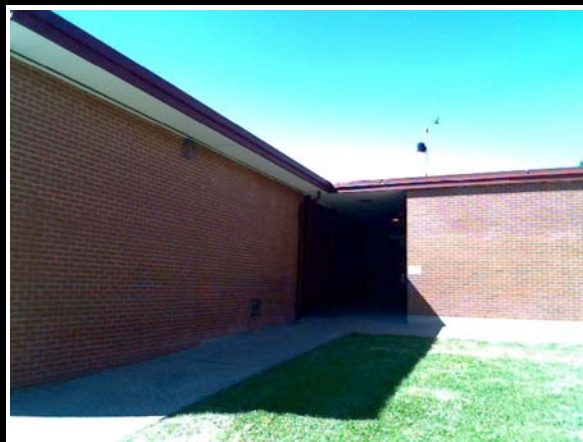
Jeff\_sch01B

Type	Basic Score	Vert Irreg	Plan Irreg	Pre-Code	Post-Bench	Soil C	Soil D	Soil E	RVS Score
Primary	C2	3.6	-2	-0.5	0	0	-0.8	0	0	0.3
Secondary	RM1	3.6	-2	-0.5	0	0	-0.8	0	0	0.3
Tertiary		0	0	0	0	0	0	0	0	0

0.3

High (>10%)

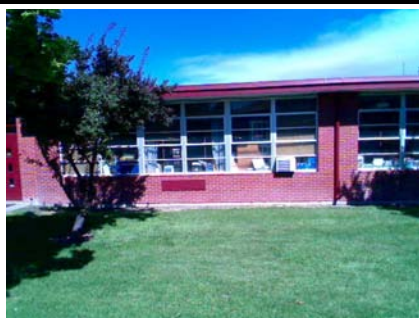
W Elevation View

Plan Irregularities	Vertical Irregularities
Reentrant Corners: Other (Adjacent Build/Entity)	Steps in Elevation View: Single Change
None	None
None	None

Falling Hazards	Poor Conditions
None	None
None	None
None	None

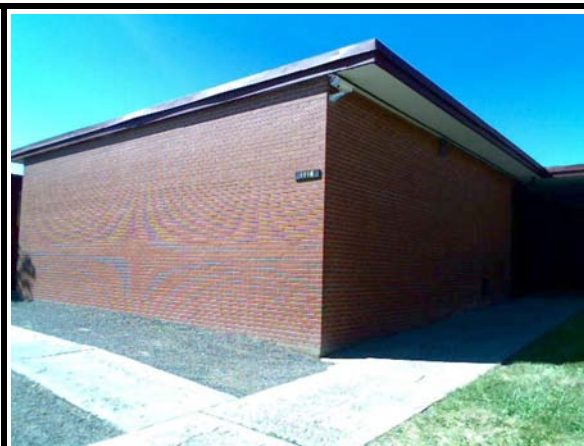
Jeff\_sch01C

Type	Basic Score	Vert Irreg	Plan Irreg	Pre-Code	Post-Bench	Soil C	Soil D	Soil E	RVS Score
Primary	W2	4.8	0	-0.5	0	1.6	-0.8	0	0	5.1
Secondary	S2	3.6	0	-0.5	0	0	-0.8	0	0	2.3
Tertiary		0	0	0	0	0	0	0	0	0

2.3

Low (<1%)

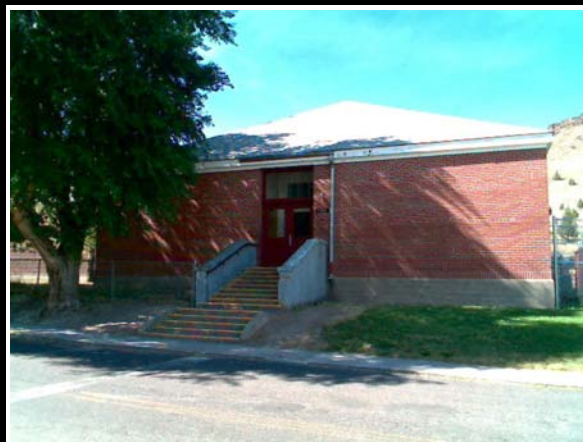
Jeff\_sch01D

Type	Basic Score	Vert Irreg	Plan Irreg	Pre-Code	Post-Bench	Soil C	Soil D	Soil E	RVS Score
Primary	URM	3.4	-1.5	-0.5	-0.4	0	-0.4	0	0	0.6
Secondary		0	0	0	0	0	0	0	0	0
Tertiary		0	0	0	0	0	0	0	0	0

0.6

High (>10%)

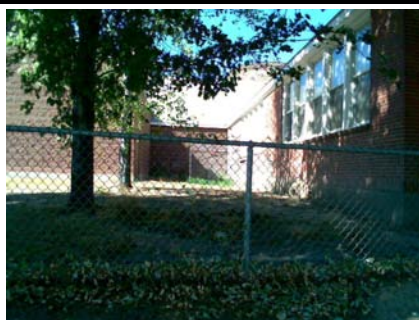
S Plan Irregularity Secondary

Plan Irregularities	Vertical Irregularities
Reentrant Corners: L Shaped	Steps in Elevation View: Single Change (Adjacent Building/Entity)
Reentrant Corners: L Shaped	None
None	None

Falling Hazards	Poor Conditions
None	None
None	None
None	None
