Rogue CC

Redwood - Building U (Gym)

Rapid Visual Screening - Senate Bill #2 - Seismic Needs Assessment  
Oregon Department of Geology and Mineral Industries

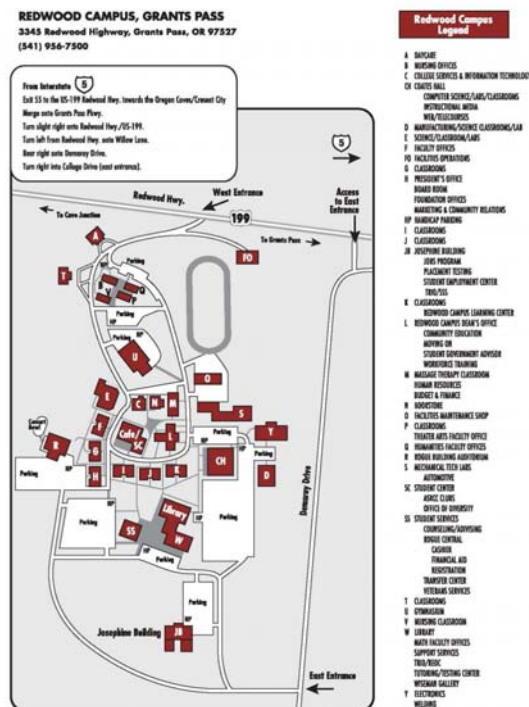
Seismicity Zone: High										
FEMA 154 Rapid Visual Screening Score Card										
	Type	Basic Score	Vert Irreg	Plan Irreg	Pre- Code	Post- Bench	Soil C	Soil D	Soil E	RVS Score
Primary	W2	3.8	-2	-0.5	0	0	0	0	0	1.3
Secondary		0	0	0	0	0	0	0	0	0
Tertiary		0	0	0	0	0	0	0	0	0

W2      1.3

Moderate (>1%)

Plan Irregularities	Vertical Irregularities
Yes: Unknown	Yes: Unknown

Falling Hazards	Poor Conditions
None	
None	
None
