Applegate Valley RFPD 9

Building Type		County	
Fire - RFPD		Josephine	
Street			
1076 Kubli Rd			
City	State	Zip	
Grants Pass	OR	97527	
Latitude		Longitude	
42.31545		123.23004	
Tracking Code		Inspection Date	
New Building		7/28/2006

FEMA 154 Rapid Visual Screening Score Card

Rapid Visual Screening - Senate Bill #2 - Seismic Needs Assessment
Oregon Department of Geology and Mineral Industries

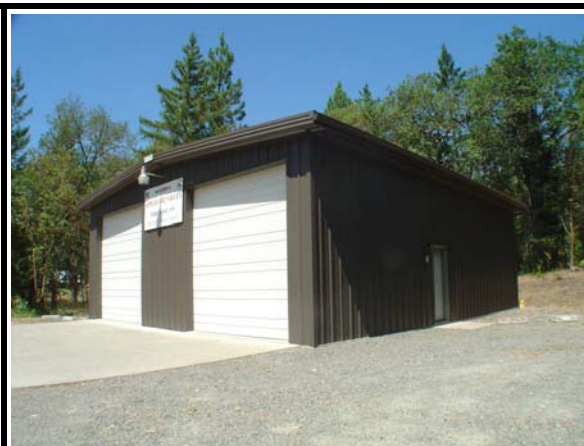
Type	Basic Score	Vert Irreg	Plan Irreg	Pre-Code	Post-Bench	Soil C	Soil D	Soil E	RVS Score
Primary	S3	3.2	0	-0.5	0	0	-0.4	0	0	2.3
Secondary		0	0	0	0	0	0	0	0	0
Tertiary		0	0	0	0	0	0	0	0	0

Low (<1%)

Enrollment	Year Built (Field Verified)	Year Built (Alt. Source)	Est. Decade Built
		1998	1990
Total Area (square ft)	Number of Stories	Basement	Pounding Potential
1512	1	No	No

Plan Irregularities	Vertical Irregularities
Torsion: Eccentric Stiffness	None
None	None
None	None

Falling Hazards	Poor Conditions
None	None
None	None
None	None

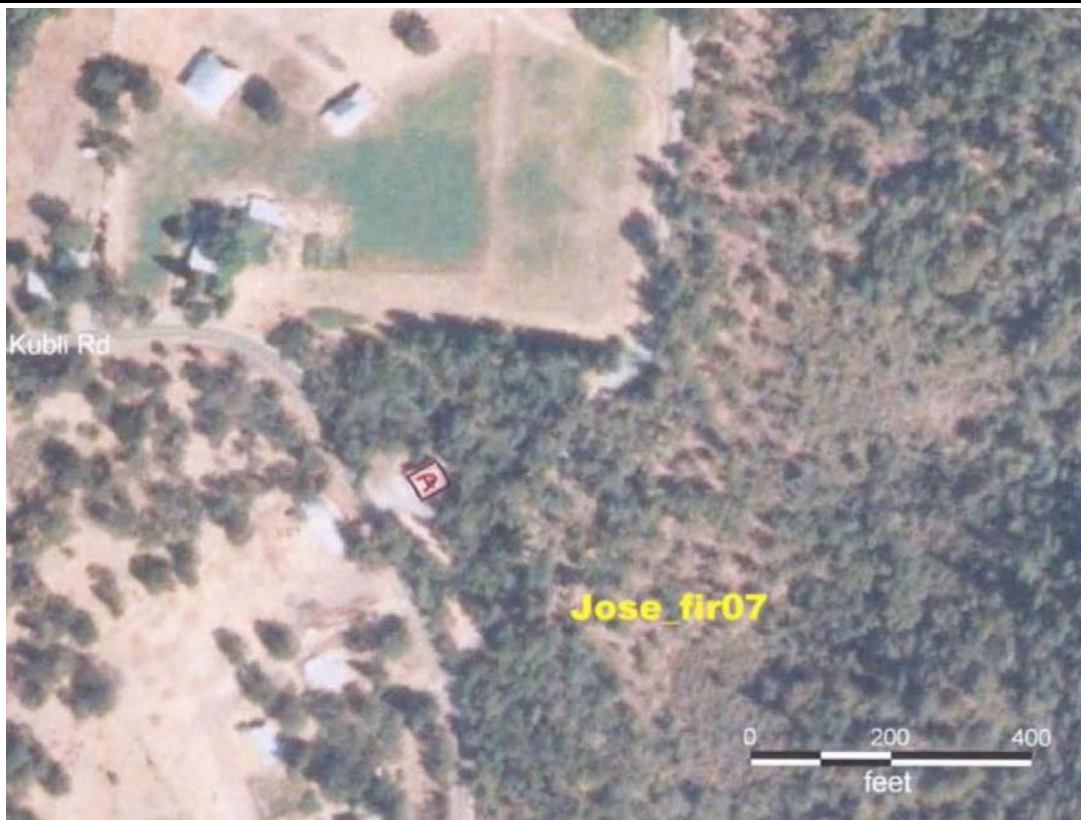
Seismicity Zone: High

FEMA-154 Collapse Potential
