# Wolf Creek RFPD

## FEMA 154 Rapid Visual Screening Score Card

Rapid Visual Screening - Senate Bill #2 - Seismic Needs Assessment  
Oregon Department of Geology and Mineral Industries

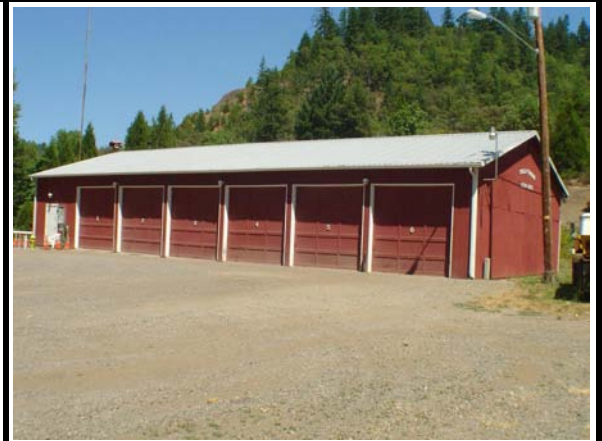
Seismicity Zone: High

| | Type | Basic Score | Vert Irreg | Plan Irreg | Pre-Code | Post-Bench | Soil C | Soil D | Soil E | RVS Score |
|---|---|---|---|---|---|---|---|---|---|---|
| Primary | W2 | 3.8 | 0 | -0.5 | 0 | 0 | 0 | 0 | 0 | 3.3 |

3.3

Low (<1%)
