# Redwood Elementary School

Jose\_sch03A

## FEMA 154 Rapid Visual Screening Score Card

Rapid Visual Screening - Senate Bill #2 - Seismic Needs Assessment  
Oregon Department of Geology and Mineral Industries

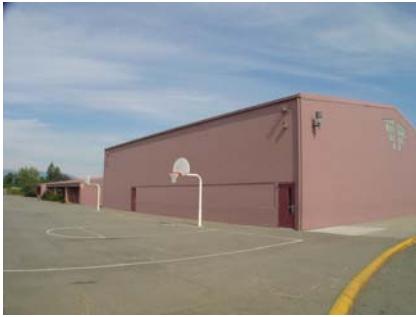
Enrollment 475	Year Built (Field Verified) 1945	Year Built (Alt. Source) 1945	Est. Decade Built 1980
Total Area (square ft) 47376	Number of Stories 1	Basement	Pounding Potential No
Plan Irregularities		Vertical Irregularities	
Reentrant Corners: Other		Steps in Elevation View: 2 to 3 Changes	
Large Diaphragm or Central Opening		None	
None		None	
Falling Hazards		Poor Conditions	
None		None	
None		None	
None		None

SE General Site	S Vertical Irregularity Primary	S Plan Irregularity Primary

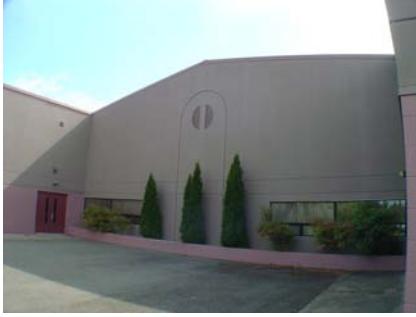
W Secondary Structural Type	N Plan Irregularity Secondary
